Coal Mining Risk Assessment

Land to the Rear of 13 Risdale
Road

Report Ref: B4355/24

October 2024

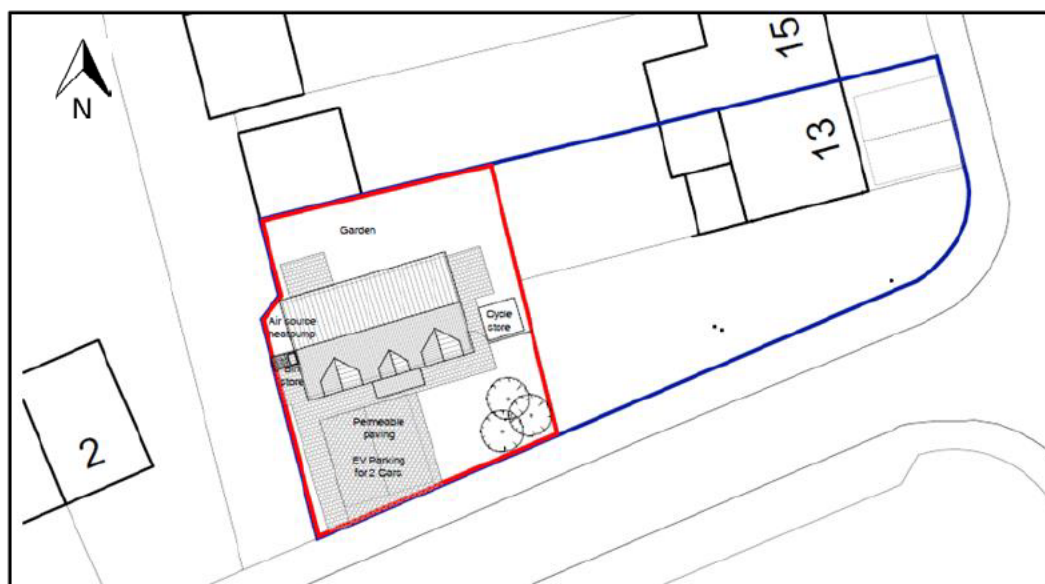
Figure 1 – Proposed Development Layout Details

- 1.3 It is proposed to construct 1 new detached residential dwelling with permeable paving, EV parking, an air source heat pump and associated soft landscaping.
- 1.4 Details of the proposed development are shown in Figure 1 below.

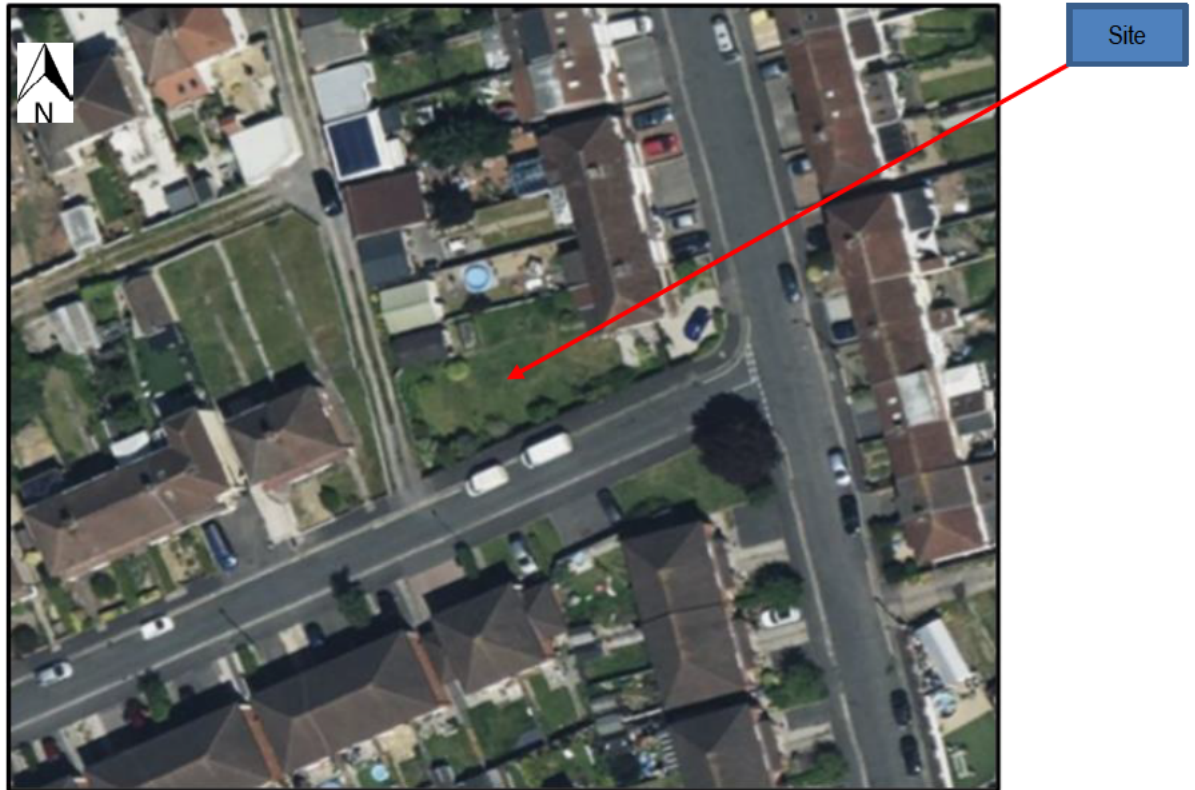
Figure 2 – Aerial Photograph Showing Site Location and Surrounding Area

- 2.1 The site is located to the rear of 13 Risdale Road, in Ashton, approximately 3km southwest of Bristol city centre at approximate National Grid Reference 356663, 170368, and with a nearest postcode of BS3 2QU. The site and surrounding area are shown in Figure 2 below.

- 2.2 The site is located in a residential area and is bounded on all sides by houses and associated gardens.
- 2.3 At the time of writing this report, the site was used as garden space for 13 Risdale Road and bound by fence panels.
