Coal Mining Risk Assessment

Emery Road

Brislington

Report Ref: B5271/25

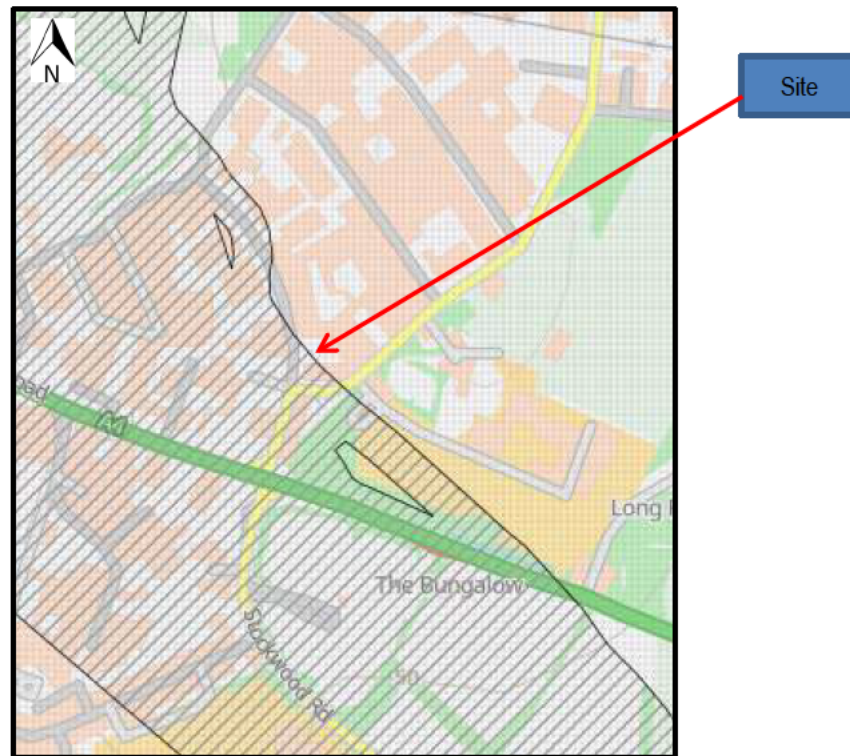
Figure 5 – Plan Showing Site Location and Development High Risk (Hatched) Area

- 3.8 Probable unrecorded workings are recorded to be present beneath the site.
- 3.9 Examination of the Coal Authority online interactive map viewer indicates the western half of the site is located within a Development High Risk Area (DHRA), associated with past underground mining, as shown in Figure 5 overleaf. It is likely the development high risk area is associated with potential shallow depth workings in the coal outcrop shown across the site, as discussed below.

- 4.8 Examination of the Coal Authority online interactive map viewer indicates the site is located in a Development High Risk Area (DHRA), associated with unrecorded past underground workings.
