## **Construction Noise and Vibration Monthly Report – July 2025**

**London Borough of Ealing**

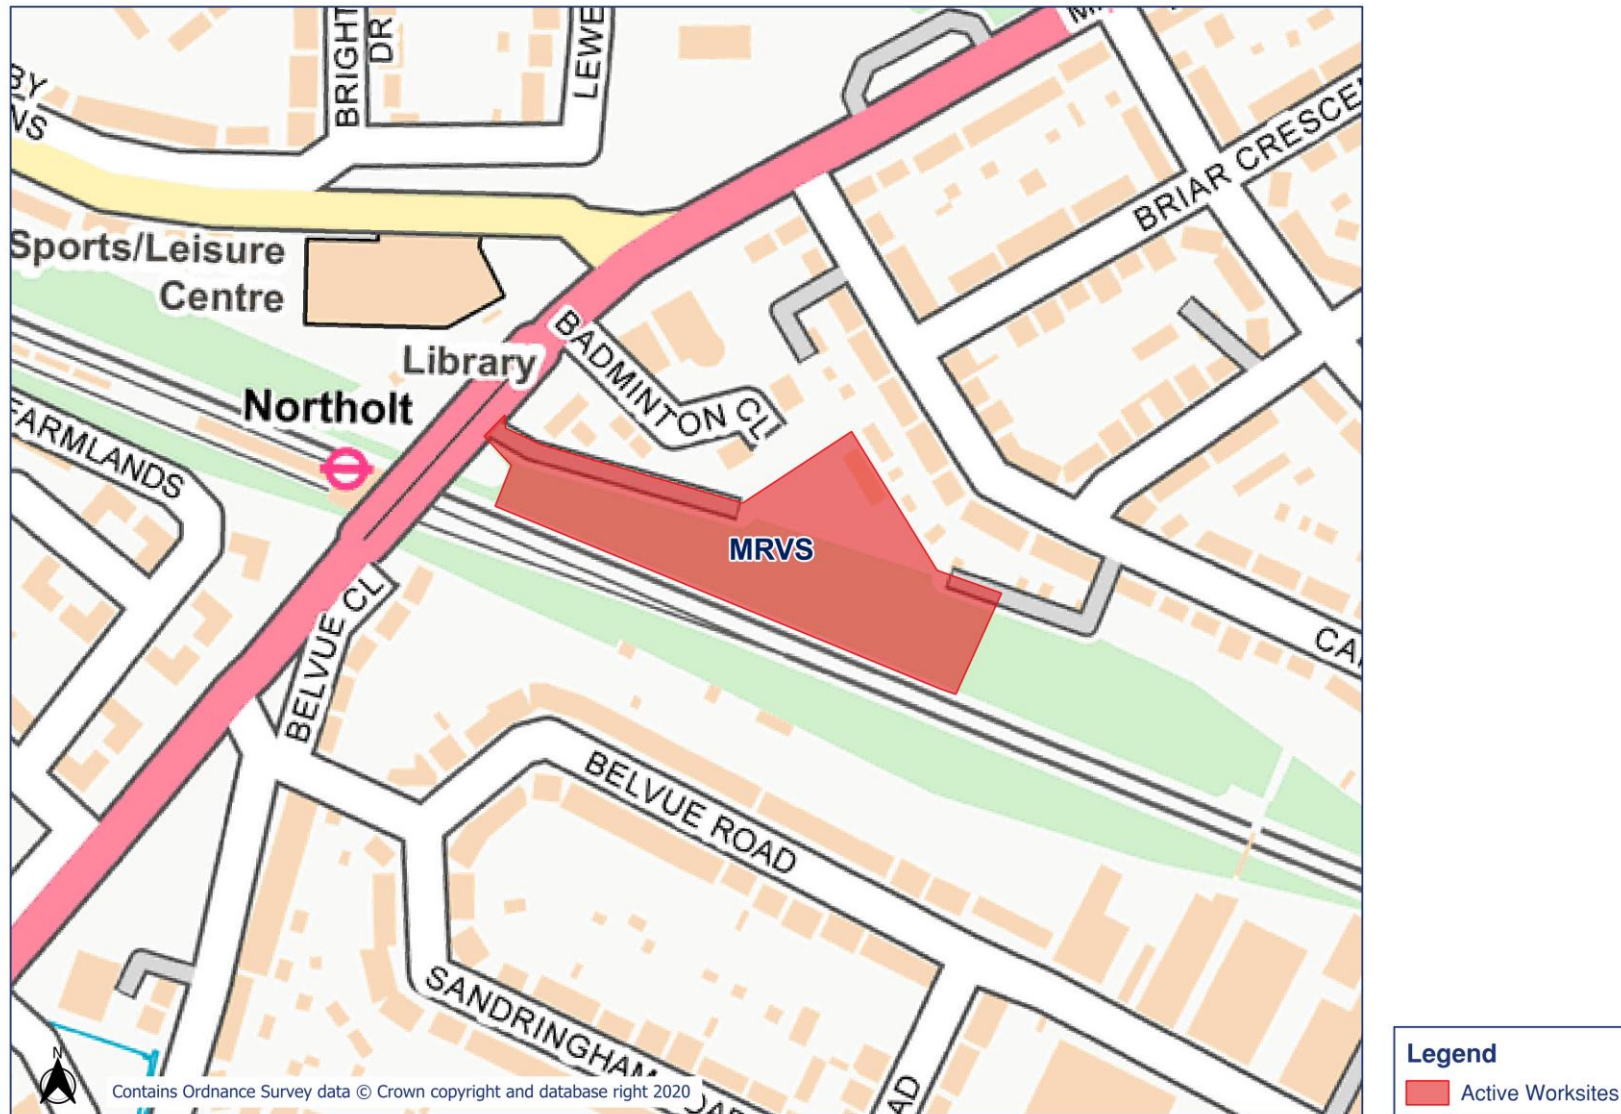
## Worksite Identification Plan - 1

- 1.1.4 Active construction sites in the local authority area, where noise and vibration monitoring were conducted during this period, include:
- Mandeville Road Ventilation Shaft worksite, reference MRVS (see plan 1 in Appendix A), where work activities included:

- Concrete element construction.
    - Concrete breaking.
    - Removal of temporary tunnel boring machine segments and foamed concrete backfill.
  - Green Park Way Ventilation Shaft worksite, reference GPWVS (see plan 2 in Appendix A), where work activities included:

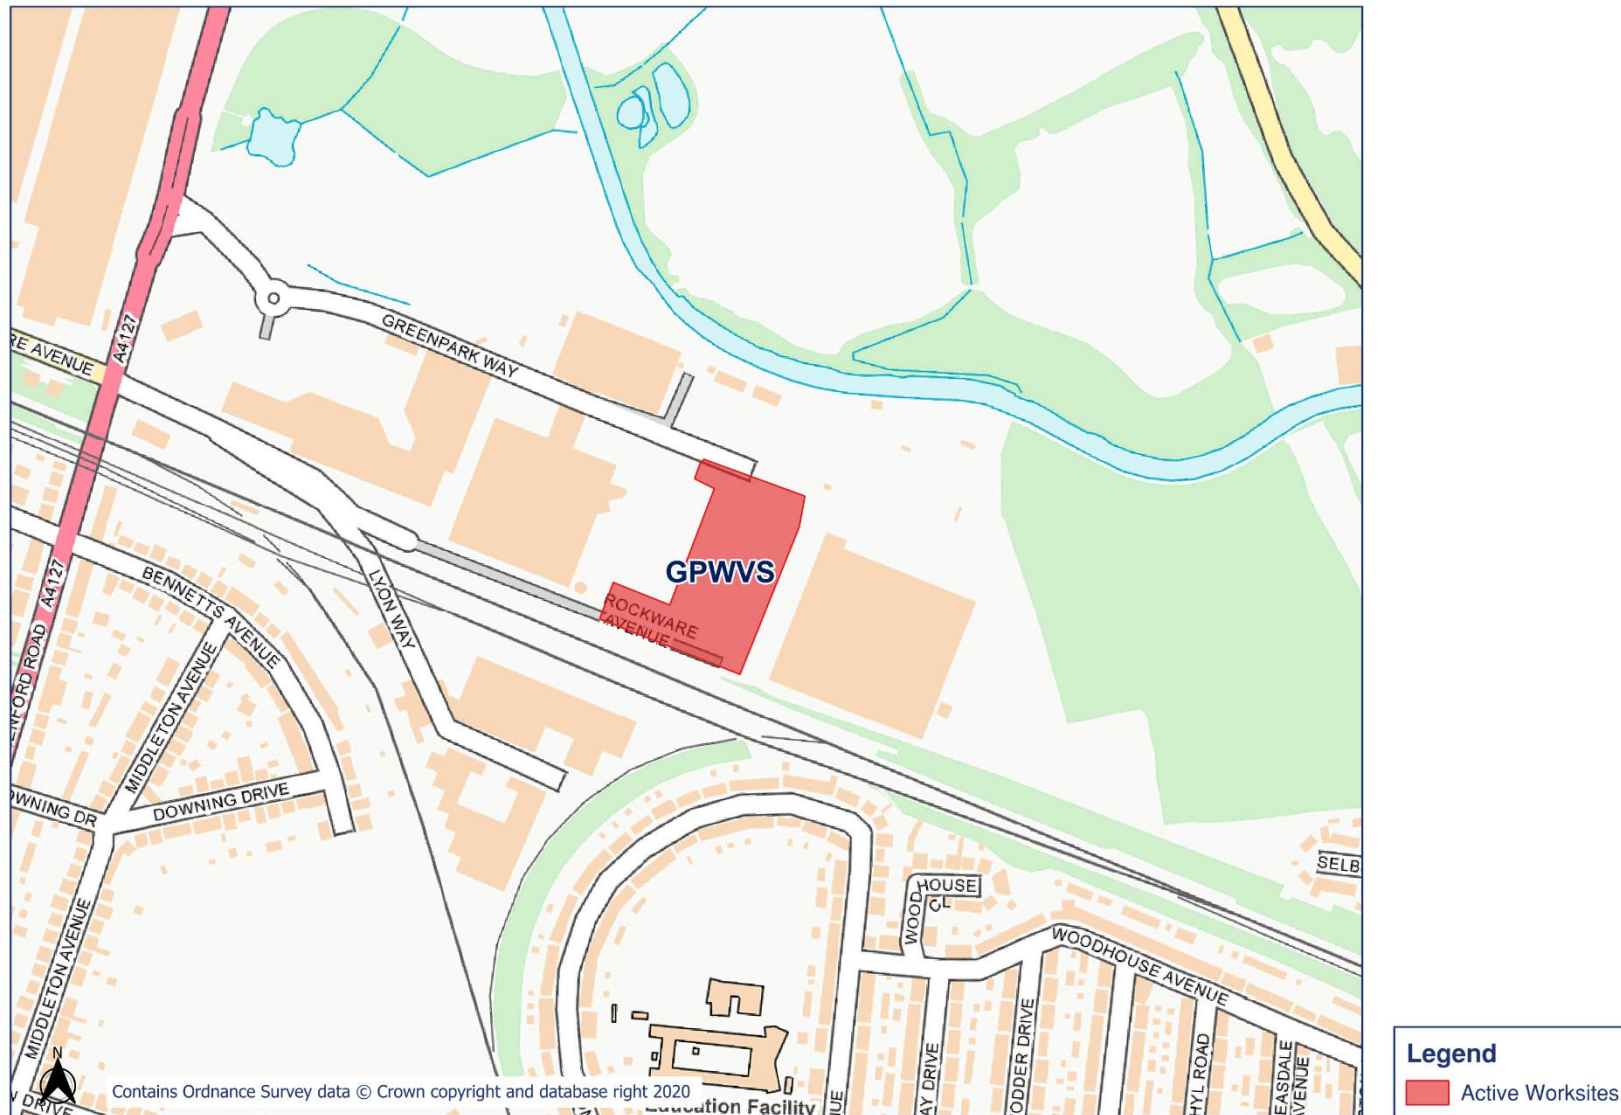
## Worksite Identification Plan - 2

- General site operations, including maintenance and road sweeping.
    - Utility works.

- Maintenance of shaft dewatering system.
- Tunnel boring machine works including lifting, section removal and dismantling.
- Installation of dewatering wells.

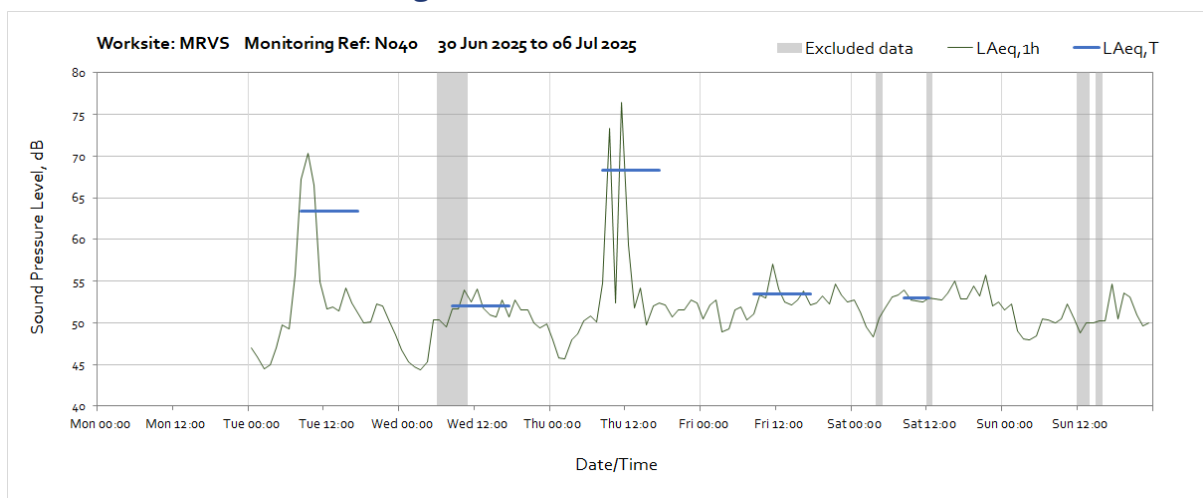
### Worksite: MRVS – Monitoring Ref: N040

The following graphs show the hourly measured ambient noise level  $L_{Aeq,1h}$  and, where relevant, the averaged noise level  $L_{Aeq,T}$  values, where the time period T is as specified in Table 1 of HS2 Information Paper E23. Periods where noise levels are adversely affected by weather or only measured for part of the period, which are not representative of HS2 construction works, have been greyed out and excluded from the calculation of the  $L_{Aeq,T}$  values in Table 3 of the main report.

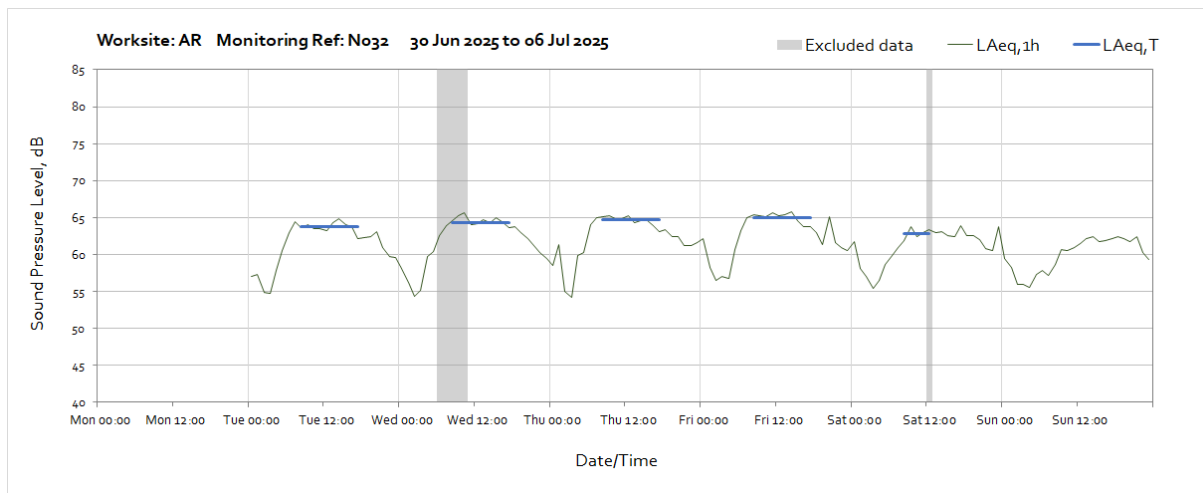
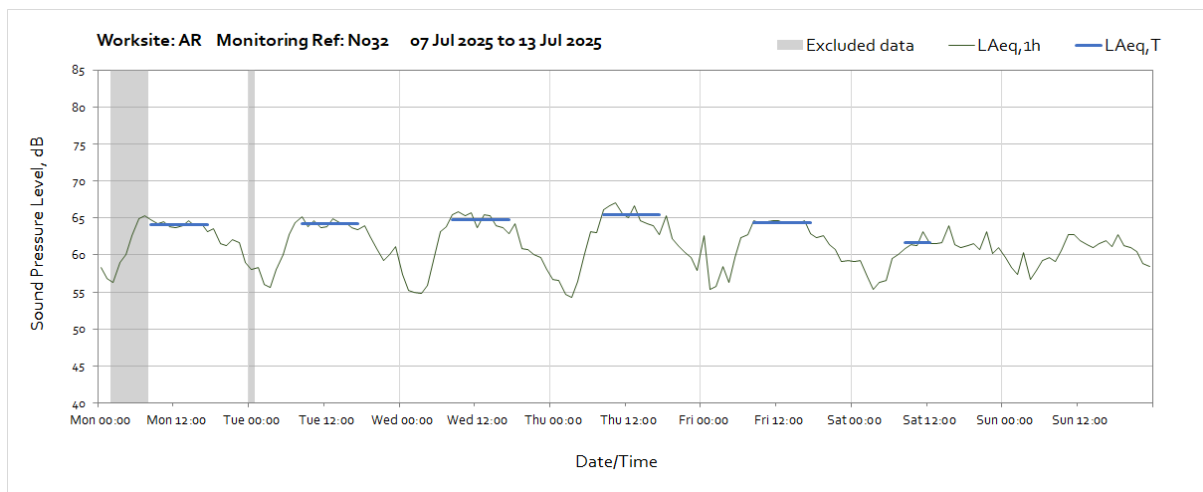
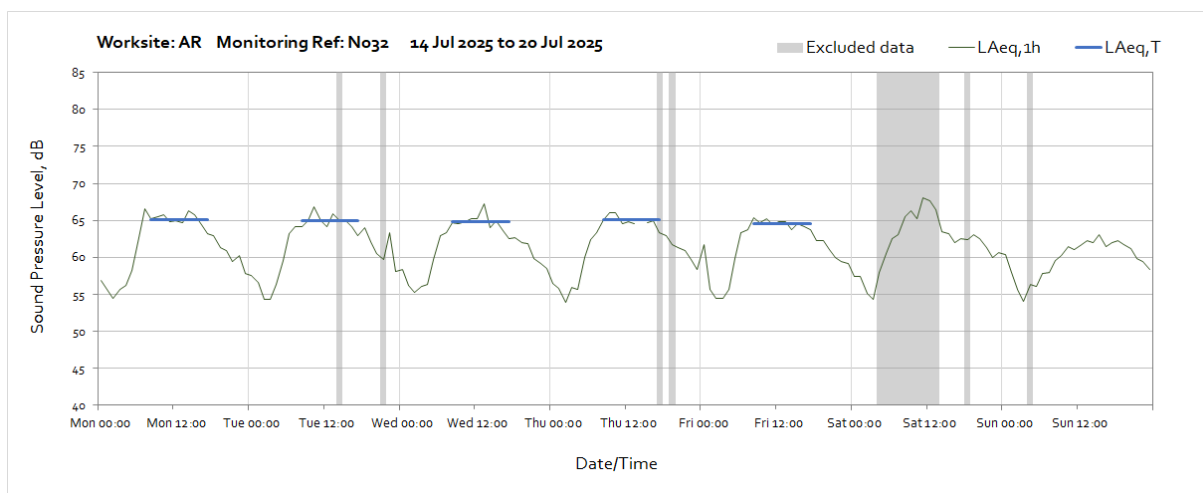
## Worksite: AR – Monitoring Ref: N032

Note: Missing data between 14:00 and 15:00 on Thursday 17<sup>th</sup> July was due to monitor maintenance.

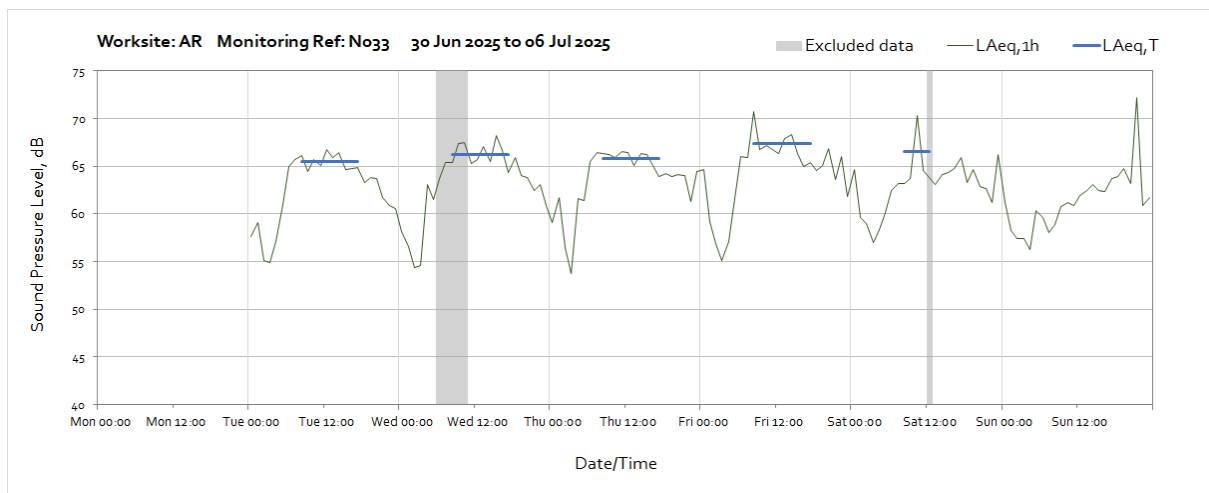
## Worksite: AR – Monitoring Ref: N033

Note: Missing data between 12:00 and 14:00 on Thursday 17<sup>th</sup> July was due to monitor maintenance.

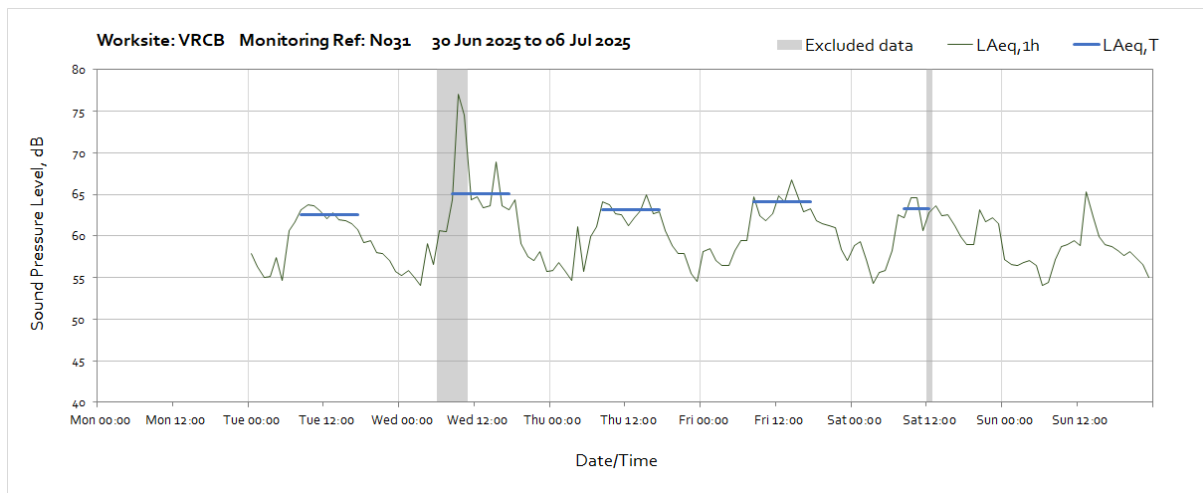
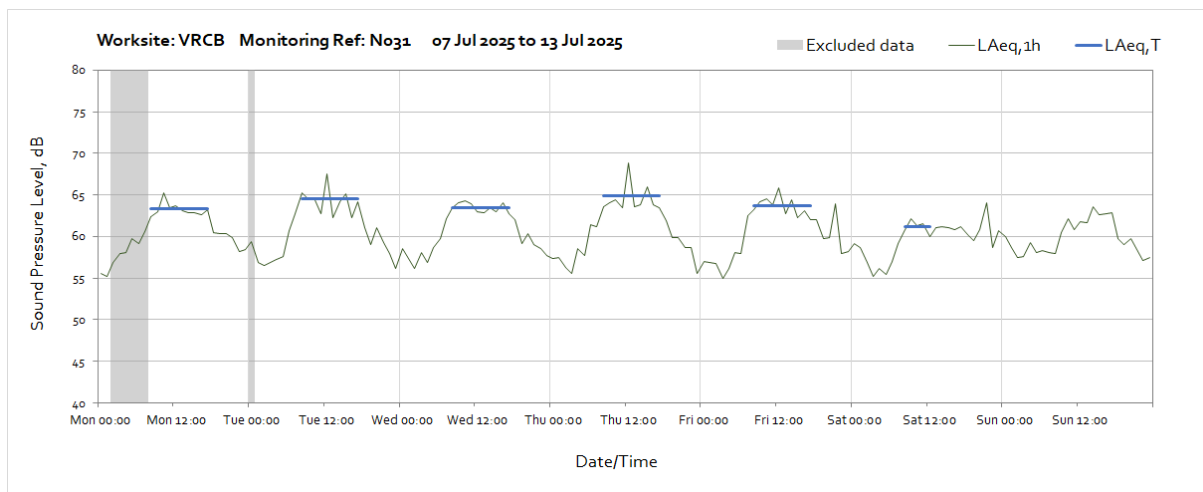
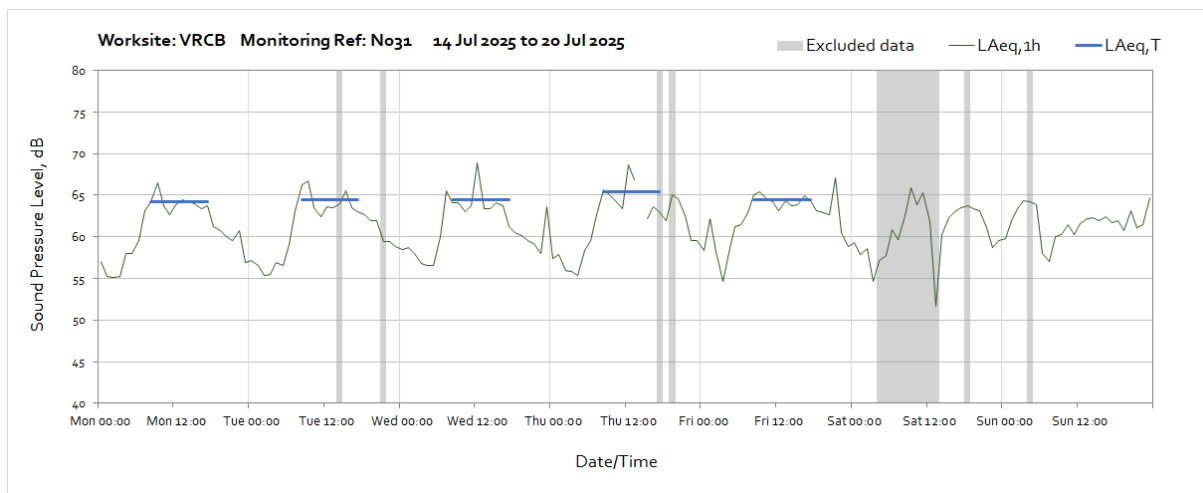
## Worksite: VRCB – Monitoring Ref: N031

Note: Missing data between 14:00 and 15:00 on Thursday 17<sup>th</sup> July was due to monitor maintenance.

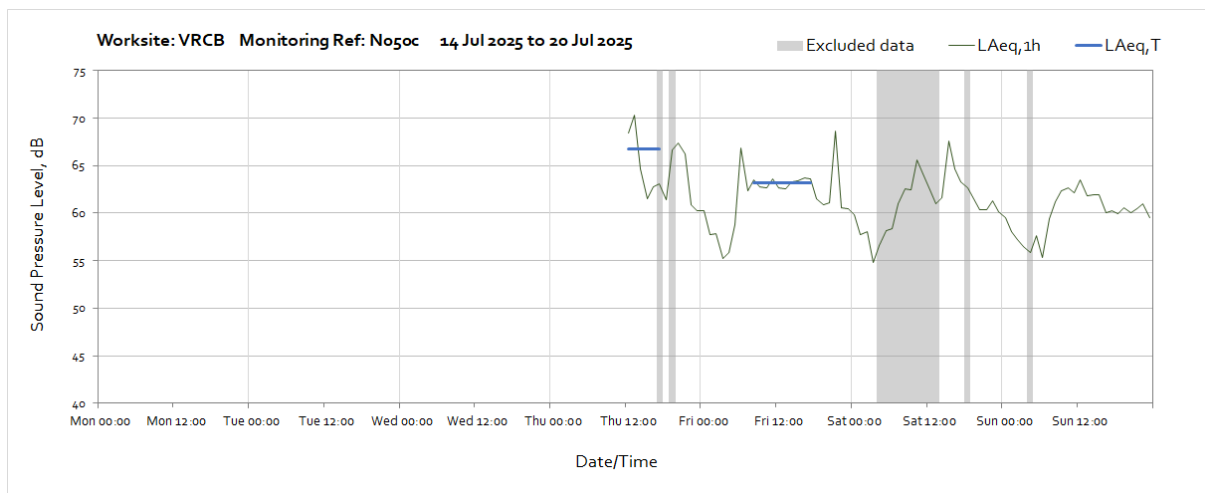
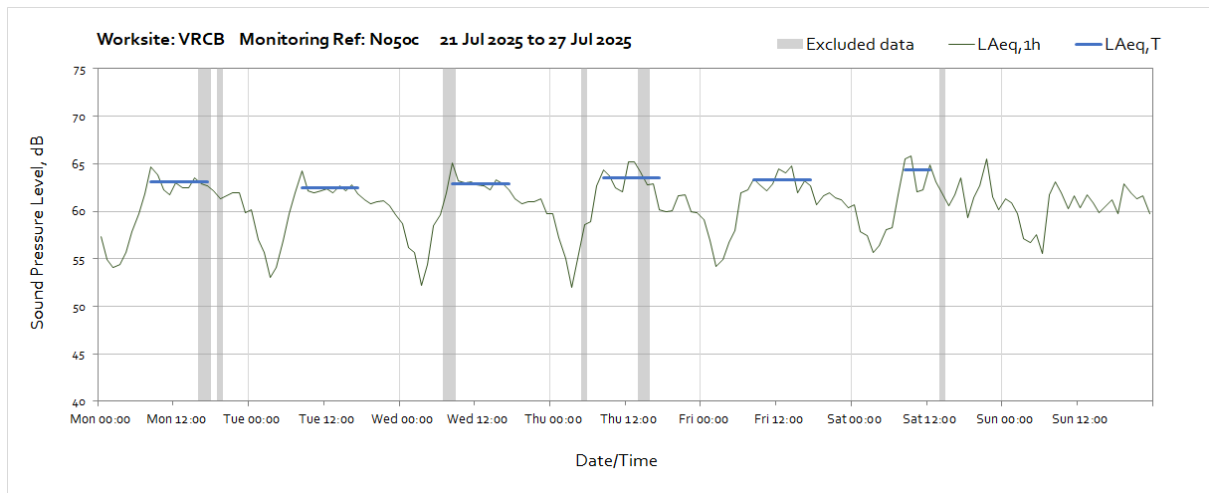
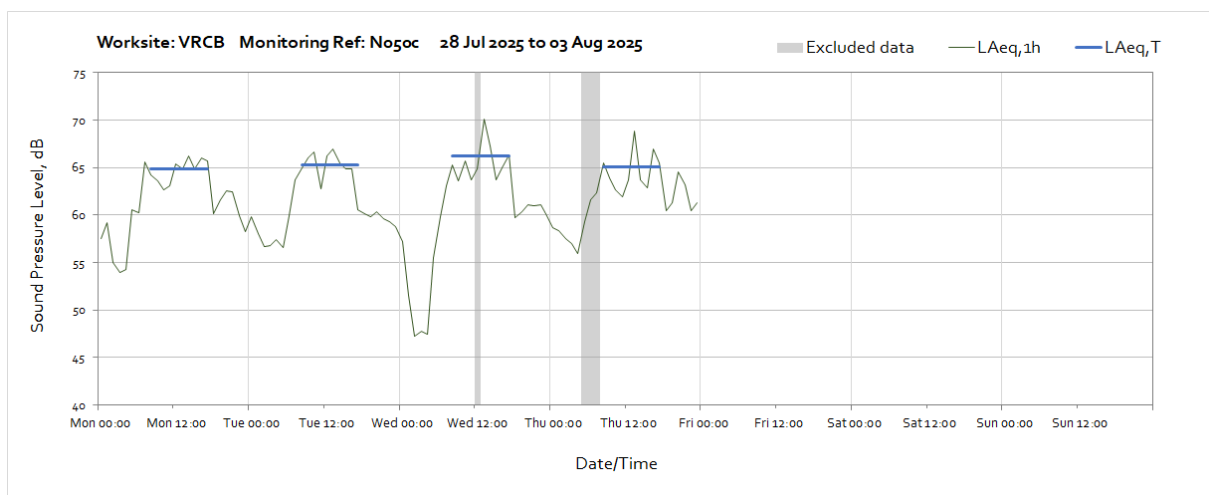
## Worksite: VRCB – Monitoring Ref: N050c

Note: Noise monitor installed at 12:00 on Thursday 17<sup>th</sup> July.

- 2.1.3 Appendix C presents graphs of the noise and vibration monitoring data over the month for each of the measurement locations. Noise data presented consists of the hourly  $L_{Aeq}$  values and, where relevant, the  $L_{Aeq,T}$  values (where the time period T has been taken to be the averaging period as specified in Table 1 of HS2 Information Paper E23). Vibration data presented consist of hourly PPV values. The full data set for the monitoring equipment can be found at the following location:  
<https://data.gov.uk/dataset/24542ae7-dd44-444f-b259-871c4cc43b5e/environmental-monitoring-data>.

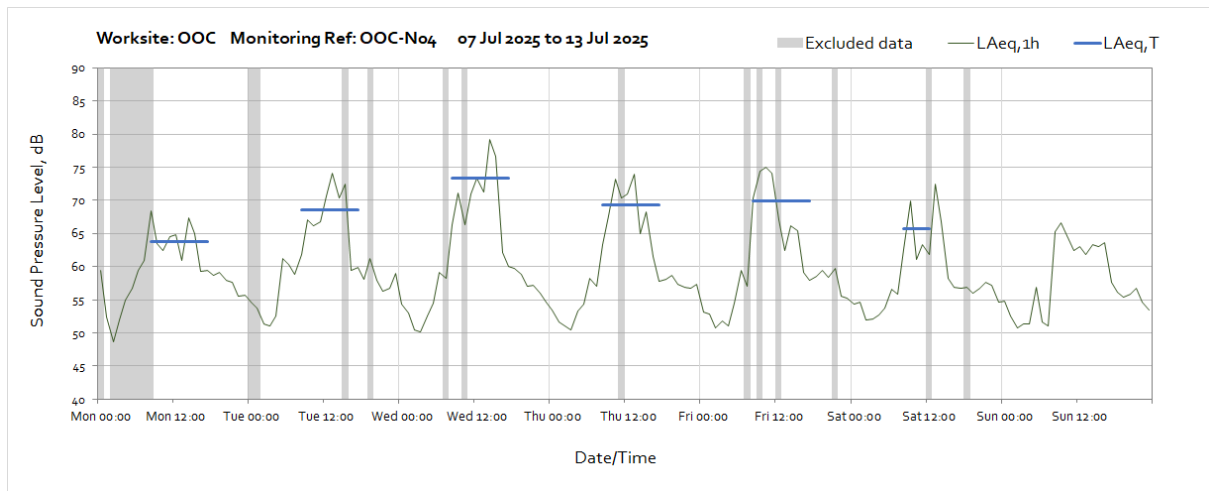
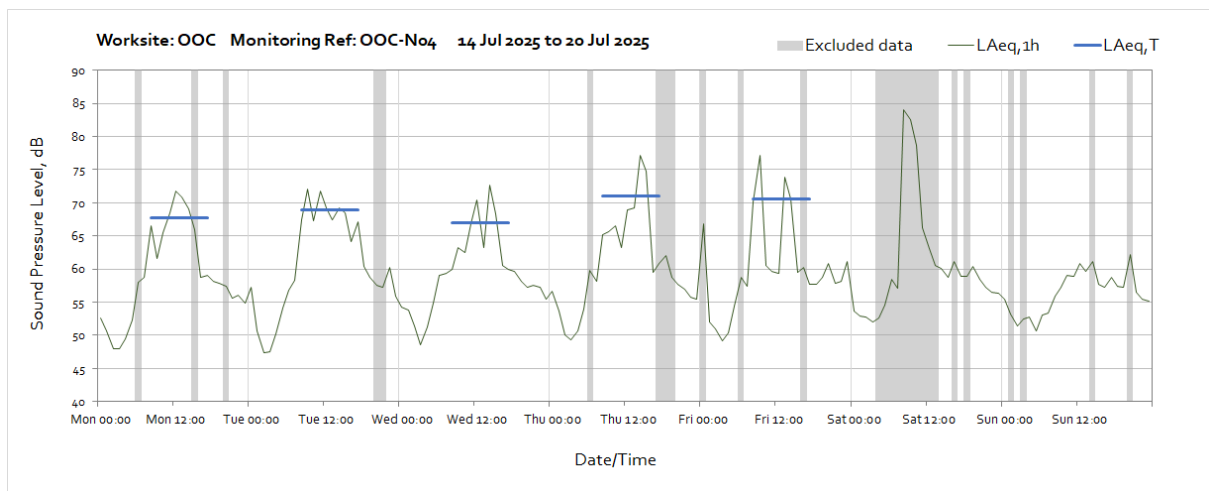
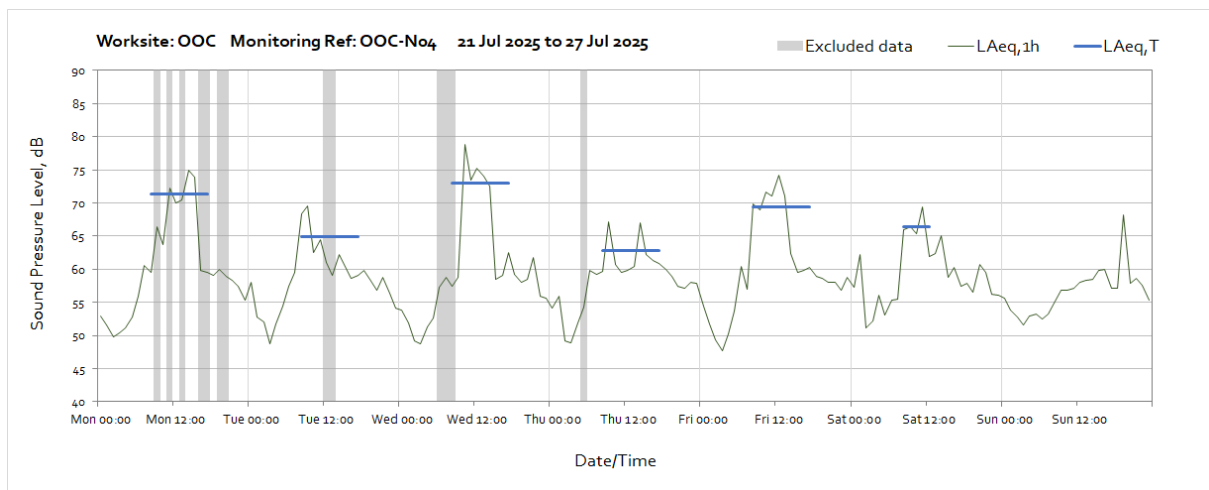
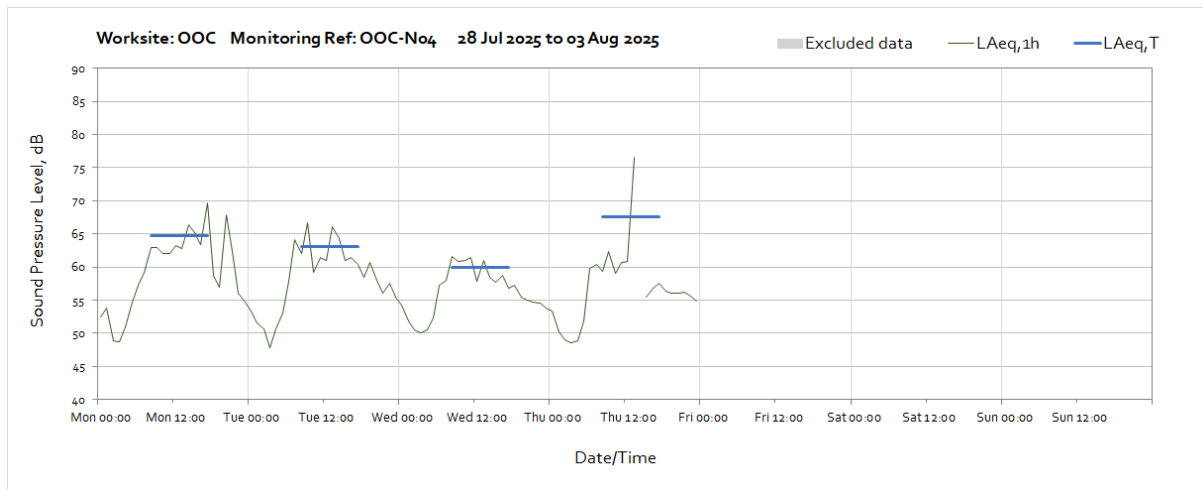
## Worksite: OOC – Monitoring Ref: OOC-N04

Note: Missing data between 14:00 and 15:00 on Thursday 31<sup>st</sup> July was due to power loss.

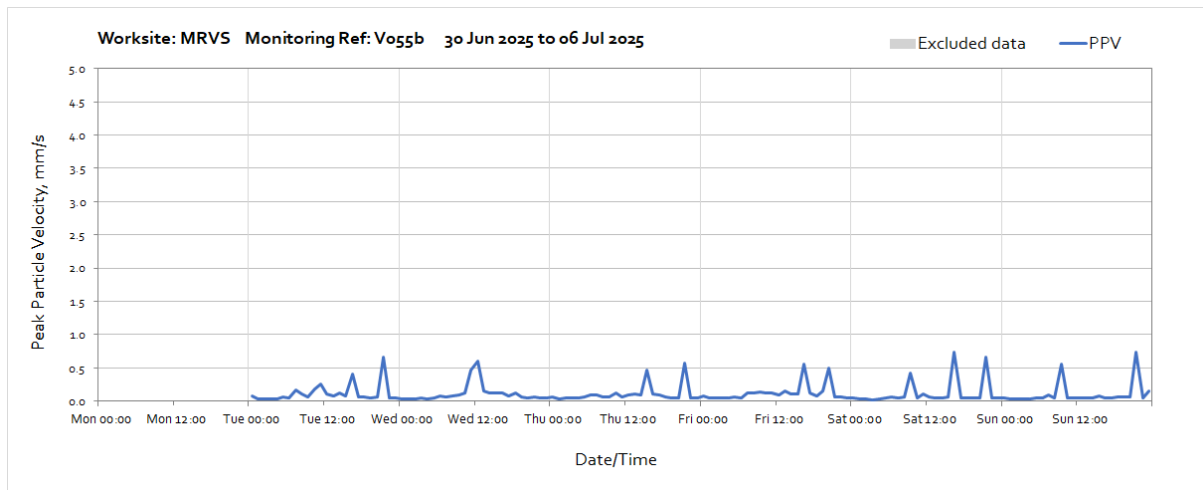
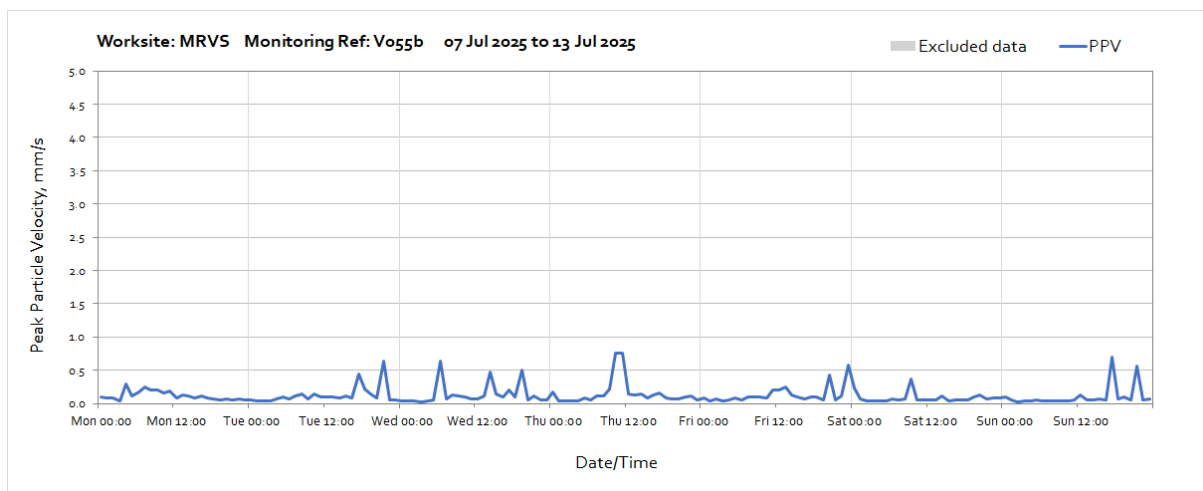
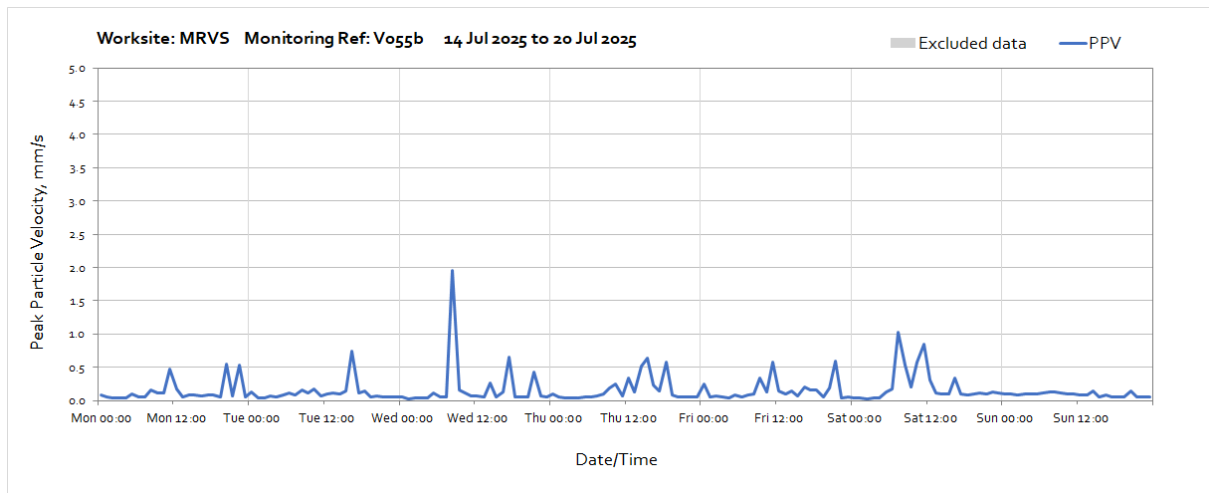
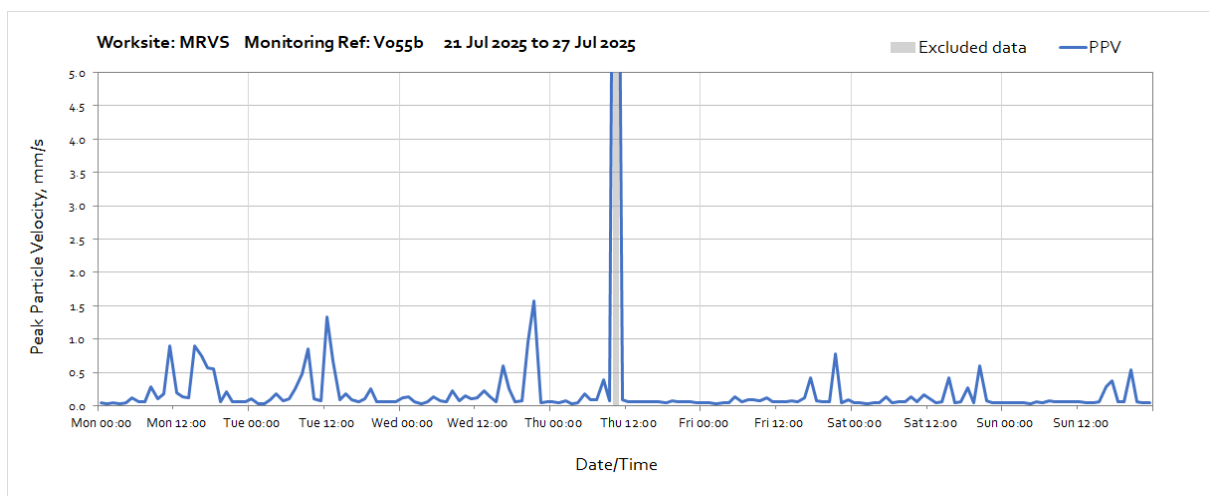
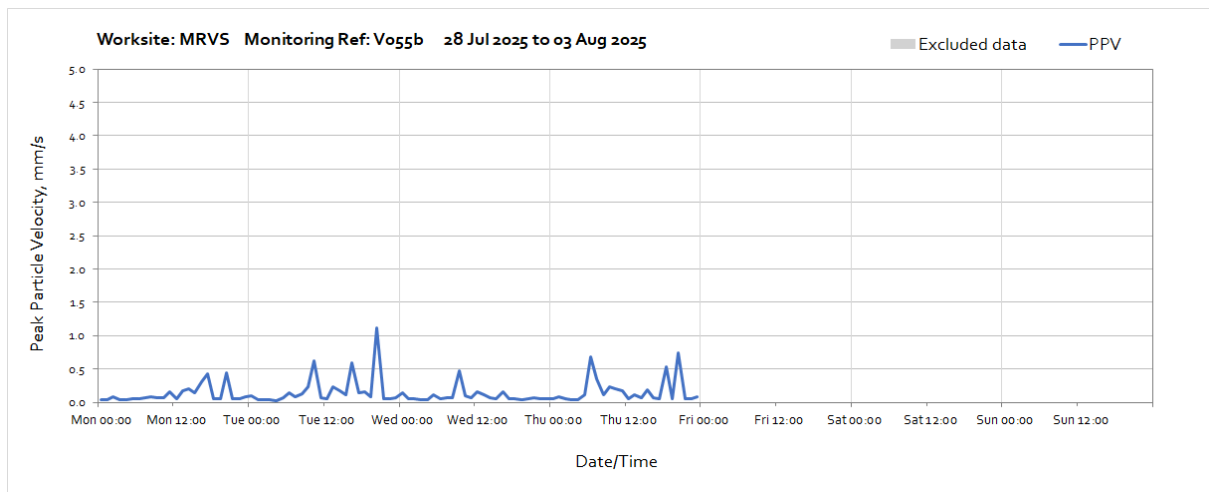
### Worksite: MRVS – Monitoring Ref: V055b

The following graphs show the hourly measured peak particle velocity PPV recorded during the monitoring period. The graphs show the highest PPV of the three orthogonal axis x, y and z. Periods where PPV values have been affected by local interference with the vibration monitor or only measured for part of the period, which are not representative of HS2 construction works, have been greyed out and excluded when calculating values in Table 4 of the main report.

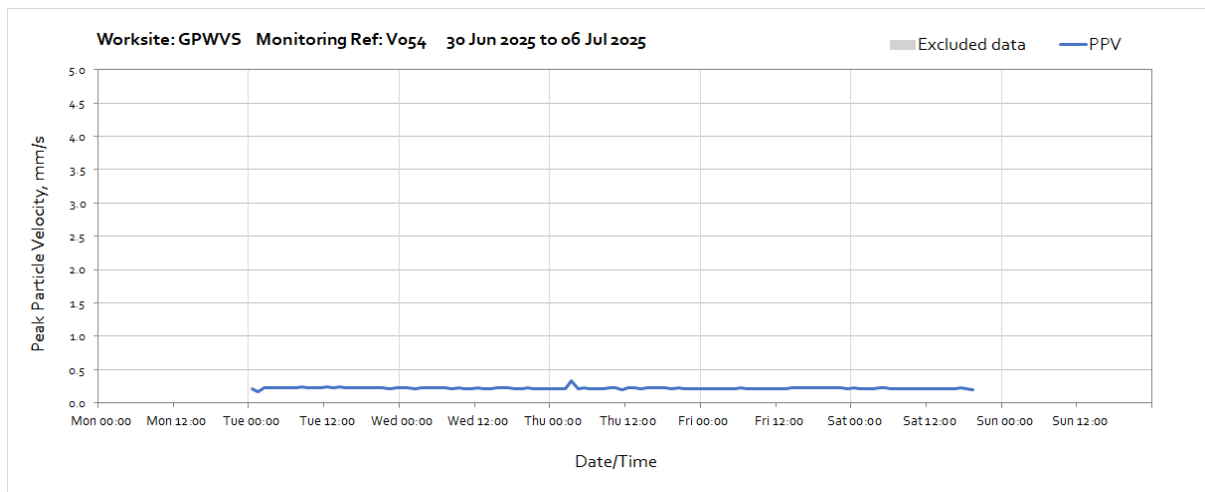
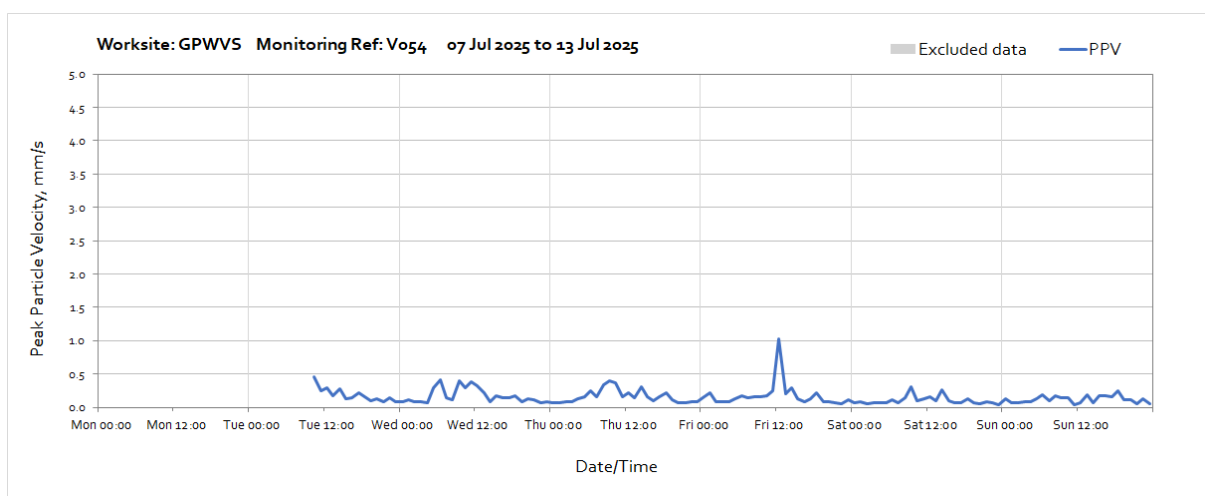
### Worksite: GPWVS – Monitoring Ref: V054

Note: Missing data between 20:00 on Saturday 5<sup>th</sup> July and 10:00 on Tuesday 8<sup>th</sup> July was due to a depleted battery.

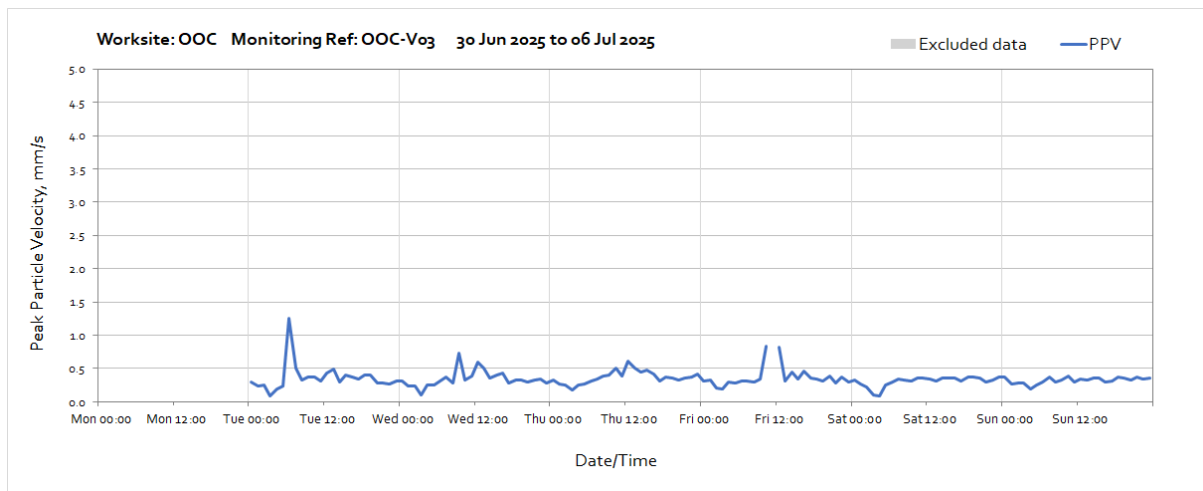
## Worksite: OOC – Monitoring Ref: OOC-V03

Note: Missing data between 11:00 and 12:00 on Friday 4<sup>th</sup> July was due to meter fault.

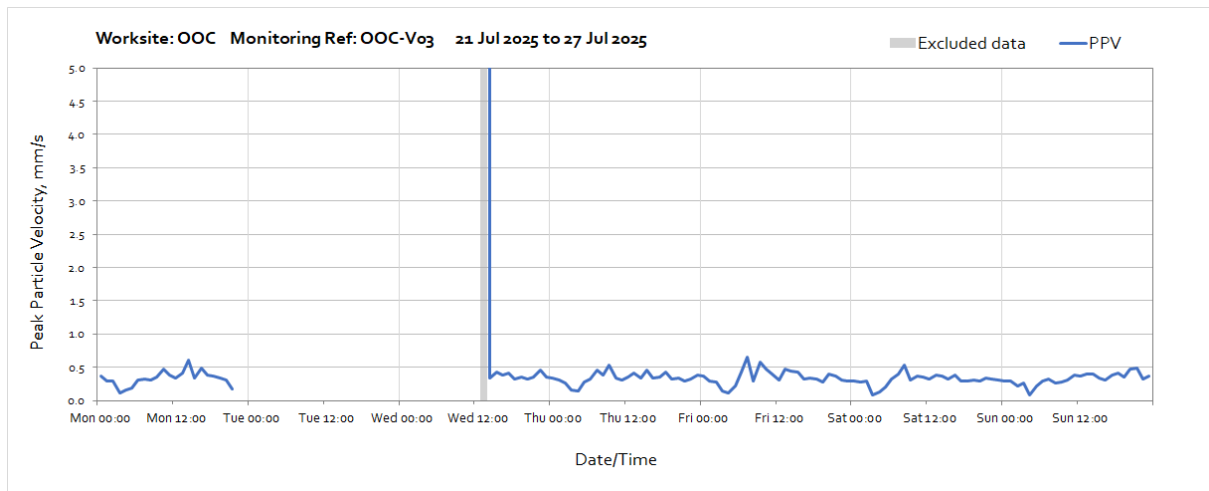
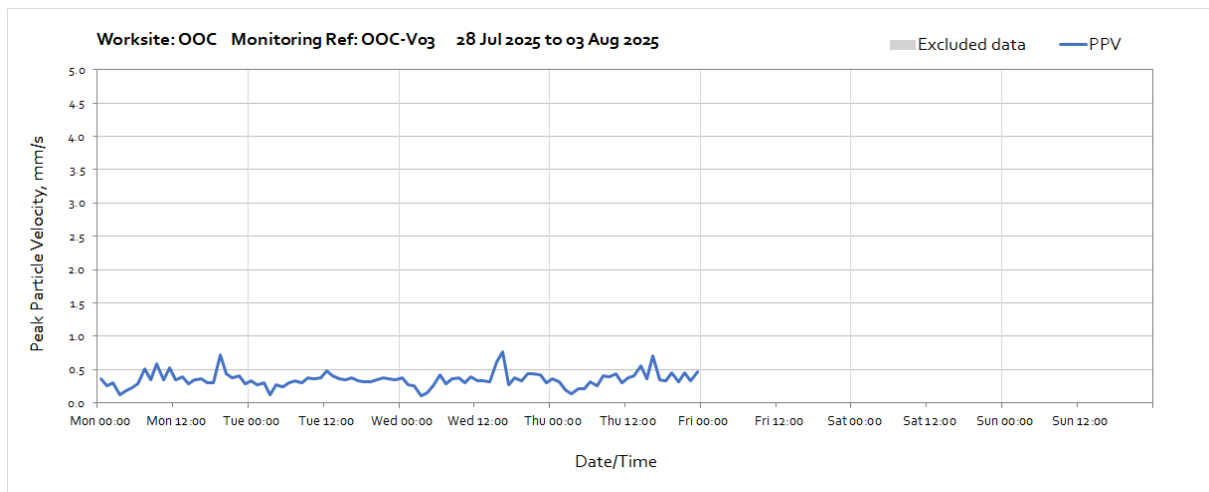
Note: Missing data between 22:00 on Monday 21<sup>st</sup> July and 13:00 on Wednesday 23<sup>rd</sup> July was due to power loss at the monitoring station.
