Construction noise and vibration Monthly Report – July 2025

London Borough of Hillingdon

Non-Technical Summary

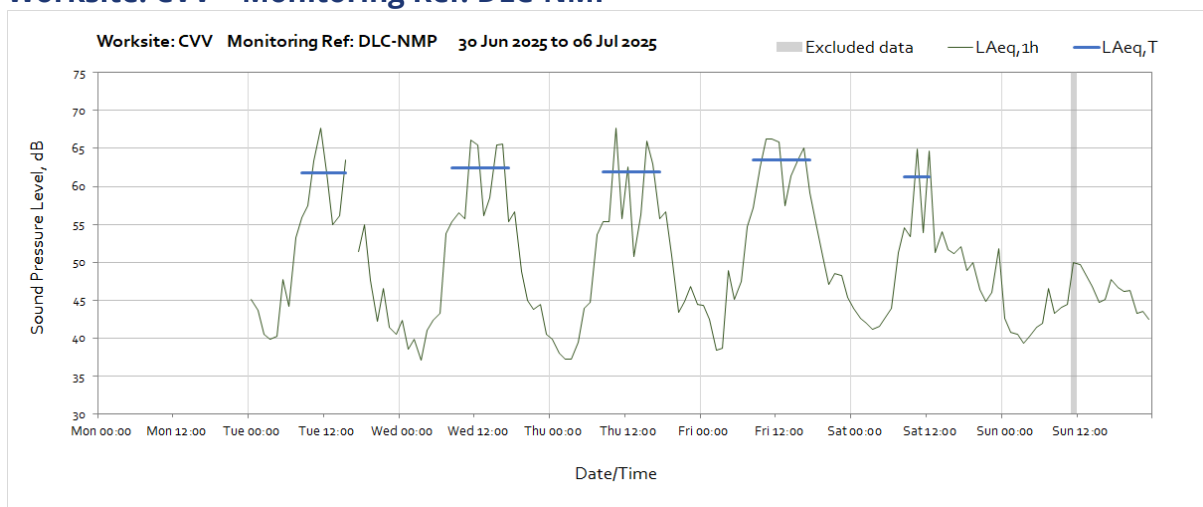
Worksite: CVV – Monitoring Ref: DLC-NMP

Note: Missing data between 16:00 and 17:00 on Tuesday 1st July was due to field calibration.

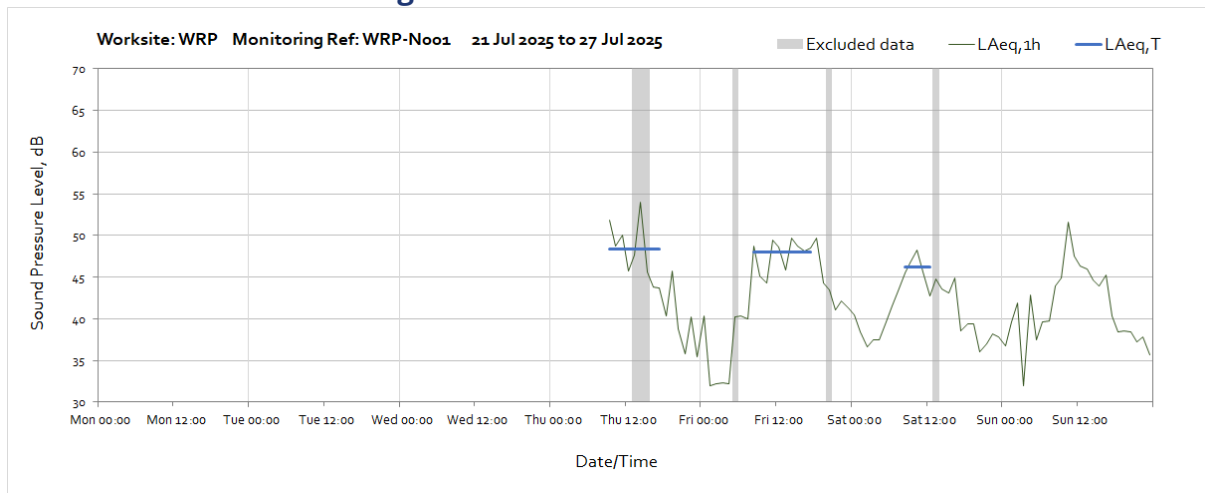
Worksite: WRP – Monitoring Ref: WRP-N001

Note: Missing data between beginning of month and 09:00 on Thursday 24th August was due to a fault at the monitoring station which is now resolved.
