September 2025

# **Construction Noise and Vibration Monthly Report – July 2025**

North Warwickshire Borough Council

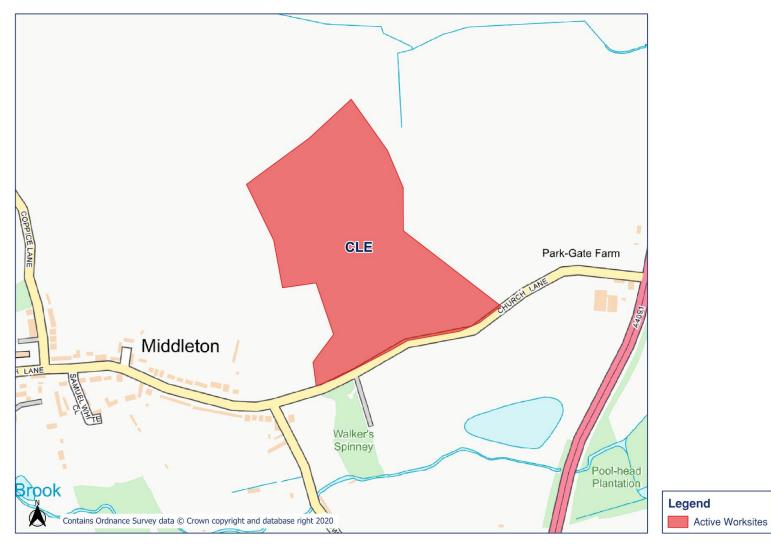
## **HS2** Worksite Identification Plan - 1

- 1.1.3 Construction sites in the local authority area where monitoring was undertaken during this period include:
  - Church Lane Embankment worksite, ref.: CLE (see Plan 1 in Appendix A), where work activities included:

- Shuttering including striking shutters.
    - Platform works.
    - o Backfilling.
    - Concrete works including concrete pours.
  - Kingsbury Main Compound worksite, ref.: KMC (see Plan 2 in Appendix A), where work activities included:

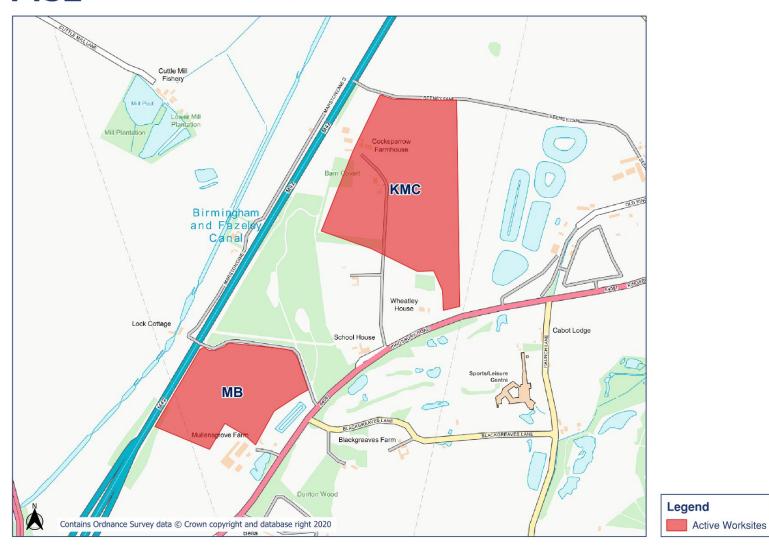
## **HS2** Worksite Identification Plan - 2

- Operation of precast segment yard.
    - Operation of concrete batching plants.
    - Operation of offices and welfare facilities.

- Marston Box/Marston Lane worksite, ref.: MB (see Plan 2 in Appendix A), where no works were underway.
- Faraday Avenue Embankment and Underbridge worksite, ref.: FAEU (see Plan 3 in Appendix A), where works activities included:

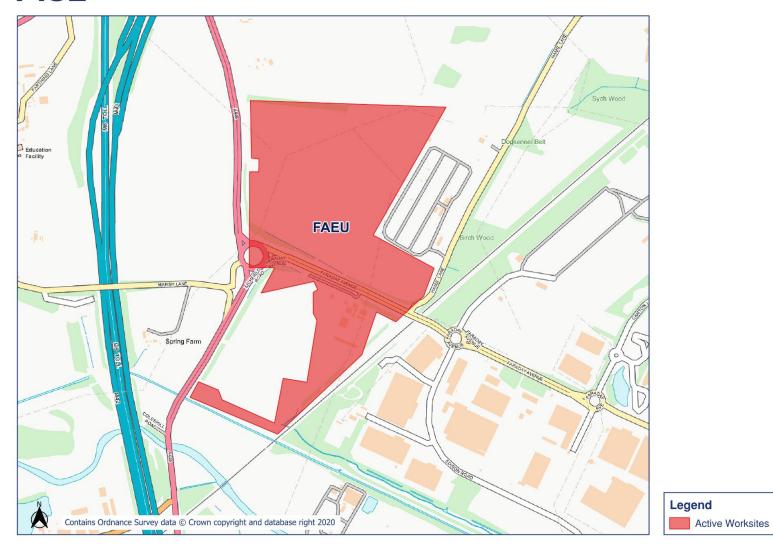
## **HS2** Worksite Identification Plan - 3

- Segment installation works, including delivery, lifting, gluing, installation and tensioning.
  - Platform and formwork installation, including grouting.

- Cable and mast activities including, stay cable tensioning, mast movements, and threading and tensioning operations.
  - o Final segment adjustments including hydraulic jacking.

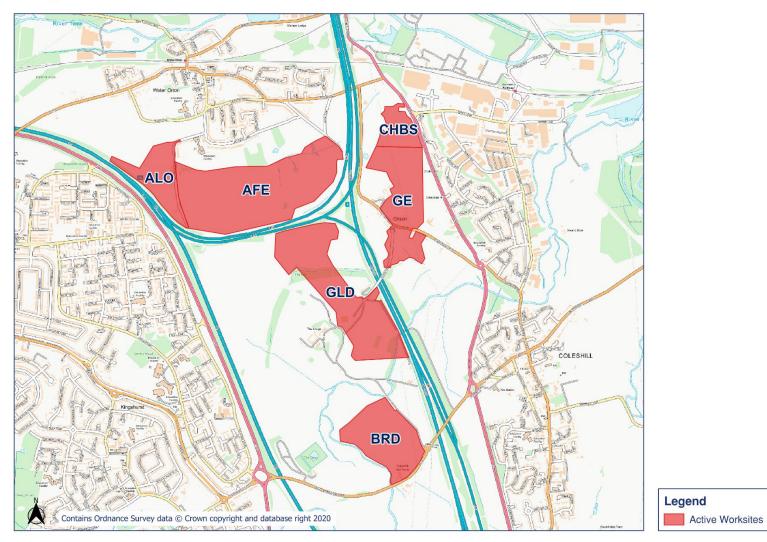
#### **Worksite Identification Plan - 4**

- Chattle Hill Box Structure worksite, ref.: CHBS (see Plan 4 in Appendix A), where work activities included:
  - o Demobilisation.
  - o Piling works, including mobilisation and sheet pile installation.

- Cofferdam excavation.
  - Pile cap construction.
- Attleboro Lane Overbridge worksite, ref.: ALO (see Plan 4 in Appendix A), where no works were underway.

- Marsh Lane Embankment worksite, ref: MLE (See Plan 4 in Appendix A), where work activities included:
  - Piling platform construction.
  - o Dig and replace.

- Embankment construction.
  - Haul road operation and maintenance.
  - Culvert installation.
  - Retaining wall works.
  - Stockpiling.
  - Compound operation.

- Generator operation.
  - Traffic management.

- Gilson Embankment worksite, ref.: GE (see Plan 4 in Appendix A), where works activities included:
  - o Earthworks.
  - Material movements.
  - Site maintenance.

- Gilson Drive worksite, ref.: GLD (see Plan 4 in Appendix A), works activities included:
  - o Earthworks.
- Birmingham Road worksite, ref.: BRD (see Plan 4 in Appendix A), work activities included:

- Decking installation.
  - Haul road works.
  - o Earthworks.
  - Stockpiling.
- 1.1.4 The applicable standards, guidance, and monitoring methodology is outlined in the construction noise and vibration monitoring methodology report which can be found at the following location <a href="https://www.gov.uk/government/collections/monitoring-the-environmental-effects-of-hs2">https://www.gov.uk/government/collections/monitoring-the-environmental-effects-of-hs2</a>. Noise and vibration monitoring reports for previous months can also be found at this location.

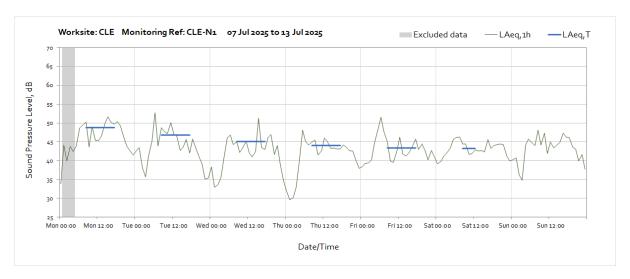
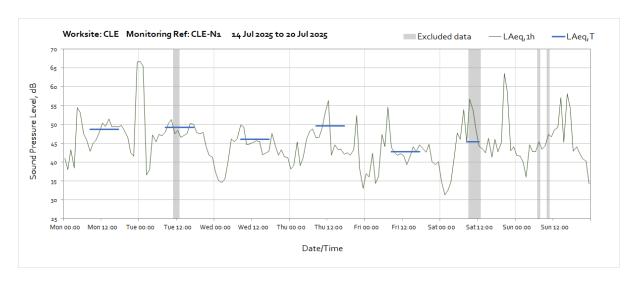
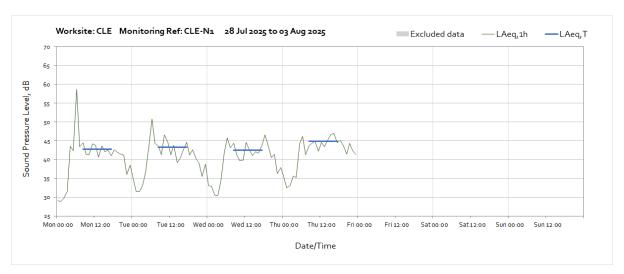
#### Worksite: CLE - Monitoring Ref: CLE-N1

The following graphs show the hourly measured ambient noise level  $L_{Aeq,1h}$  and, where relevant, the averaged noise level  $L_{Aeq,T}$  values, where the time period T is as specified in Table 1 of HS2 Information Paper E23. Periods with adversely weather affected noise levels are greyed out and have been excluded from the calculation of the  $L_{Aeq,T}$  values in Table 3 of the main report.:

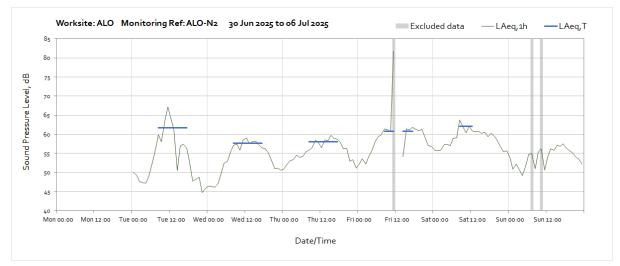
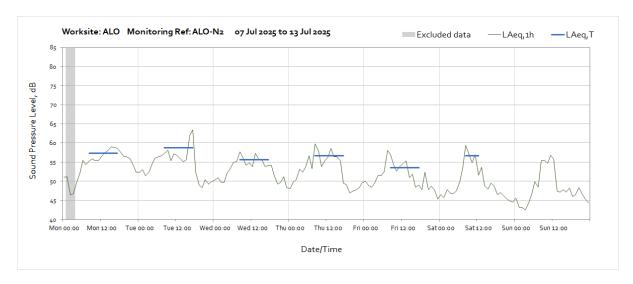
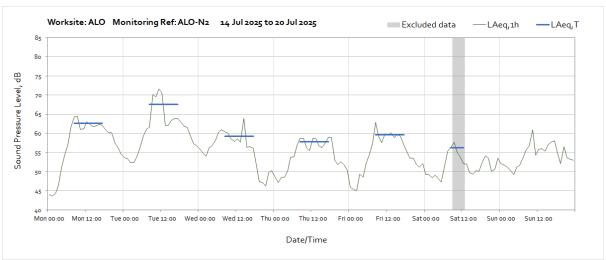
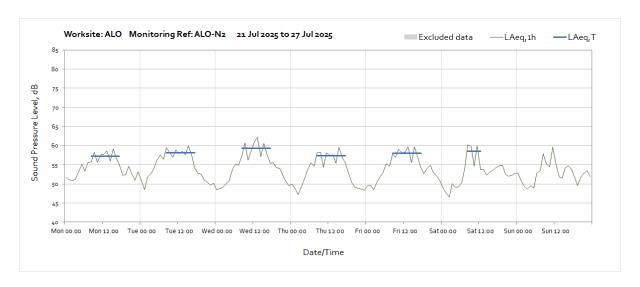
## **Worksite: ALO - Monitoring Ref: ALO-N2**

Note: Missing data between 12:00 and 14:00 on Friday 4<sup>th</sup> July was due to monitor recalibration.

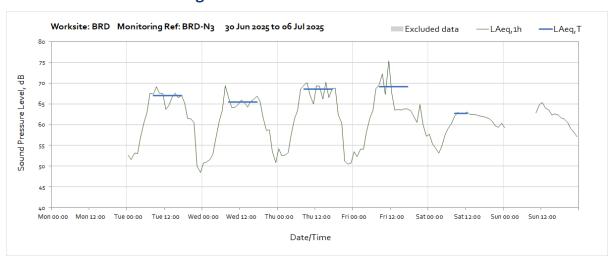
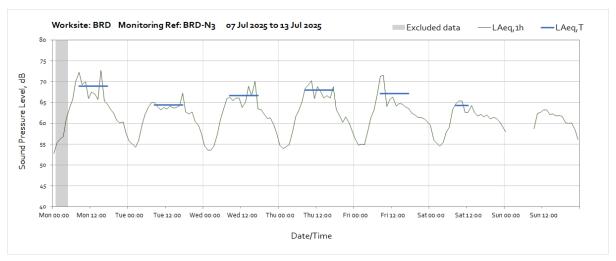
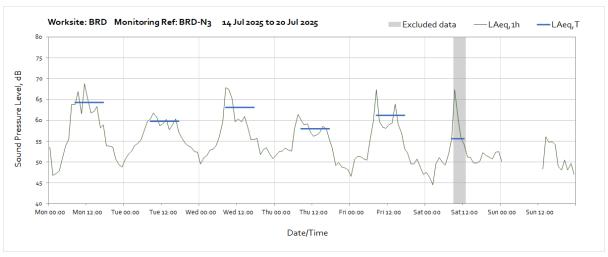
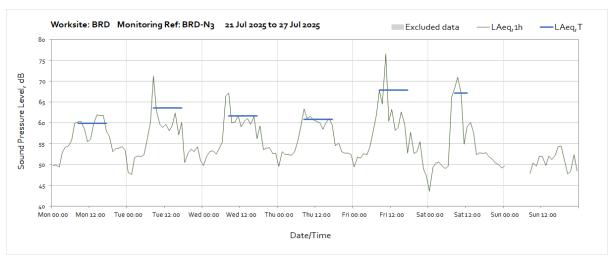
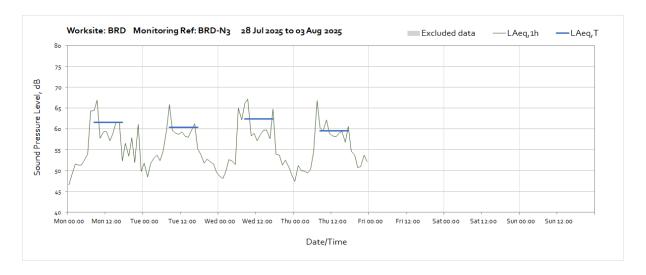
## **Worksite: BRD - Monitoring Ref: BRD-N3**

Note: Missing data between 01:00 and 10:00 on Sunday  $6^{th}$  July was due to a clock synchronisation issue at the monitoring station.

Note: Missing data between 01:00 and 09:00 on Sunday 13<sup>th</sup> July was due to a clock synchronisation issue at the monitoring station.

Note: Missing data between 01:00 and 13:00 on Sunday 20<sup>th</sup> July was due to a clock synchronisation issue at the monitoring station.

Note: Missing data between 01:00 and 08:00 on Sunday 27<sup>th</sup> July was due to a clock synchronisation issue at the monitoring station.

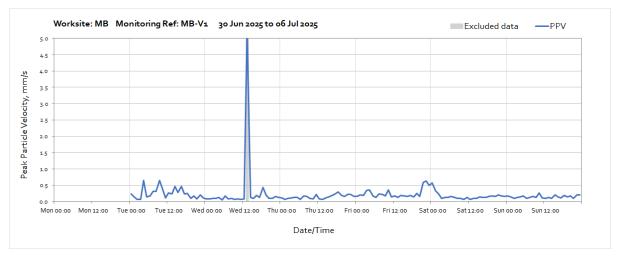
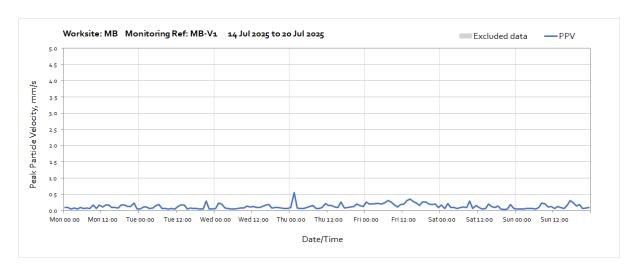
### Worksite: MB - Monitoring Ref: MB-V1

The following graphs show the hourly measured peak particle velocity PPV recorded during the monitoring period. The graphs show the highest PPV of the three orthogonal axes x, y and z. Where high values of PPV were caused by local interference with the vibration monitor, which are not representative of HS2 construction works, these values have been greyed out in the following charts and have been excluded to calculate values in Table 4 of the main report.

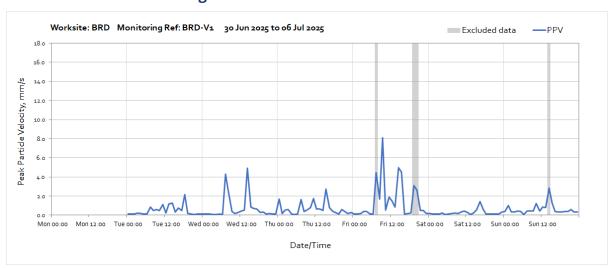
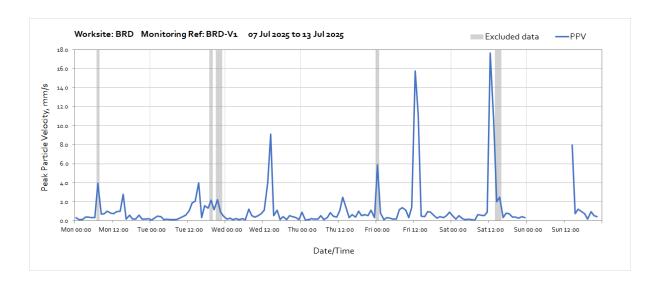
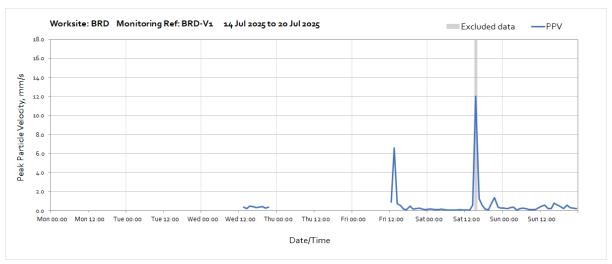
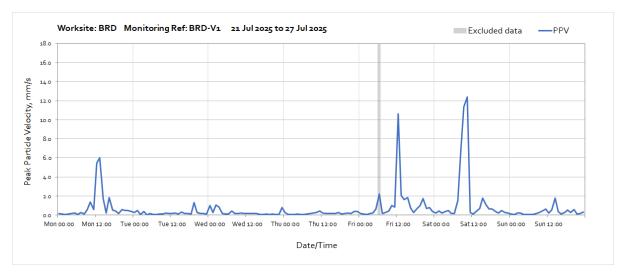
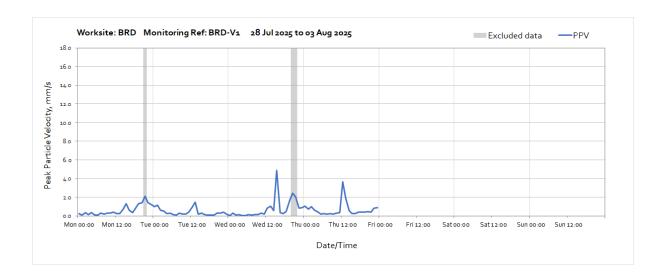
### Worksite: BRD - Monitoring Ref: BRD-V1

Note: Missing data between 00:00 and 14:00 on Sunday 13<sup>th</sup> was due to an ongoing axis issue at the monitoring station.

Note: Missing data throughout the week was due to an ongoing axis issue at the monitoring station.
