## **Air Quality and Dust Monitoring Monthly Report – August 2025**

**Birmingham City Council**

- 1.1.1 This Summary Report is published in fulfilment of commitments detailed in the High Speed Rail (London-West Midlands) Environmental Minimum Requirements, Annex 1: Code of Construction Practice, for the nominated undertaker to present the results of dust monitoring undertaken within Birmingham City Council (BCC) during August 2025.

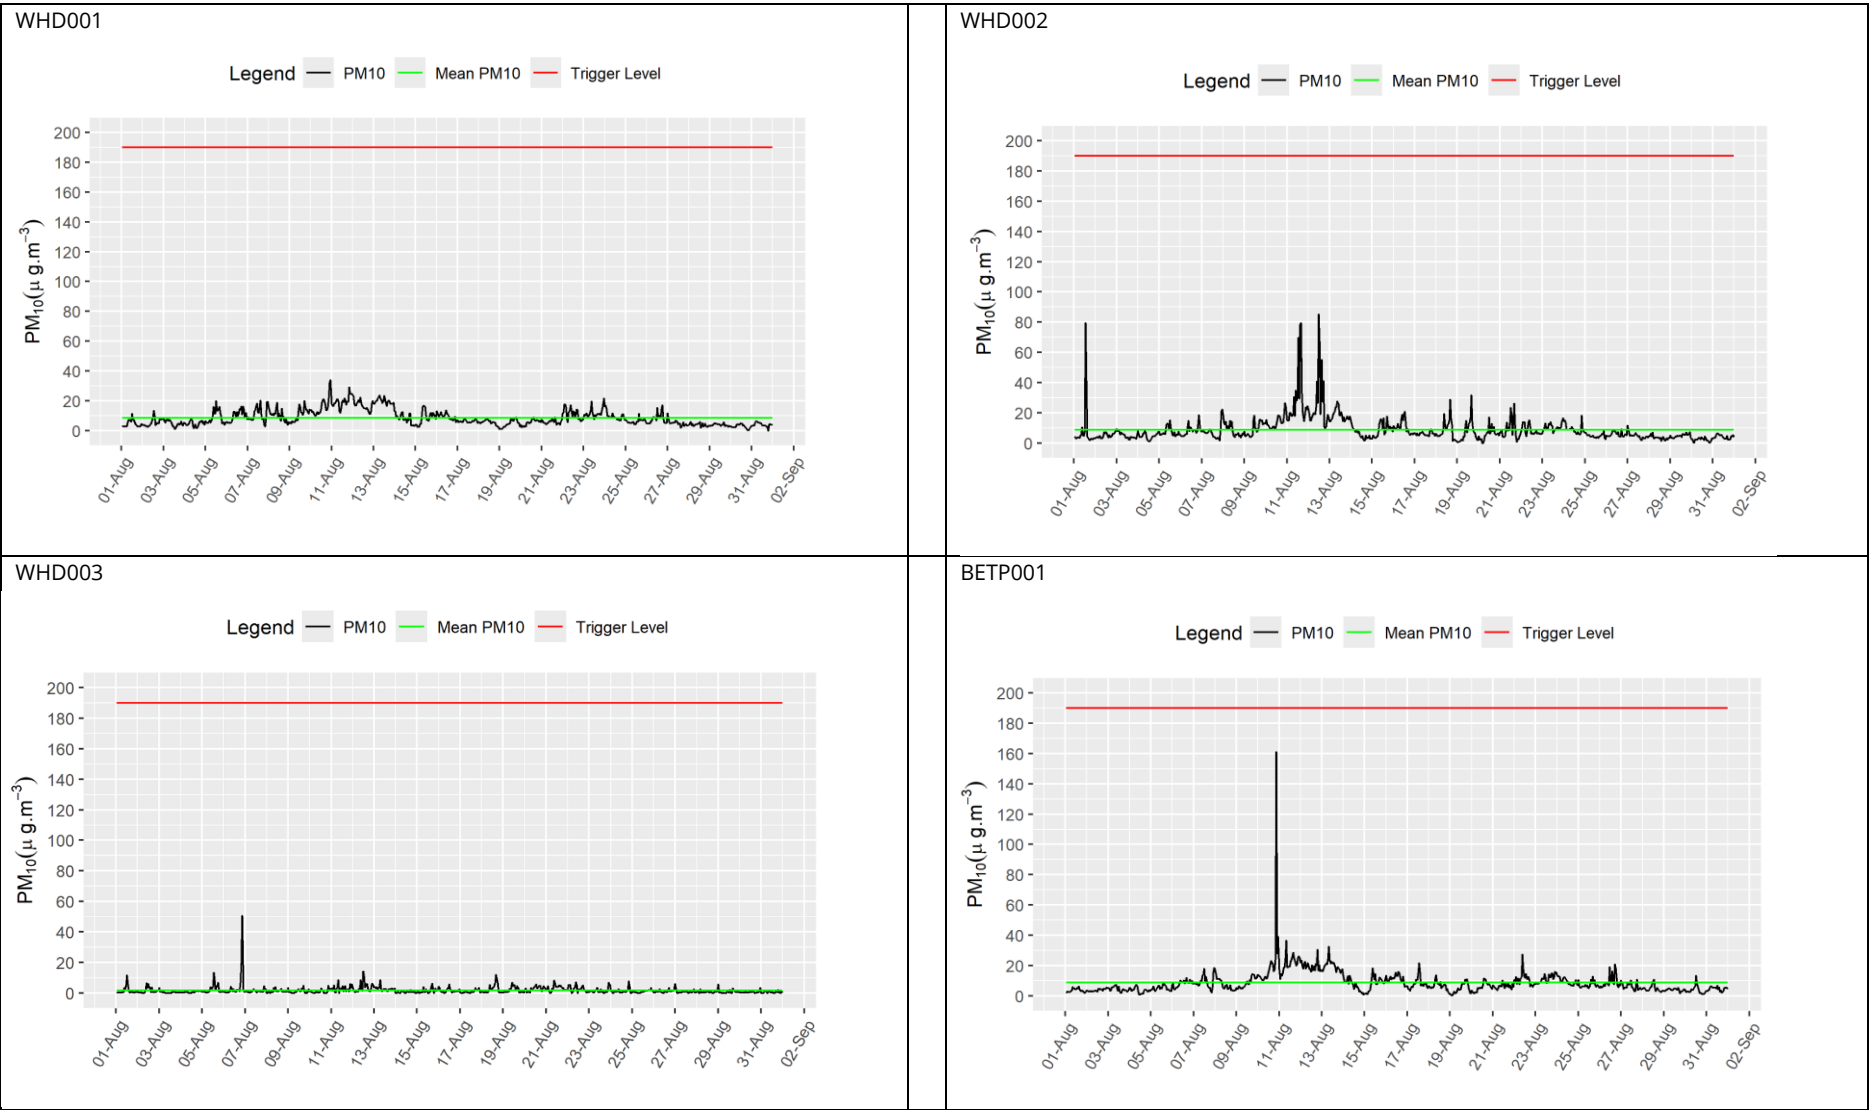
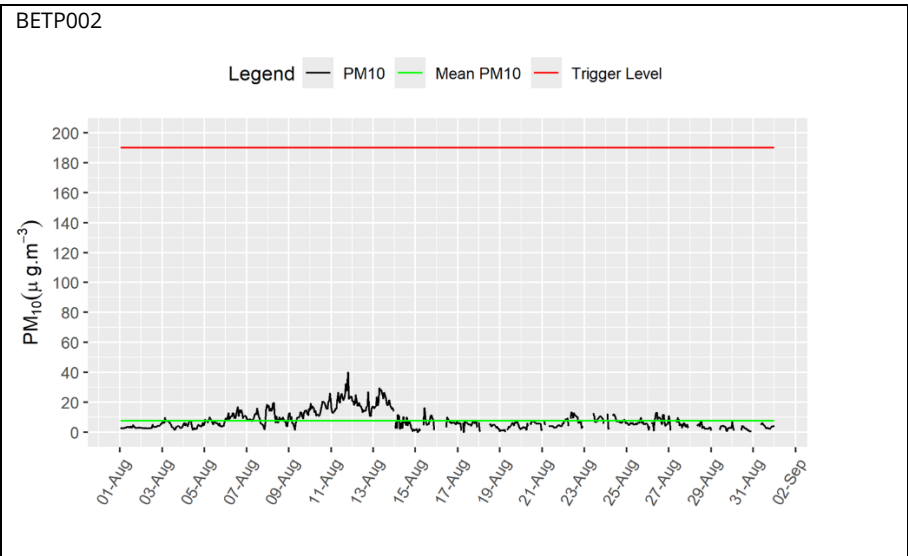
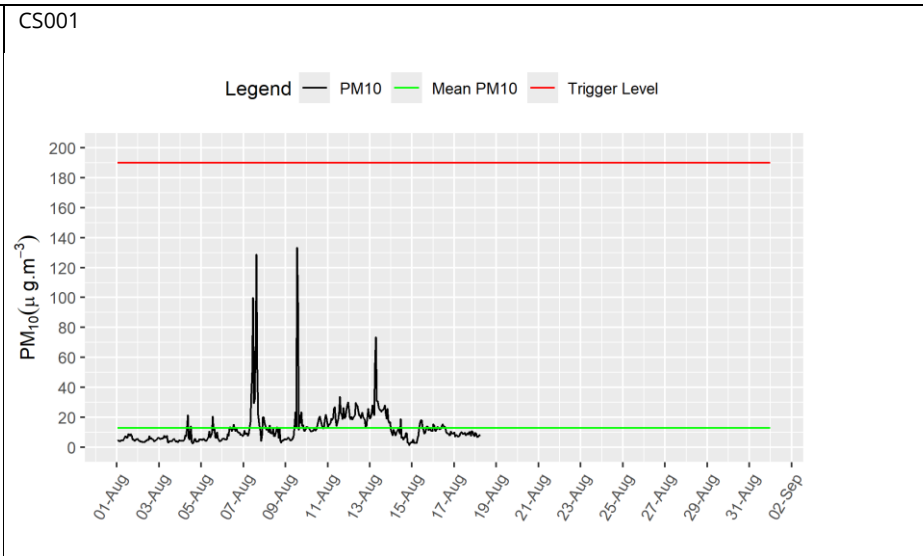
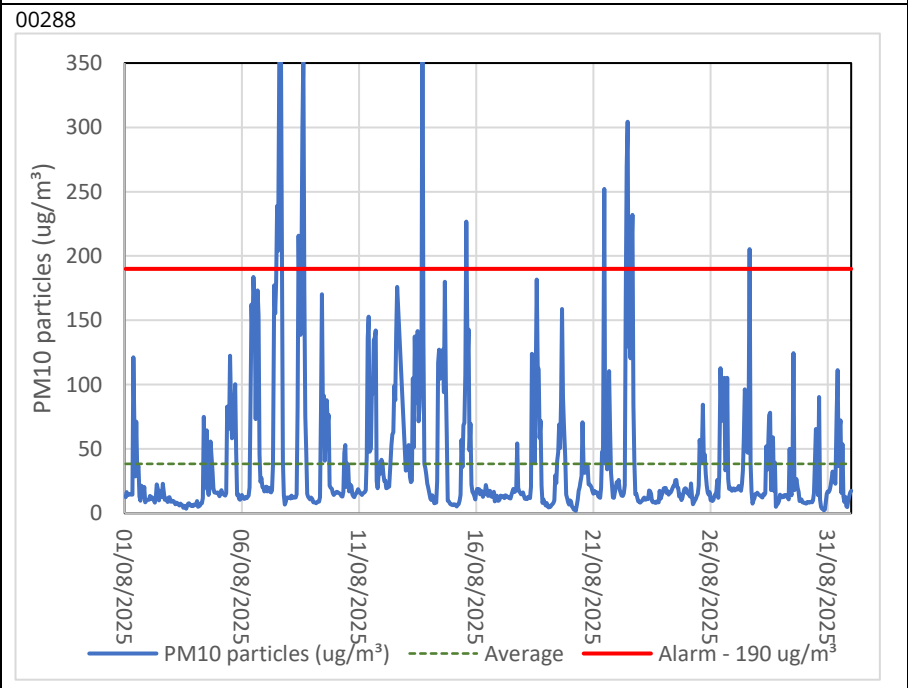
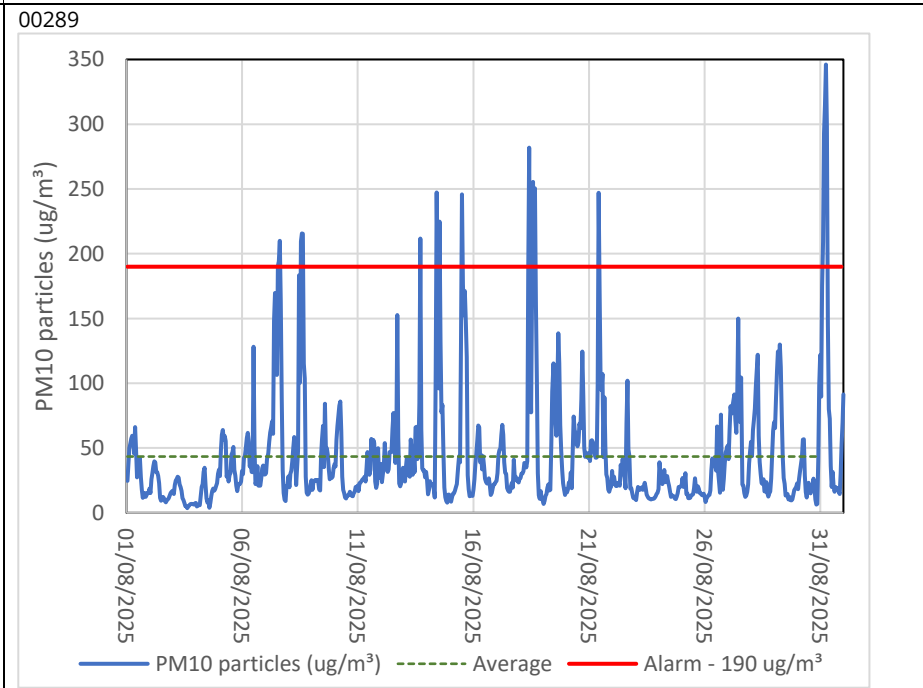
Figure 4: Construction dust 1-hour mean indicative PM<sub>10</sub> concentration for all dust monitors

1.1.6 Dust monitoring locations and results are presented in Appendix B, Table 2, together with line charts of monthly data from each dust monitor, presented in Figure 4. All continuous dust monitoring is undertaken using indicative monitors. Despite being Environment Agency (MCERTS) certified, indicative monitors carry a higher level of uncertainty than reference monitors, and therefore cannot be strictly compared with Air Quality Standards for human health and the environment. The purpose of the monitoring undertaken is to ensure the effectiveness of the on-site mitigation.

1.1.7 The trigger level for PM<sub>10</sub> concentrations of 190 µg/m<sup>3</sup>, over a 1-hour period, in accordance with the updated guidance document '*Guidance on Monitoring in the Vicinity of Demolition and Construction Sites (October 2018)*' has been applied.

| Monitoring site ID | Coordinates (X,Y) | Location description | Dust risk rating for site | Monitoring site active during period | Change to site since previous period report | Mean 1-hour PM10 concentration (µg/m3) | Minimum 1-hour PM10 concentration (µg/m3) | Maximum 1-hour PM10 concentration (µg/m3) | Number of 1-hour periods exceeding trigger level of 190 µg/m3 | Data capture (%) |
|---|---|---|---|---|---|---|---|---|---|---|
| 00288 | 407676, 287057 | Curzon St – East Side City Park | H | Yes | No | 38.4 | 1.9 | 460.5 | 18 | 98.9 |
| 00289 | 407450, 286896 | Curzon St – Moor St Queensway | H | Yes | No | 43.4 | 3.6 | 346.1 | 19 | 100.0 |

| Monitoring Site ID | Period of trigger alert & Concentration recorded | Investigation | Outcomes / Resolution / Remedial measures implemented |
|---|---|---|---|
| 00288 | <p>07/08/2025:<br/>11:01 – 12:00; 238.8 µg/m<sup>3</sup><br/>12:01 – 13:00; 204.1 µg/m<sup>3</sup><br/>13:01 – 14:00; 318.6 µg/m<sup>3</sup><br/>14:01 – 15:00; 460.5 µg/m<sup>3</sup><br/>15:01 – 16:00; 360.7 µg/m<sup>3</sup><br/>16:01 – 17:00; 204.9 µg/m<sup>3</sup></p> <p>08/08/2025:<br/>09:01 – 10:00; 215.7 µg/m<sup>3</sup><br/>12:01 – 13:00; 190.9 µg/m<sup>3</sup><br/>13:01 – 14:00; 299.0 µg/m<sup>3</sup><br/>14:01 – 15:00; 359.3 µg/m<sup>3</sup></p> <p>13/08/2025:<br/>16:01 – 17:00; 419.8 µg/m<sup>3</sup></p> <p>15/08/2025:<br/>13:01 – 14:00; 226.8 µg/m<sup>3</sup></p> <p>21/08/2025:<br/>10:01 – 11:00; 252.1 µg/m<sup>3</sup></p> <p>22/08/2025:<br/>09:01 – 10:00; 269.9 µg/m<sup>3</sup><br/>10:01 – 11:00; 304.5 µg/m<sup>3</sup><br/>14:01 – 15:00; 202.3 µg/m<sup>3</sup><br/>15:01 – 16:00; 232.1 µg/m<sup>3</sup></p> <p>27/08/2025:<br/>15:01 – 16:00; 205.3 µg/m<sup>3</sup></p> | <p>Extended period of dry weather on site at the time of trigger, dust controls in place to manage dust as much as practicable.</p> <p>External contractor working along site boundary where hoarding has temporary been replaced with Safe Fence near the dust monitor. During this time works were being undertaken near the dust monitor resulting in triggers.</p> | <p>All controls already in place to manage dust on site during warm / dry weather including road sweeper &amp; multiple bowsers along the haul road, dust cannon and hoses.</p> |

| Monitoring Site ID | Period of trigger alert & Concentration recorded | Investigation | Outcomes / Resolution / Remedial measures implemented |
|---|---|---|---|
| 00289 | <p>07/08/2025:<br/>12:01 – 13:00; 190.4 µg/m<sup>3</sup><br/>13:01 – 14:00; 194.2 µg/m<sup>3</sup><br/>14:01 – 15:00; 209.9 µg/m<sup>3</sup></p> <p>08/08/2025:<br/>12:01 – 13:00; 209.6 µg/m<sup>3</sup><br/>13:01 – 14:00; 215.7 µg/m<sup>3</sup><br/>14:01 – 15:00; 215.6 µg/m<sup>3</sup></p> <p>13/08/2025:<br/>16:01 – 17:00; 211.6 µg/m<sup>3</sup></p> <p>14/08/2025:<br/>09:01 – 10:00; 247.3 µg/m<sup>3</sup><br/>12:01 – 13:00; 224.8 µg/m<sup>3</sup></p> <p>15/08/2025:<br/>11:01 – 12:00; 245.9 µg/m<sup>3</sup></p> <p>18/08/2025:<br/>09:01 – 10:00; 282.0 µg/m<sup>3</sup><br/>13:01 – 14:00; 255.4 µg/m<sup>3</sup><br/>15:01 – 16:00; 250.5 µg/m<sup>3</sup></p> <p>21/08/2025:<br/>09:01 – 10:00; 247.0 µg/m<sup>3</sup></p> <p>31/08/2025:<br/>02:01 – 03:00; 209.3 µg/m<sup>3</sup><br/>03:01 – 04:00; 293.0 µg/m<sup>3</sup><br/>04:01 – 05:00; 315.0 µg/m<sup>3</sup><br/>05:01 – 06:00; 346.1 µg/m<sup>3</sup><br/>06:01 – 07:00; 298.3 µg/m<sup>3</sup></p> | <p>Vehicle movements and stockpiling taking place in this area. Evidence of dust control measures in place including water bowser, hose &amp; dust cannon to manage stockpiling activities.</p> <p>31/08/2025 – No works on site, so exceedance is not associated with any works / activities on site.</p> | <p>Works in close proximity to monitoring equipment, and dry weather. All practicable controls in place to manage dust on site during warm / dry weather including road sweeper &amp; multiple bowzers along the haul road, dust cannon and hoses.</p> |
