## **Construction Noise and Vibration Monthly Report – September 2025**

**London Borough of Hillingdon**

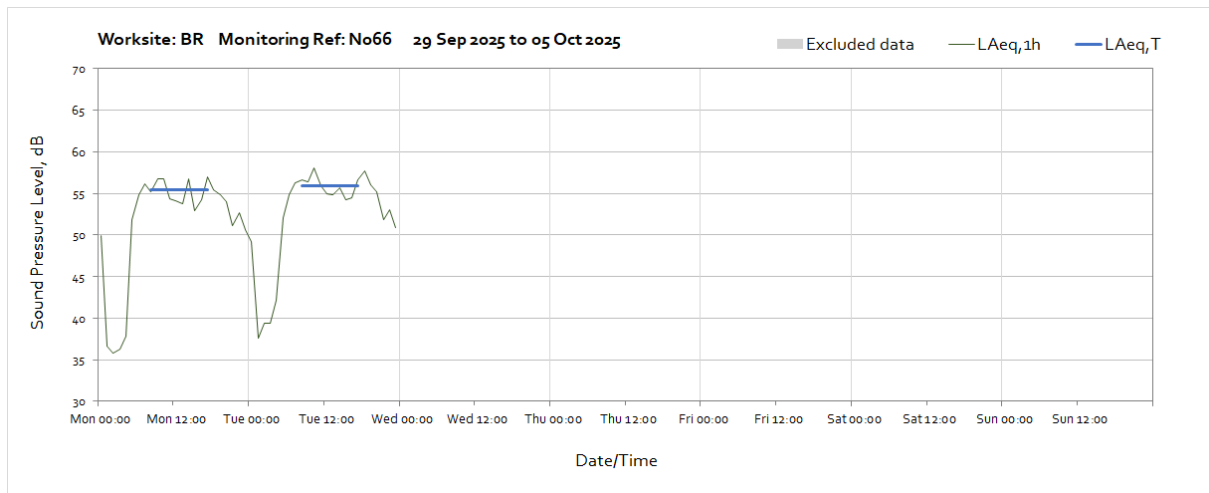
## Worksite: BR – Monitoring Ref: N066

Note: Missing data from 05:00 on Tuesday 9<sup>th</sup> September until 12:00 on Friday 19<sup>th</sup> September was due to loss of power due to insufficient sunlight reaching the solar panel which powers the monitoring station.
