## **Construction Noise and Vibration Monthly Report – September 2025**

**Solihull Metropolitan Borough Council**

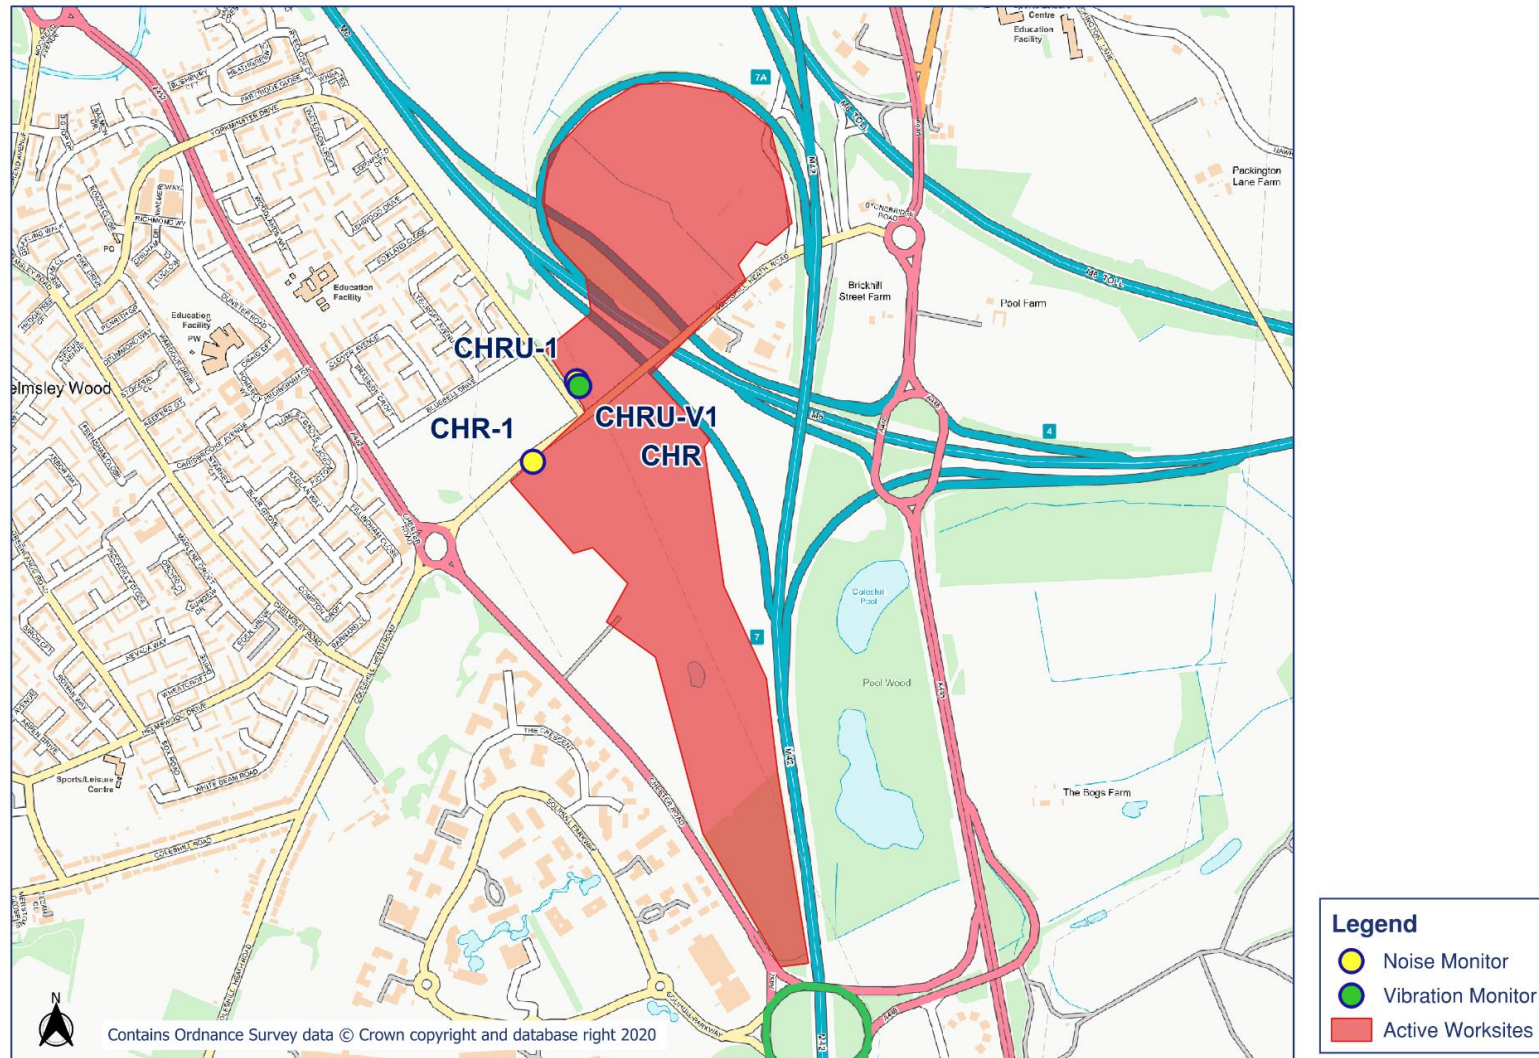
## Noise and Vibration Monitoring Plan - 1

1.2.2 Maps showing the position of noise monitoring installations are presented in Appendix B.

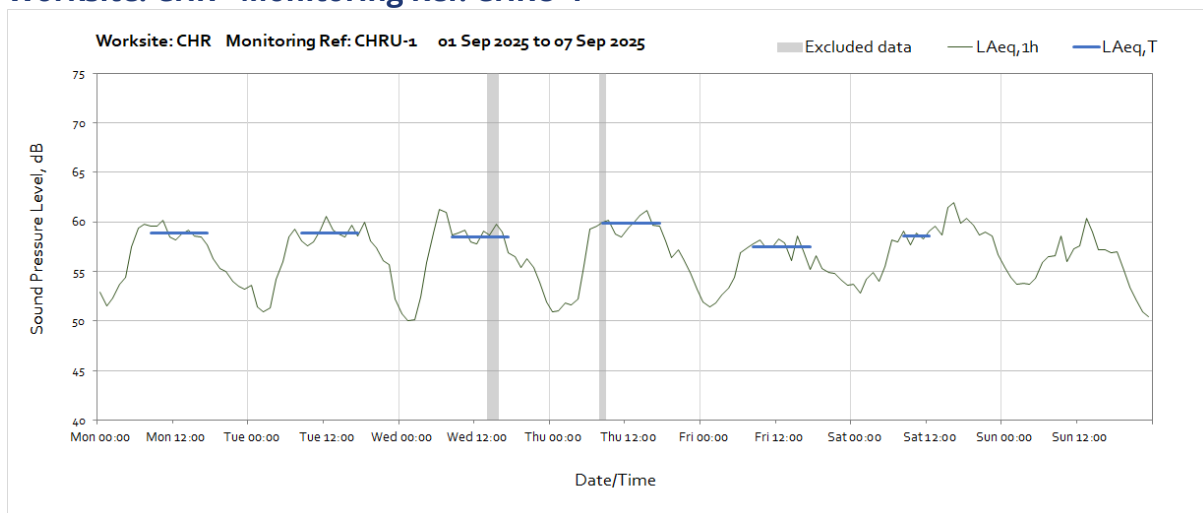
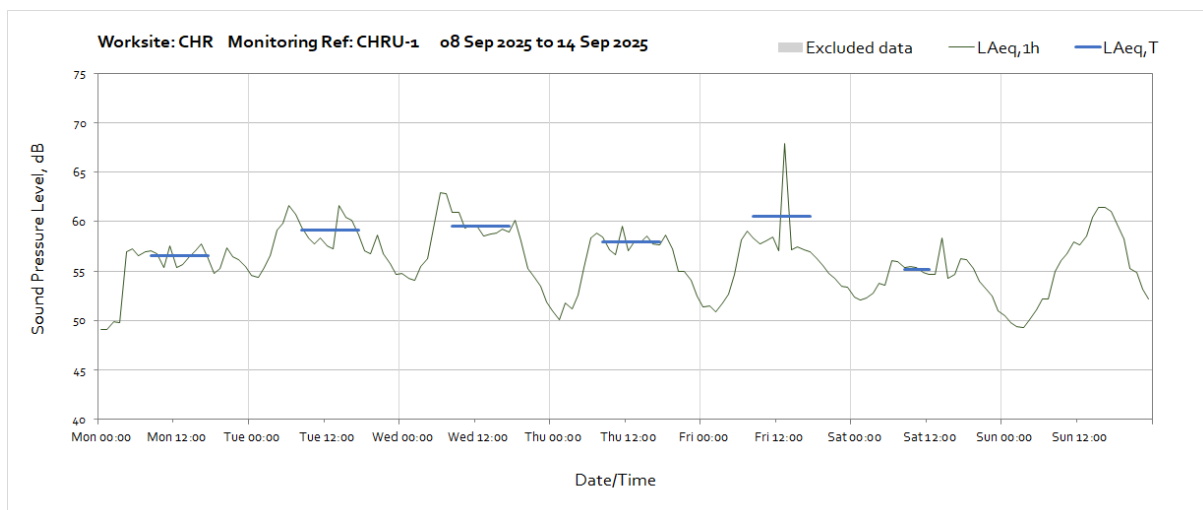
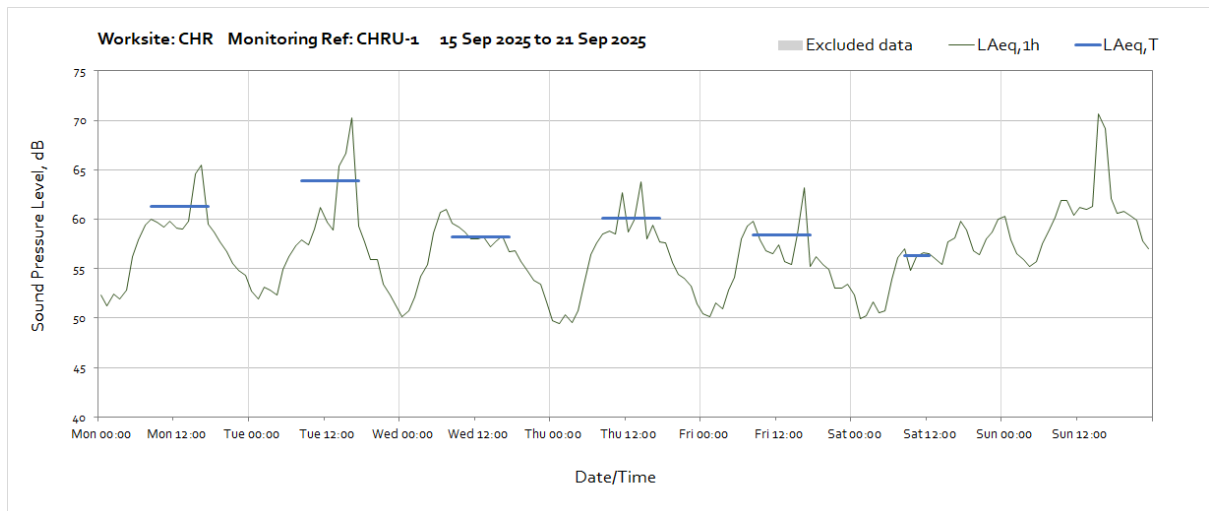
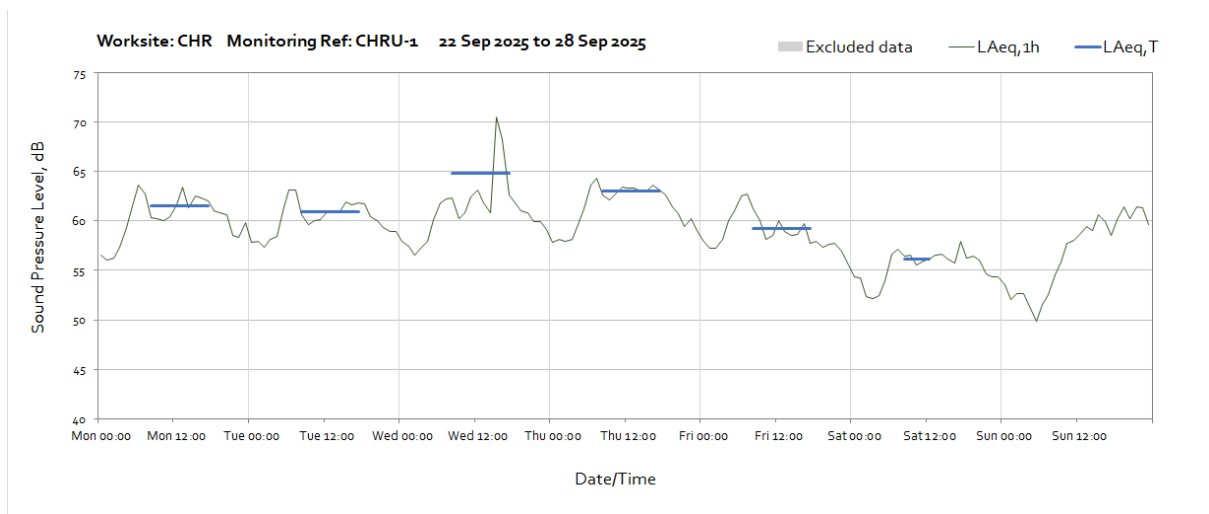
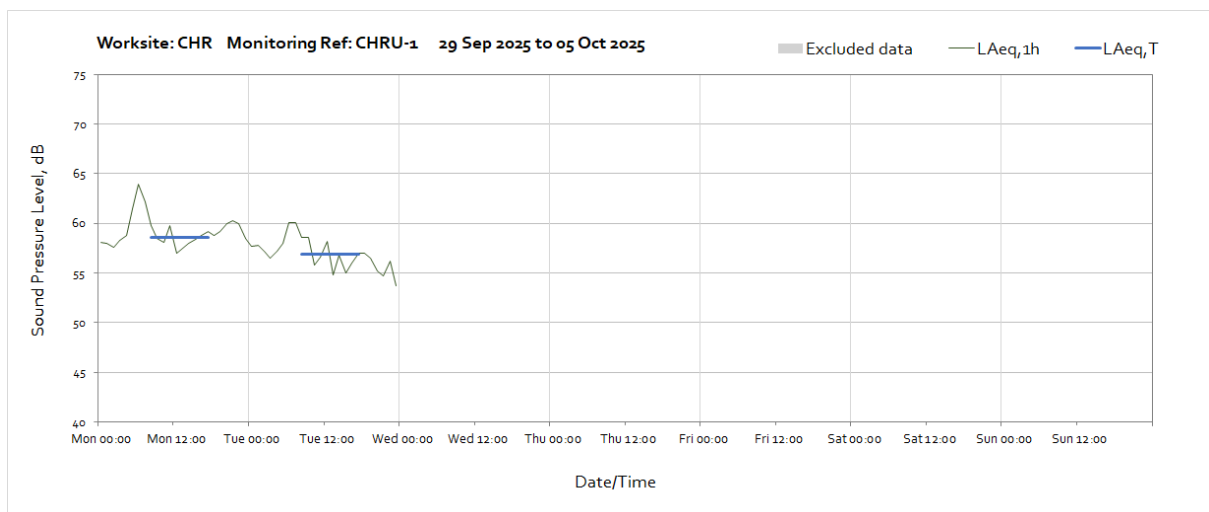
### Worksite: CHR - Monitoring Ref: CHRU-1

The following graphs show the hourly measured ambient noise level  $L_{Aeq,1h}$  and, where relevant, the averaged noise level  $L_{Aeq,T}$  values, where the time period T is as specified in Table 1 of HS2 Information Paper E23. Periods where noise levels are adversely affected by weather or only measured for part of the period, which are not representative of HS2 construction works, have been greyed out and excluded from the calculation of the  $L_{Aeq,T}$  values in of the main report.

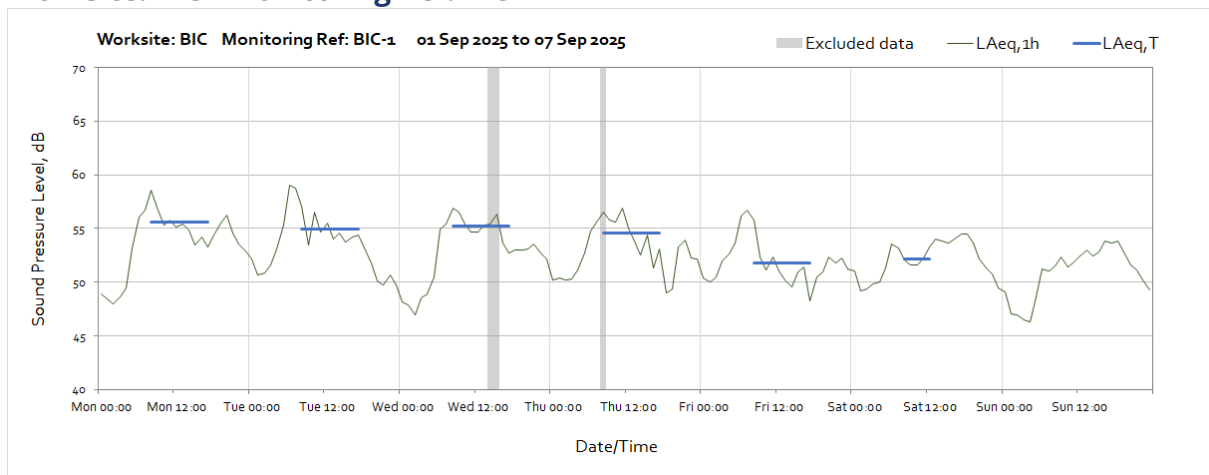
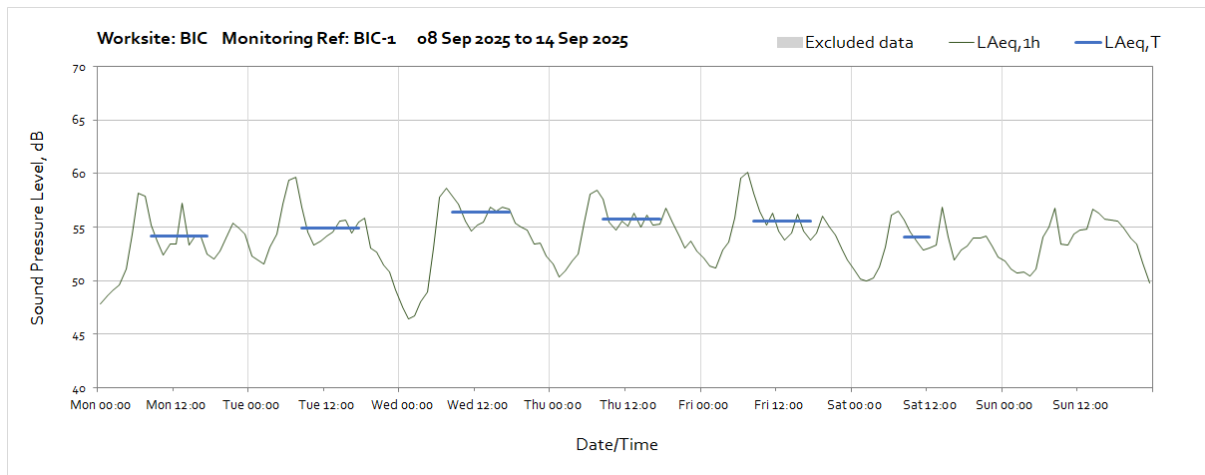
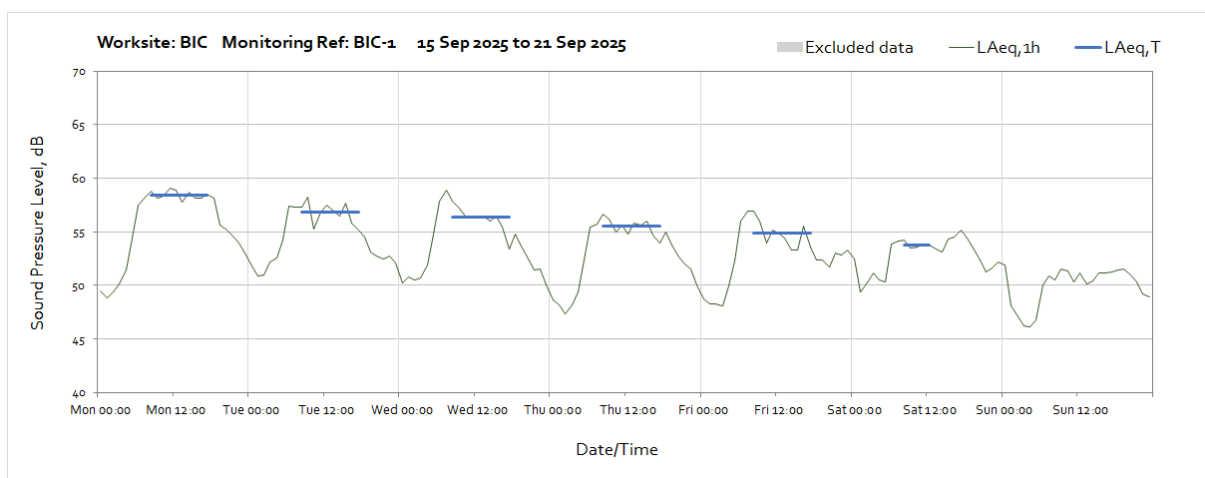
## Worksite: BIC - Monitoring Ref: BIC-1

Note: Missing data from 00:00 on Monday 22<sup>nd</sup> September until the end of the month was due to a system error at the monitoring station.

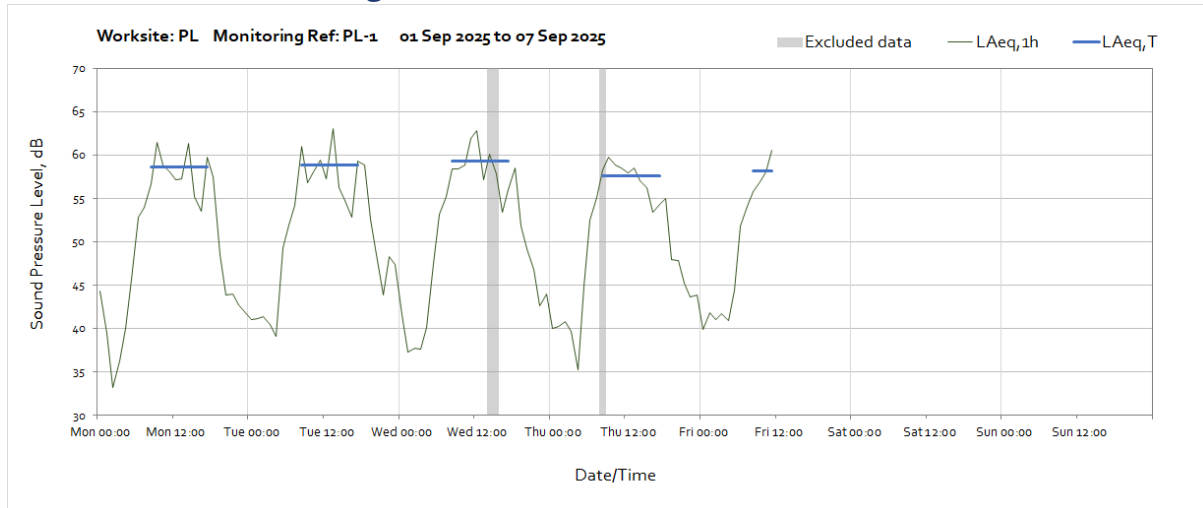
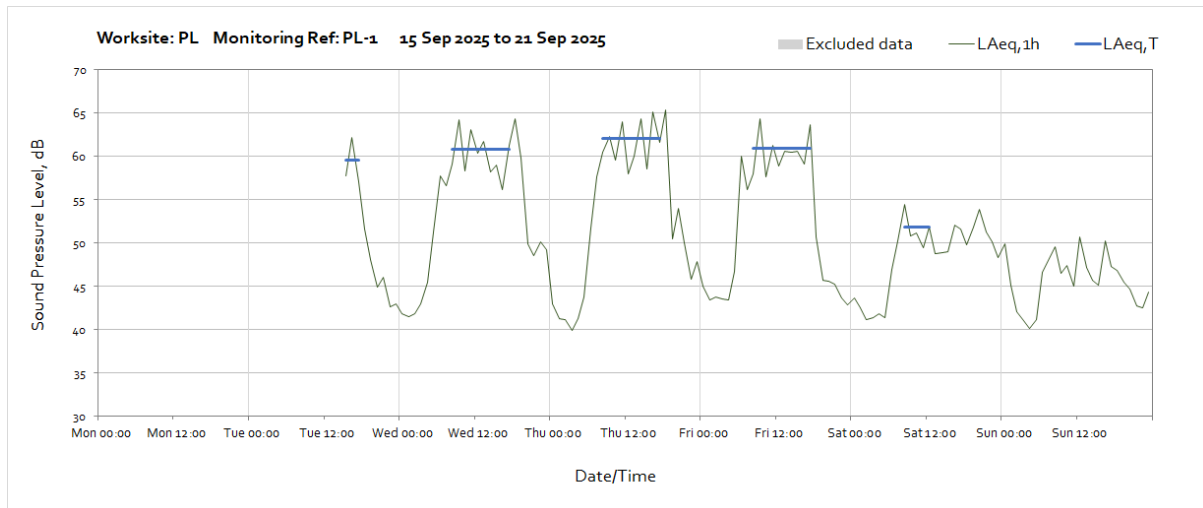
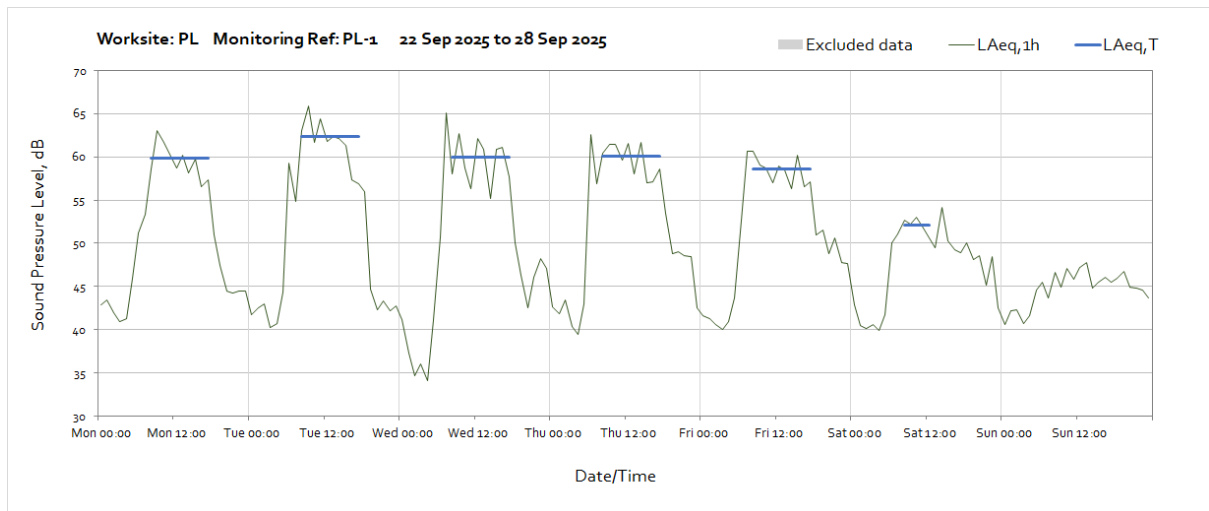
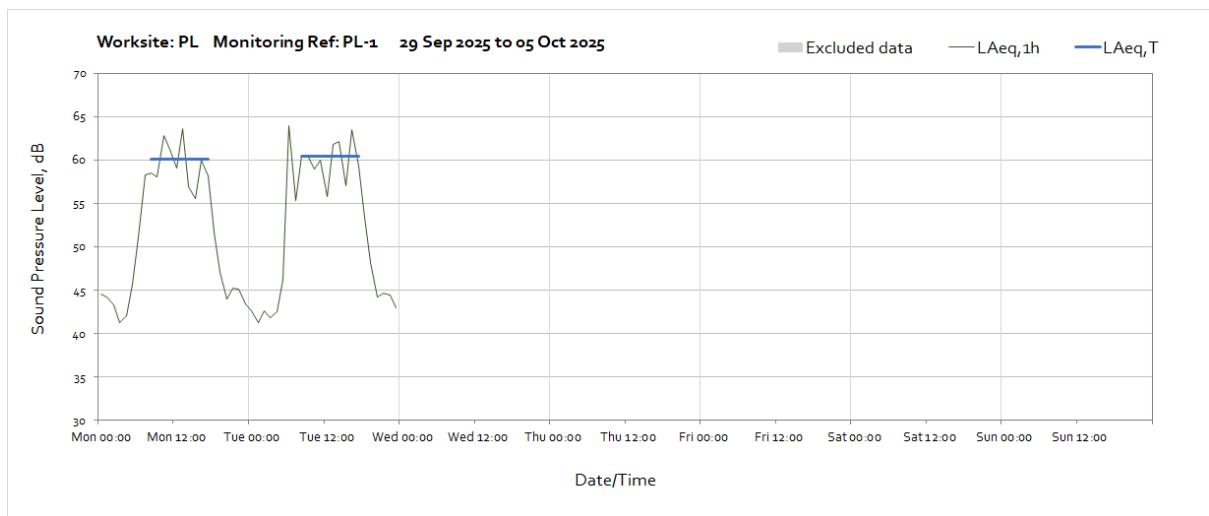
## Worksite: PL – Monitoring Ref: PL-1

Note: Missing data between 11:00 on Friday 5<sup>th</sup> and 15:00 on Tuesday 16<sup>th</sup> September was due to the replacement of the monitoring station for investigation of an ongoing issue.

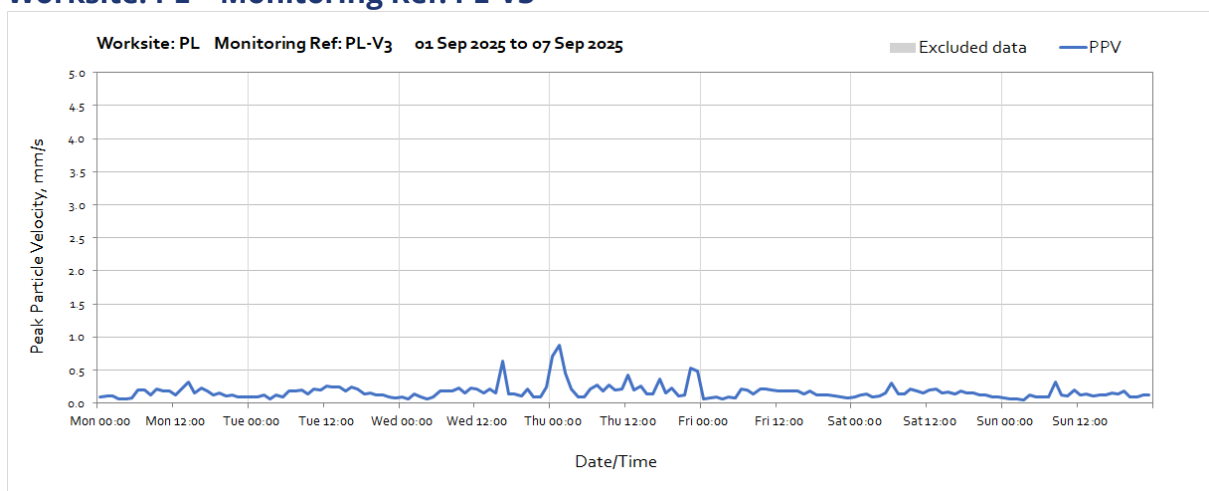
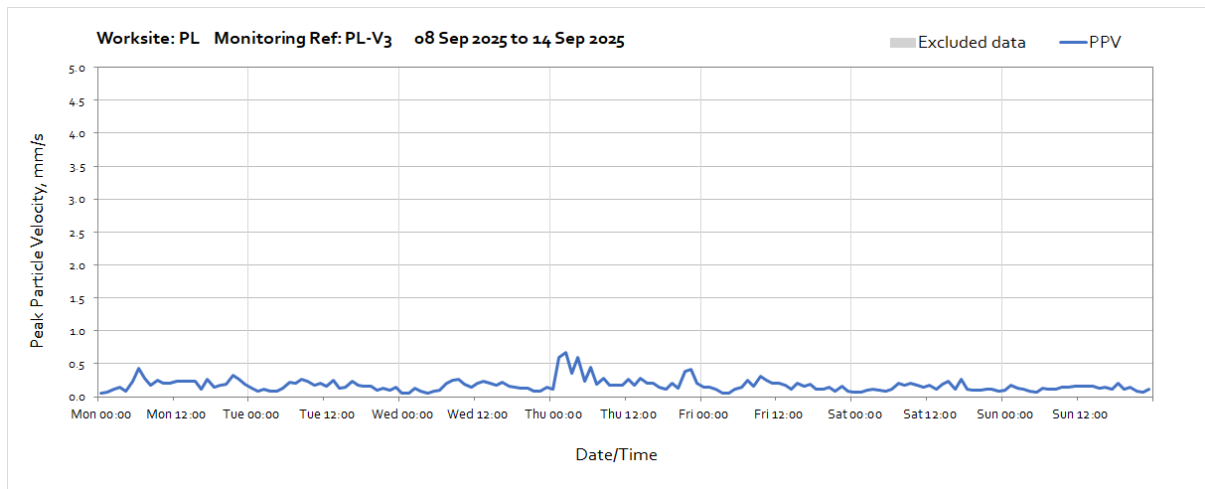
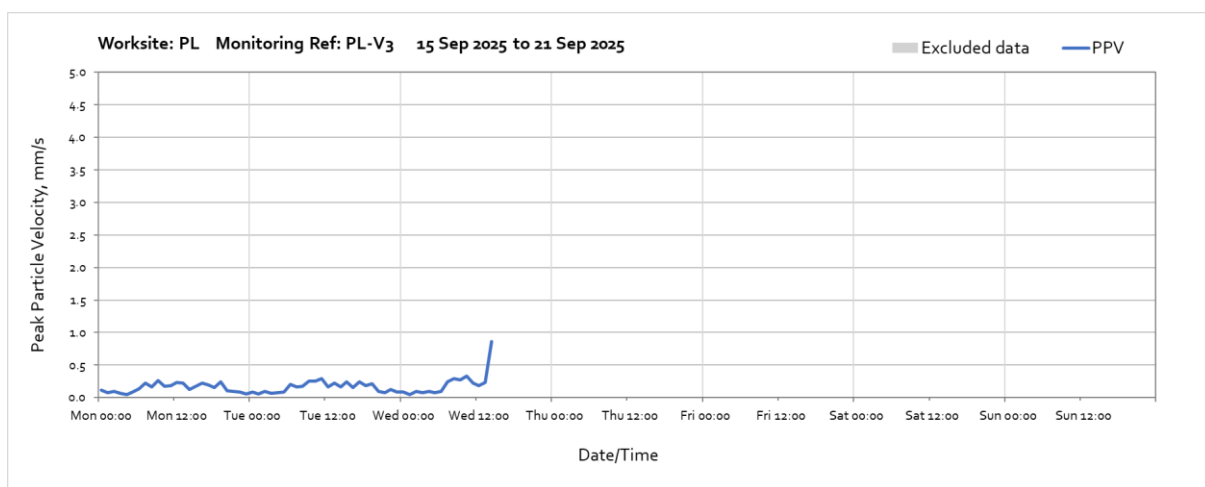
### Worksite: PL – Monitoring Ref: PL-V3

Note: Missing data from 19:00 on Tuesday 23<sup>rd</sup> September until the end of the month was due to a damaged cable at the monitoring station.
