HS2

December 2025

Construction Noise and Vibration Monthly Report – October 2025

Solihull Metropolitan Borough Council

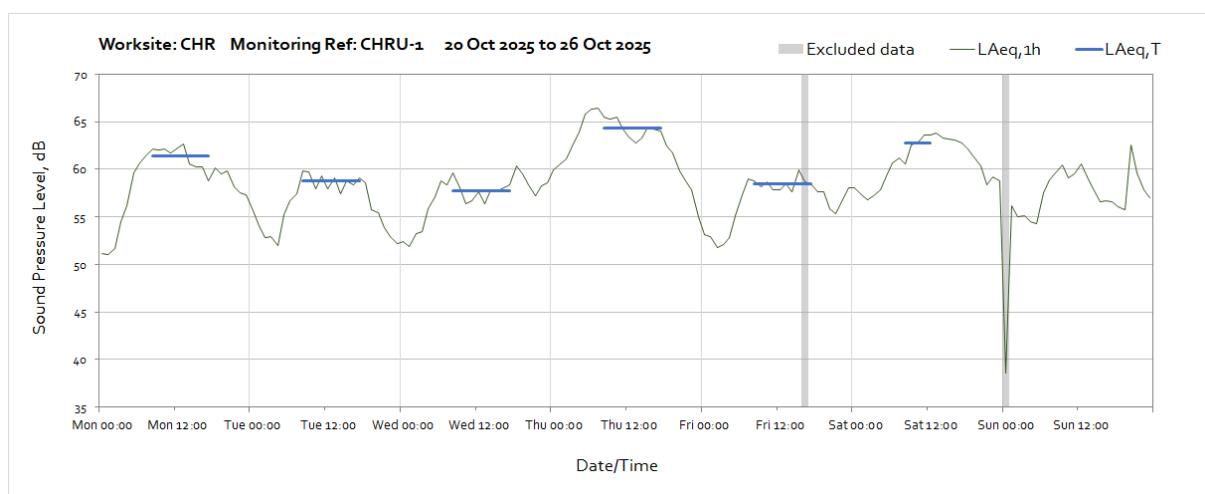
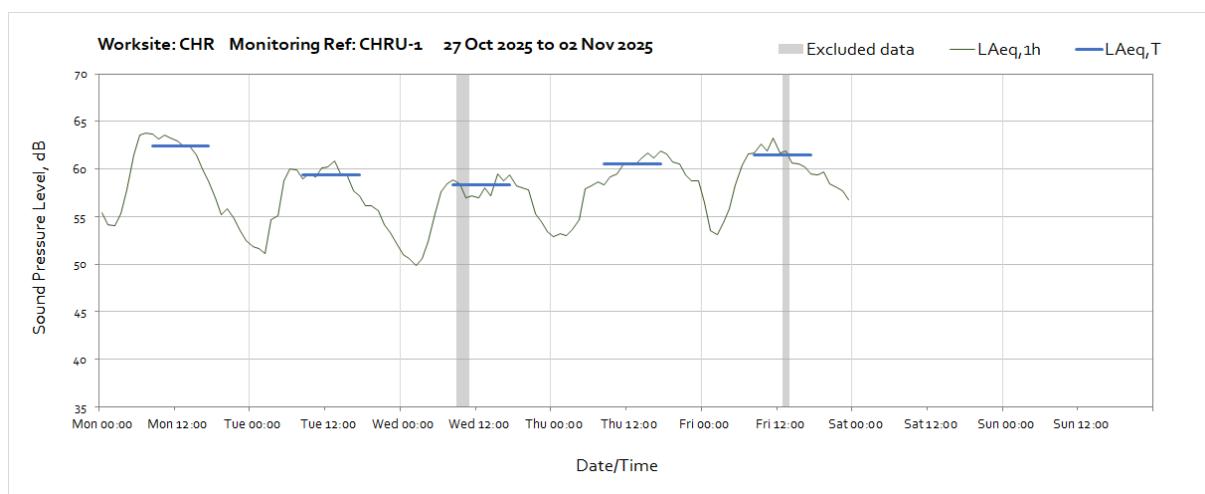
Worksite: CHR - Monitoring Ref: CHRU-1

The following graphs show the hourly measured ambient noise level $L_{Aeq,1h}$ and, where relevant, the averaged noise level $L_{Aeq,T}$ values, where the time period T is as specified in Table 1 of HS2 Information Paper E23. Periods where noise levels are adversely affected by weather or only measured for part of the period, which are not representative of HS2 construction works, have been greyed out and excluded from the calculation of the $L_{Aeq,T}$ values in of the main report.

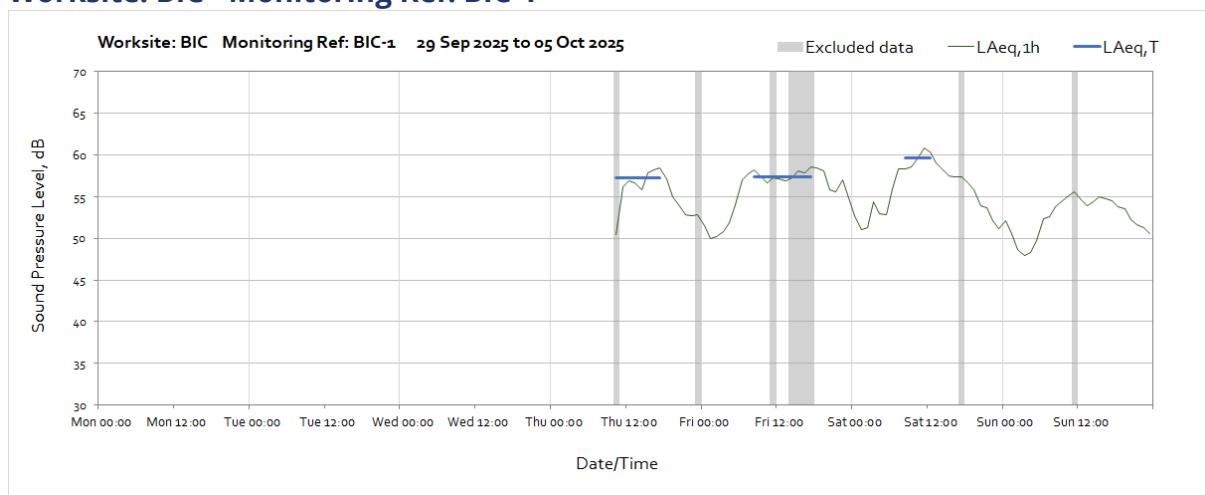
Worksite: BIC - Monitoring Ref: BIC-1

Note: Missing data between the start of the month and 10:00 on Thursday 2nd October was due to a monitoring station system error.

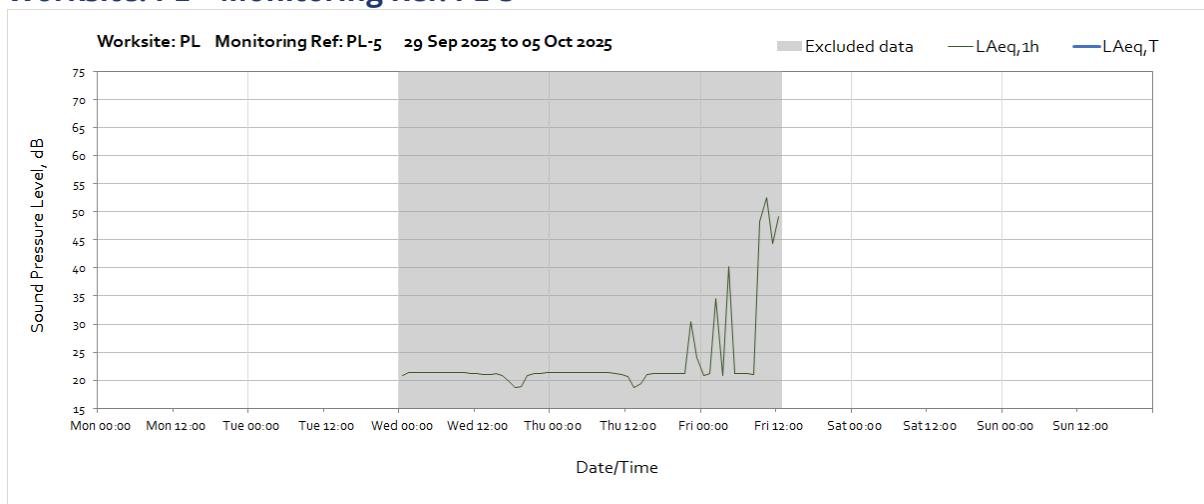
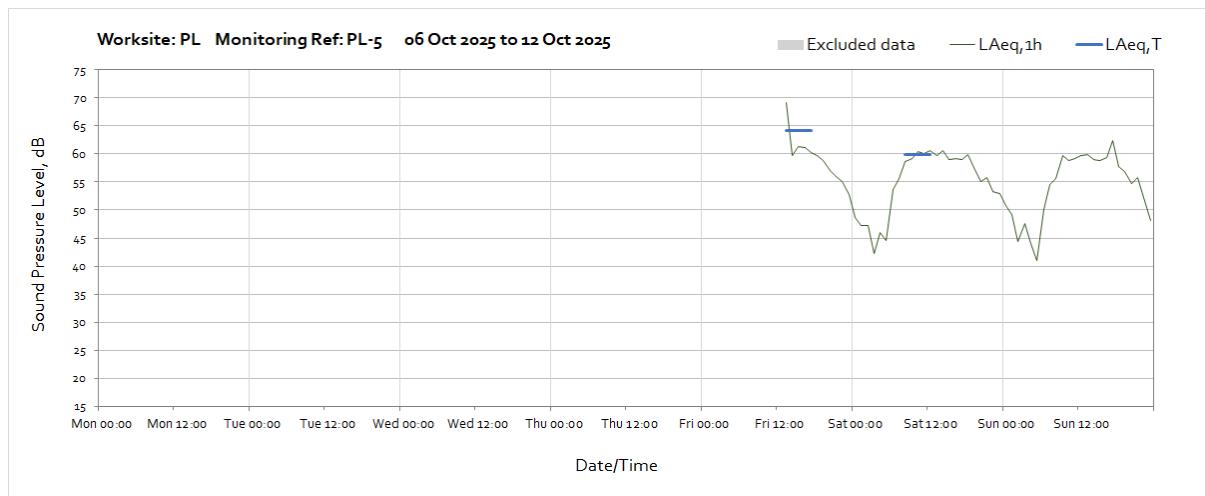
Worksite: PL – Monitoring Ref: PL-5

Note: Missing data between 13:00 on Friday 3rd October and 13:00 on Friday 10th October was due to a monitoring station power supply issue.

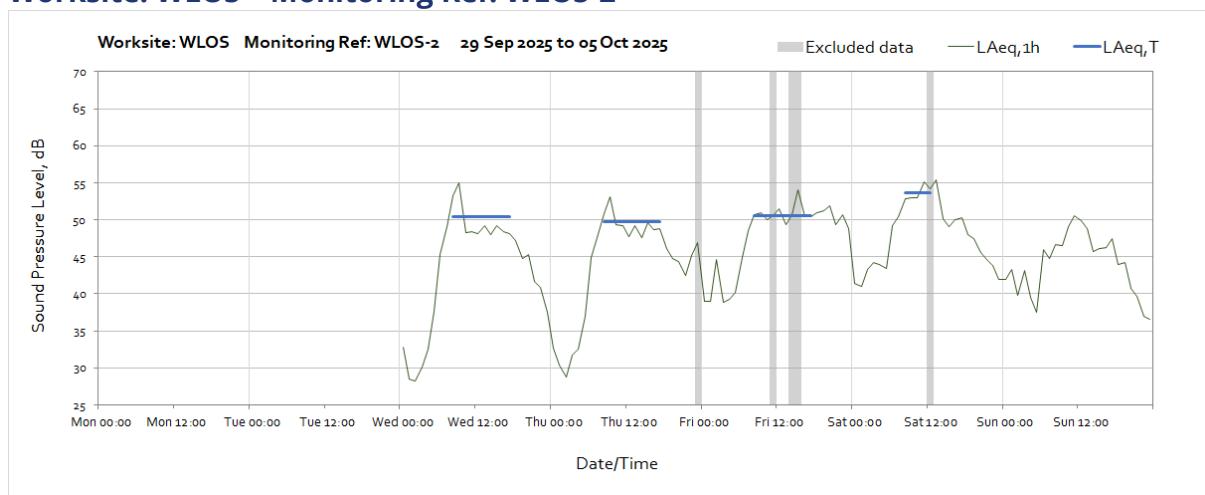
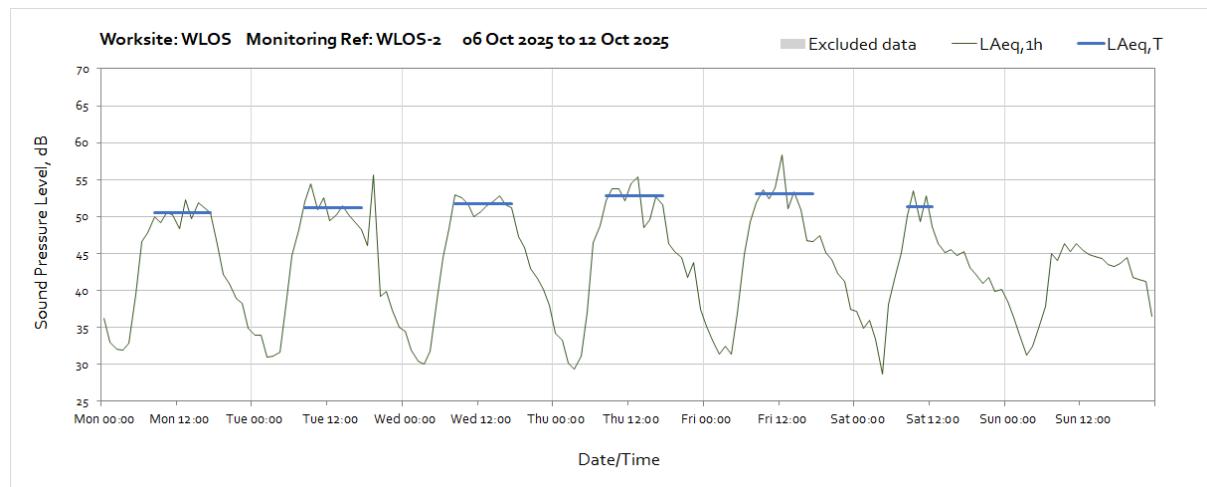
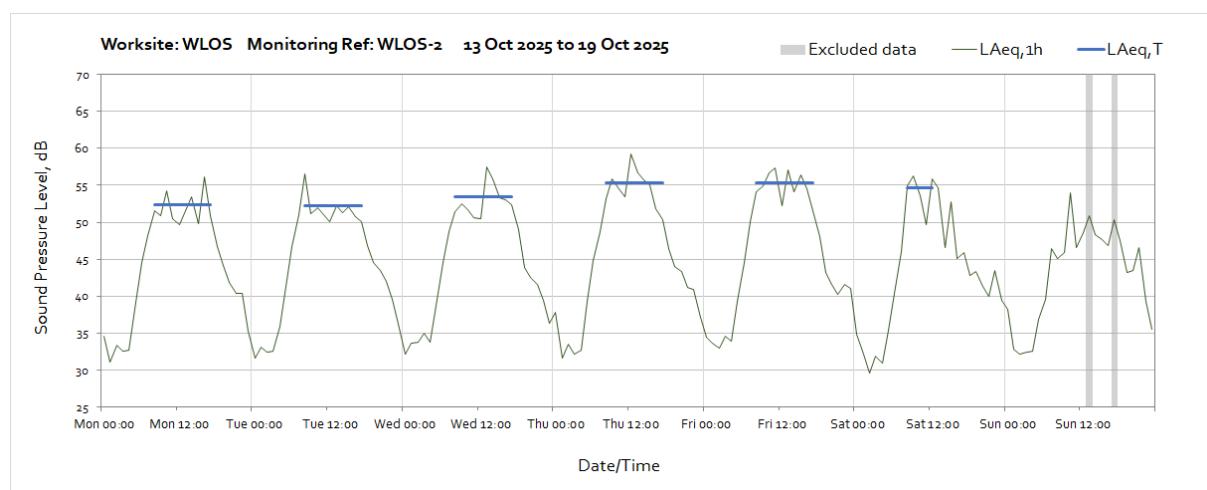
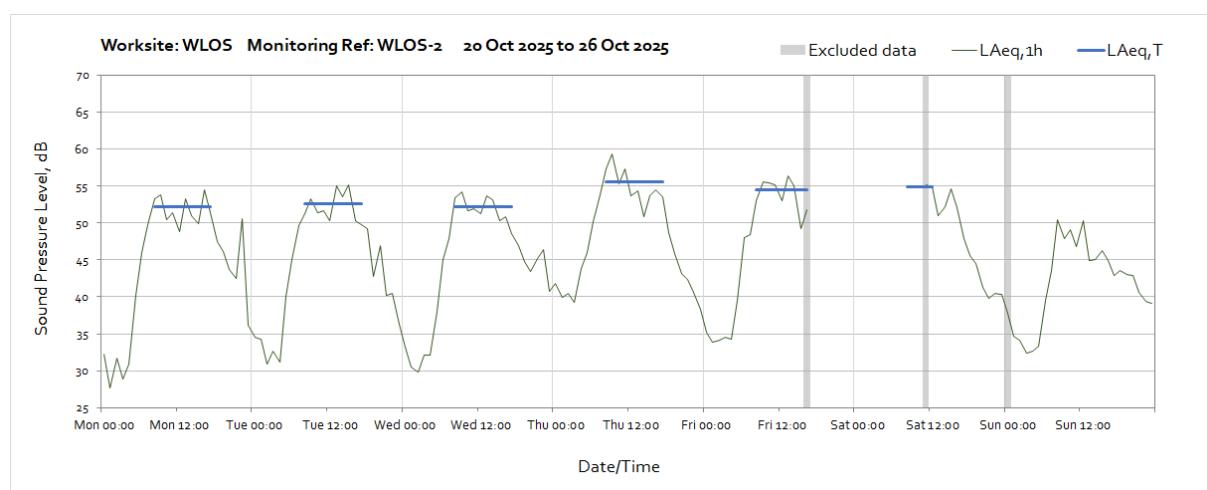
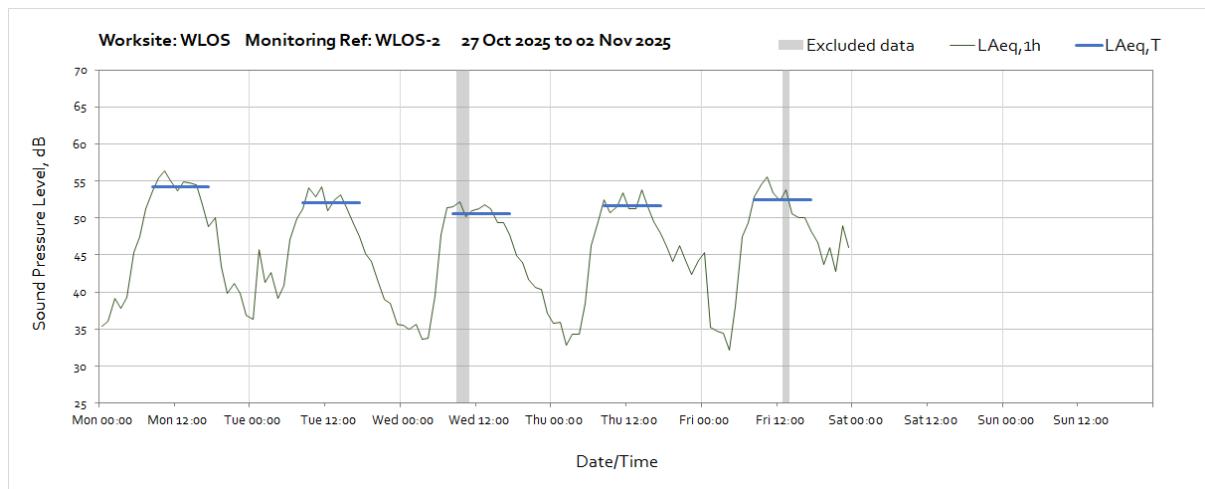
Worksite: WLOS – Monitoring Ref: WLOS-2

Note: Missing data between 17:00 on Friday 24th October and 11:00 on Saturday 25th October was due to a monitoring station power supply issue.

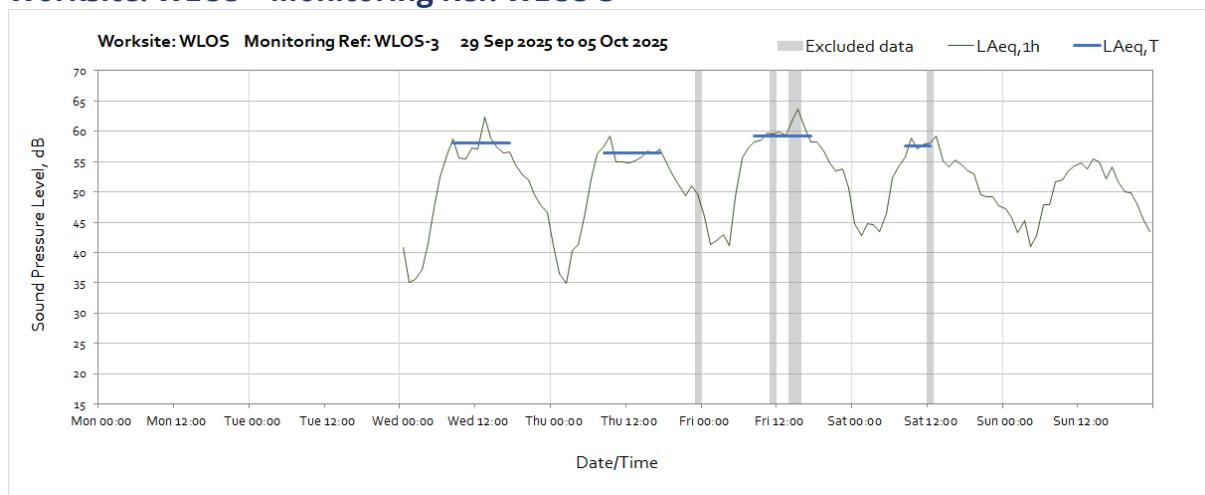
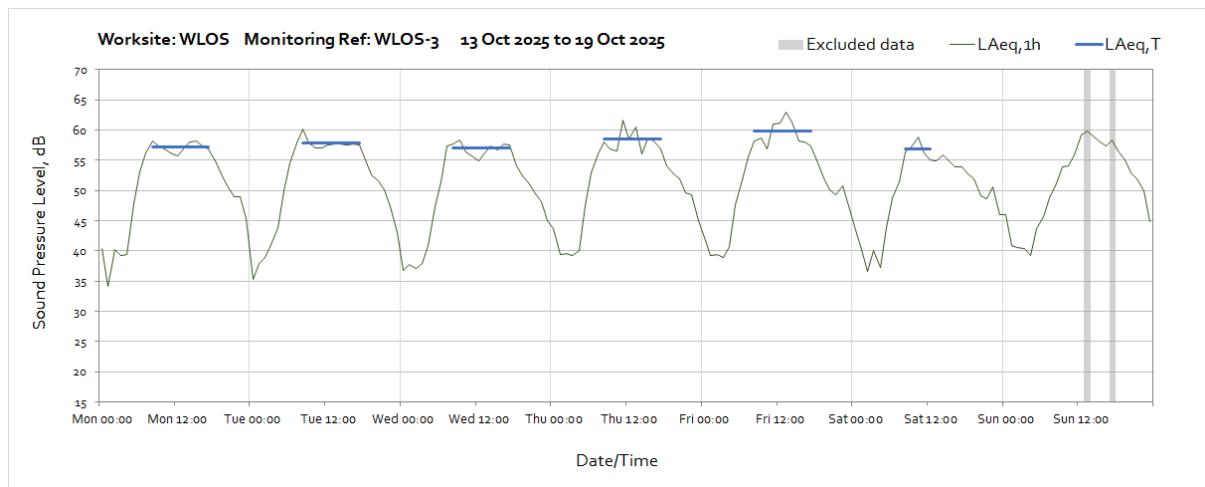
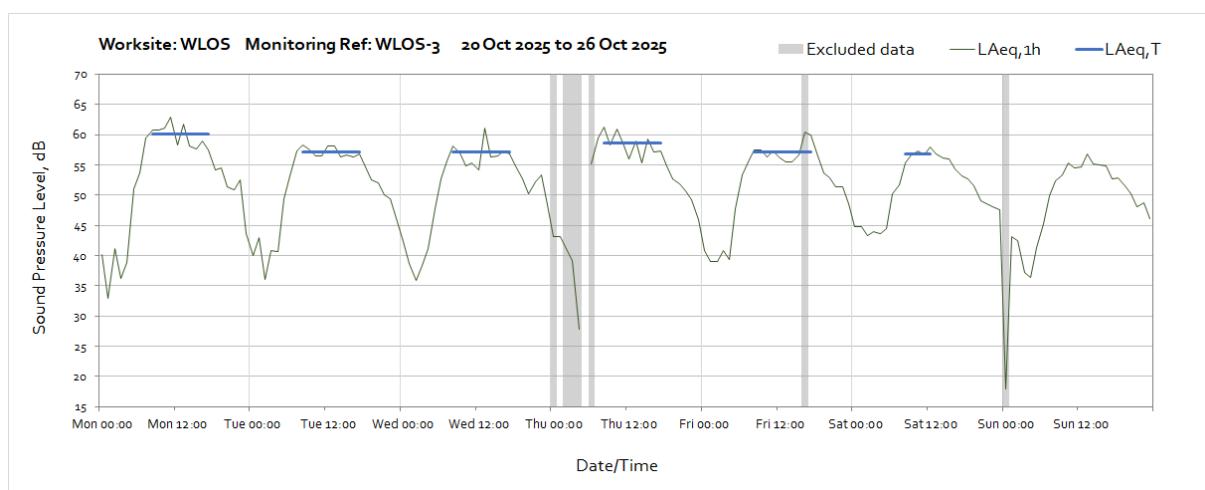
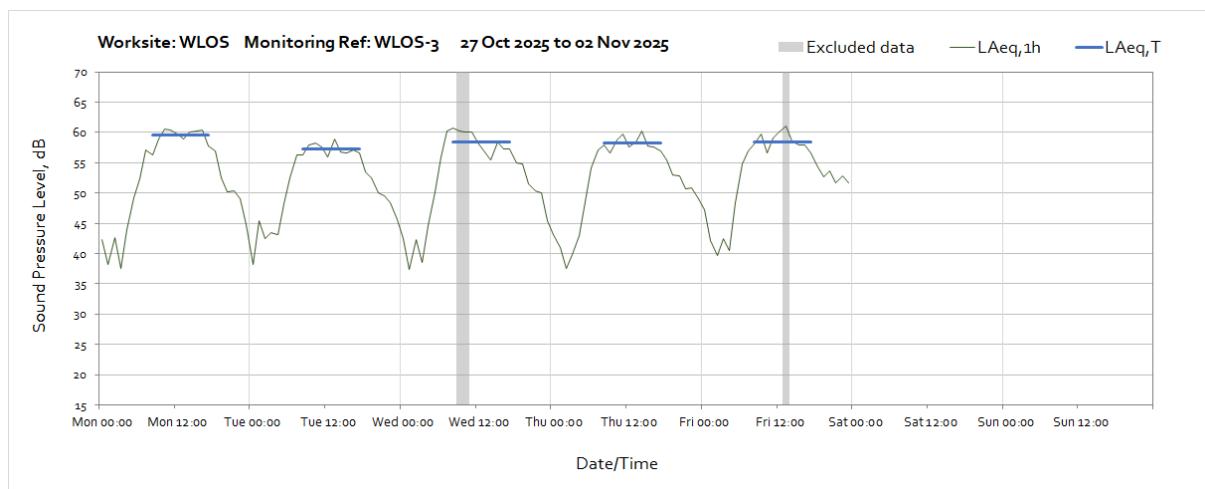
Worksite: WLOS – Monitoring Ref: WLOS-3

Note: Missing data between 05:00 and 06:00 on Thursday 23rd October was due to a communication error between the monitoring station and the server.

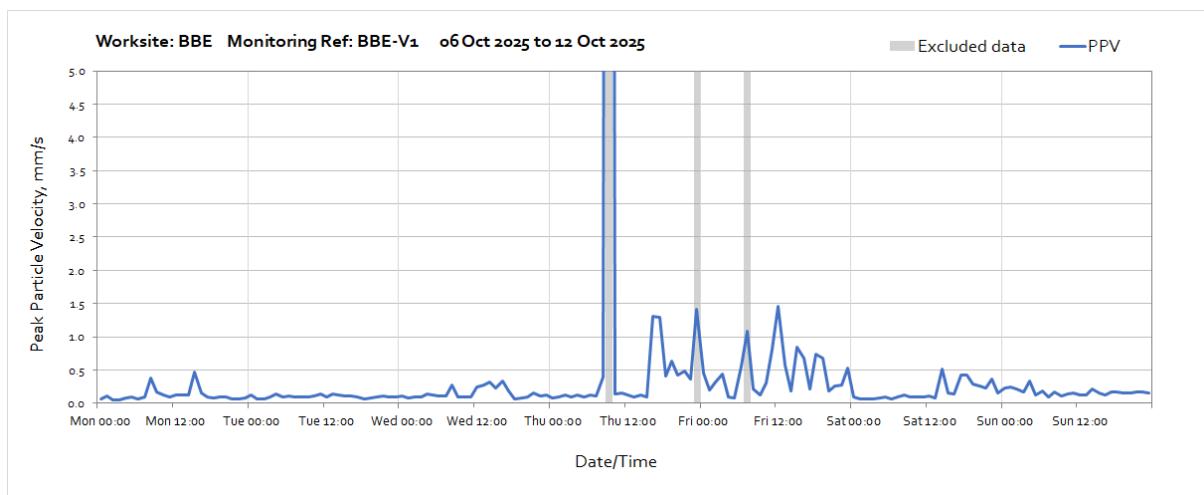
Worksite: BBE – Monitoring Ref: BBE-V1

The following graphs show the hourly measured peak particle velocity PPV recorded during the monitoring period. The graphs show the highest PPV of the three orthogonal axes x, y and z. Periods where PPV values have been affected by local interference with the vibration monitor or only measured for part of the period, which are not representative of HS2 construction works, have been greyed out and excluded when calculating values in of the main report.

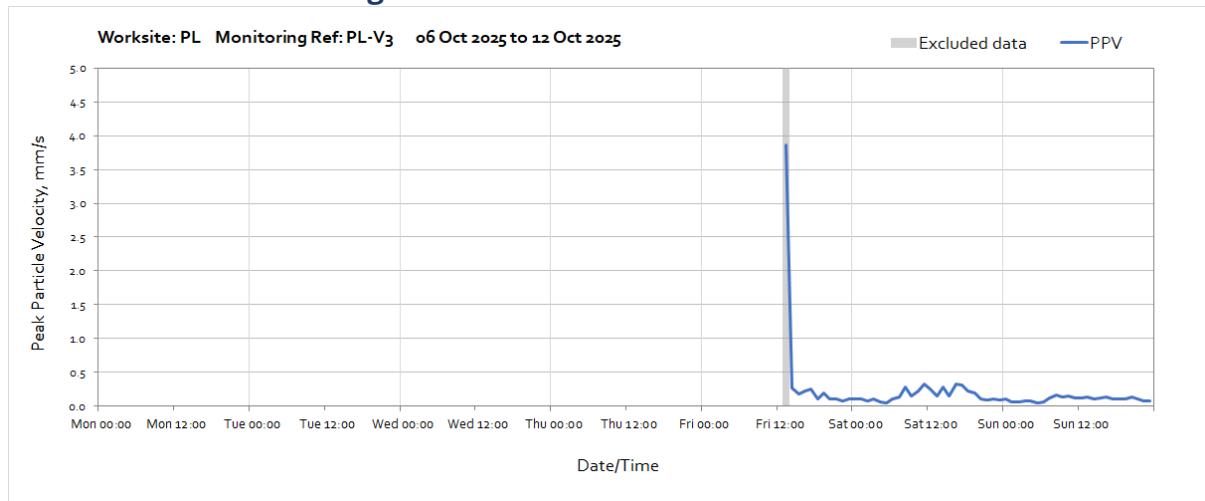
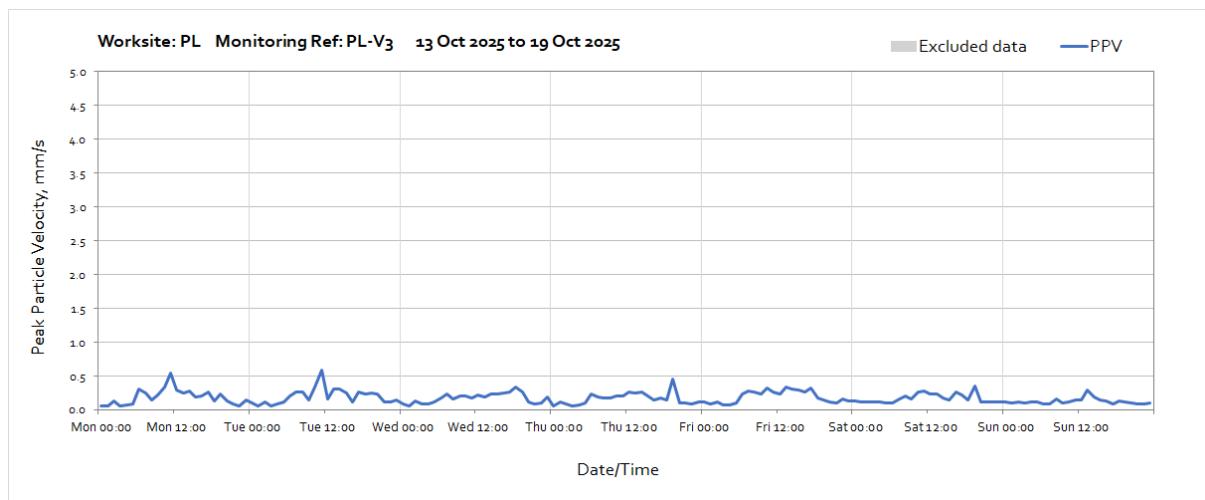
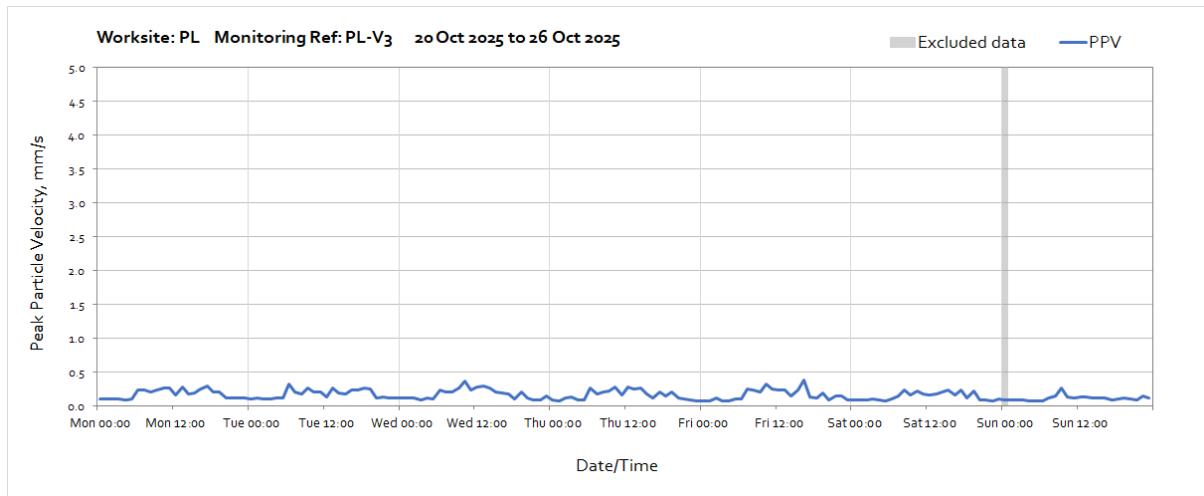
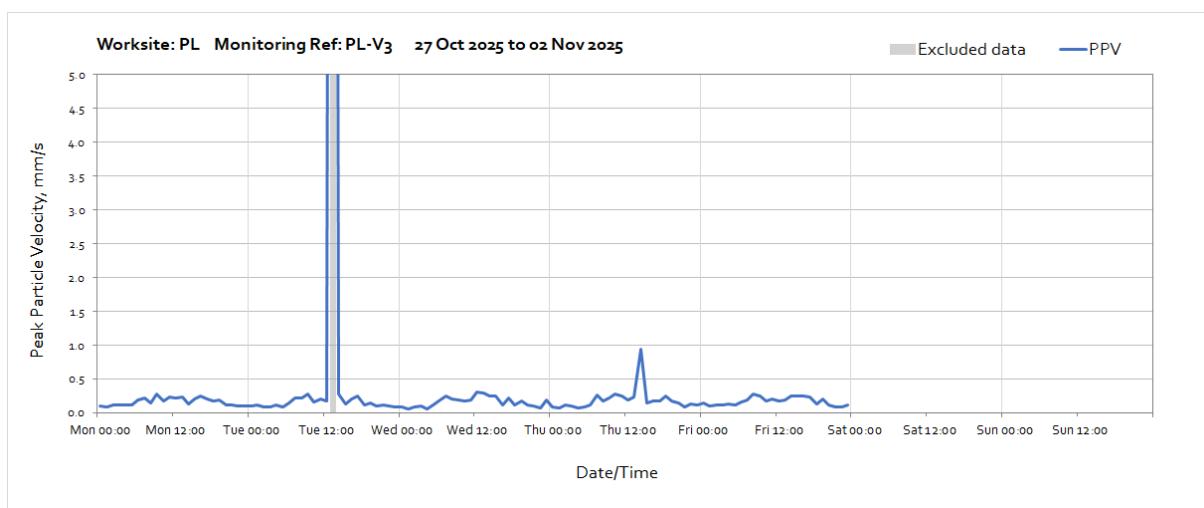
Worksite: PL – Monitoring Ref: PL-V3

Note: Missing data between the start of the month and 13:00 on Friday 10th October was due to an issue with the monitoring station cable.

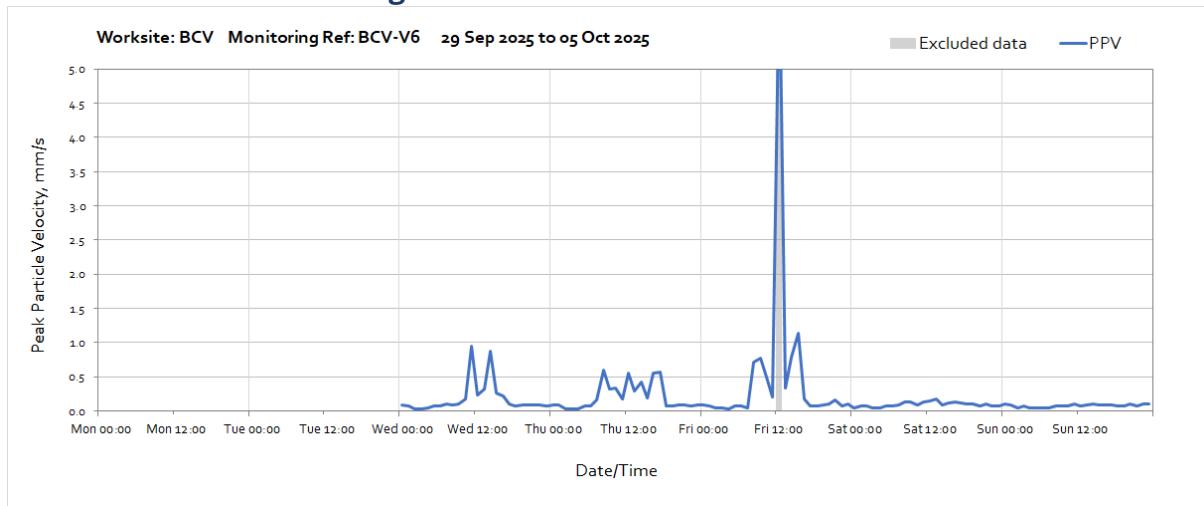
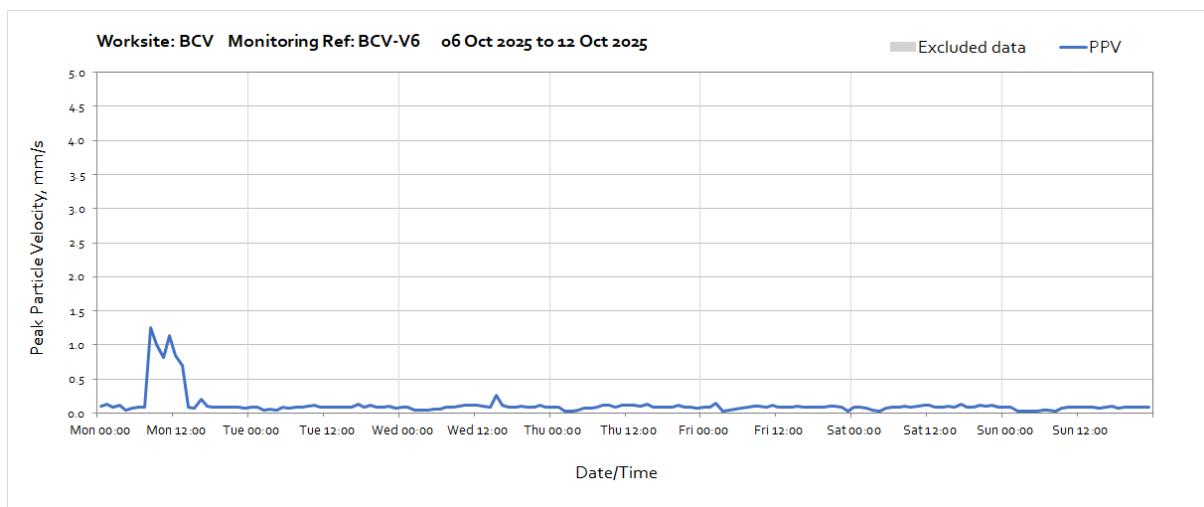
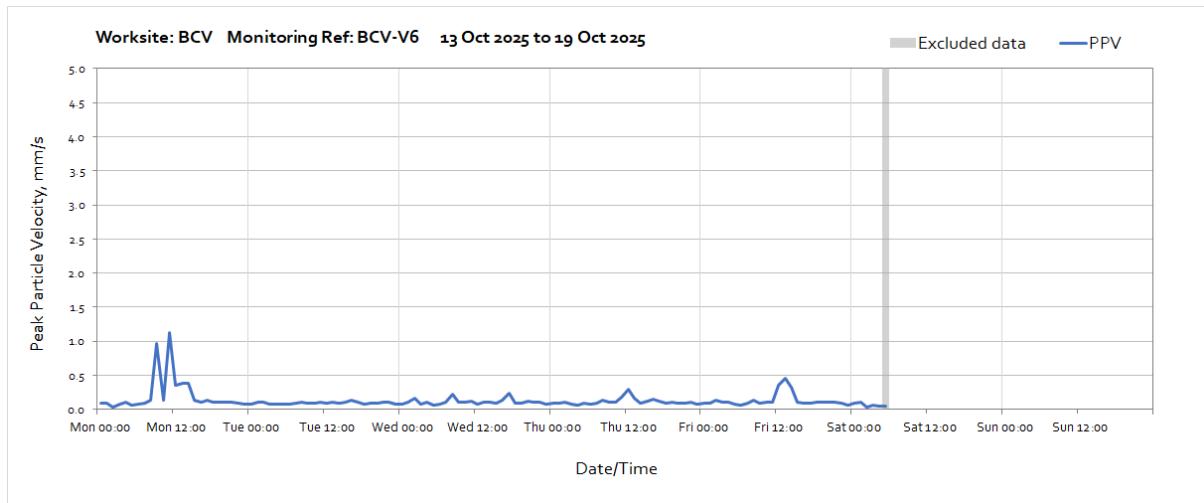
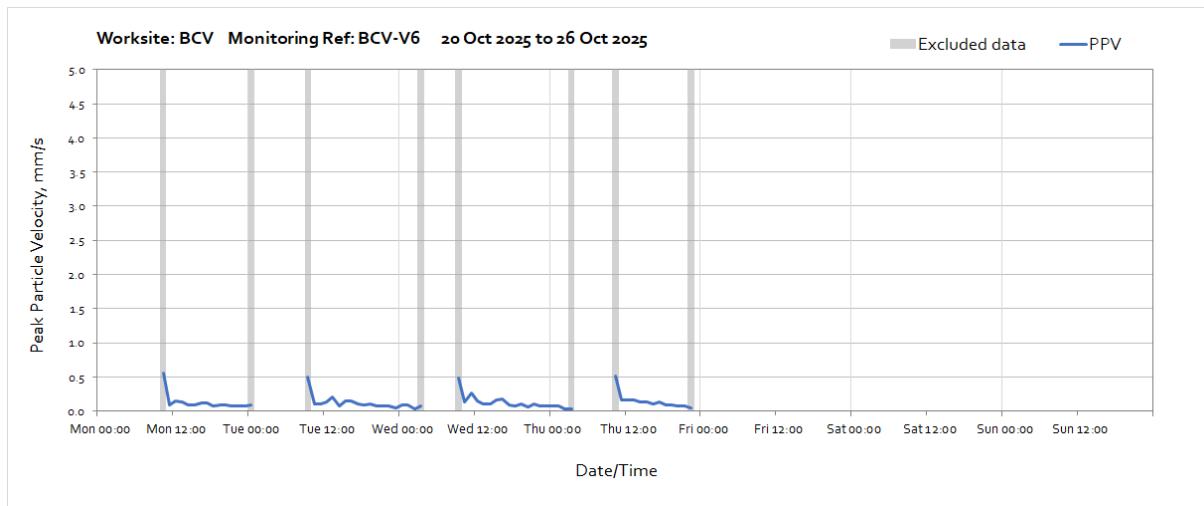
Worksite: BCV – Monitoring Ref: BCV-V6

Note: Missing data throughout the month was due to a loss of power to the monitoring station caused by poor weather conditions preventing sufficient light reaching the solar panel.

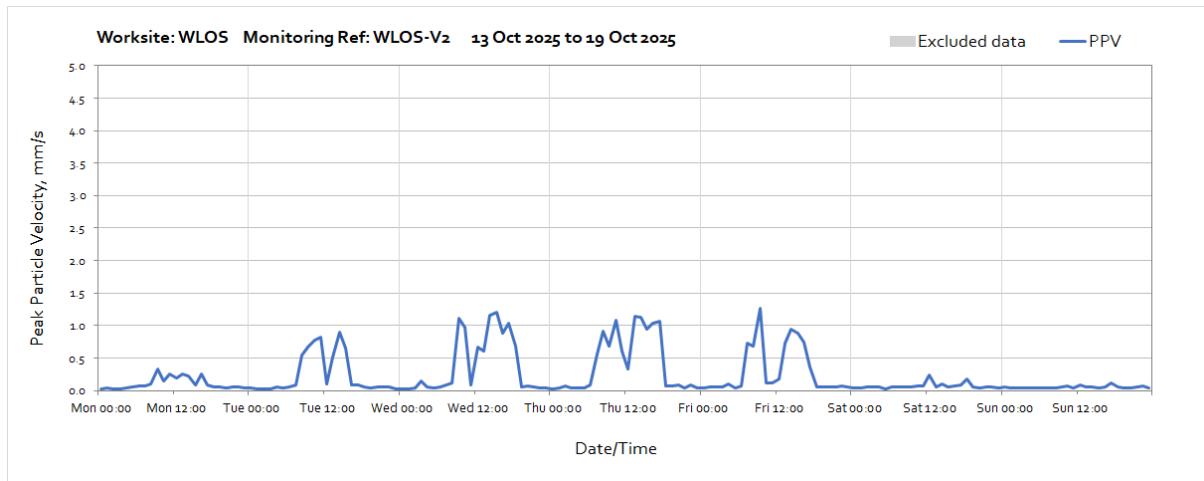
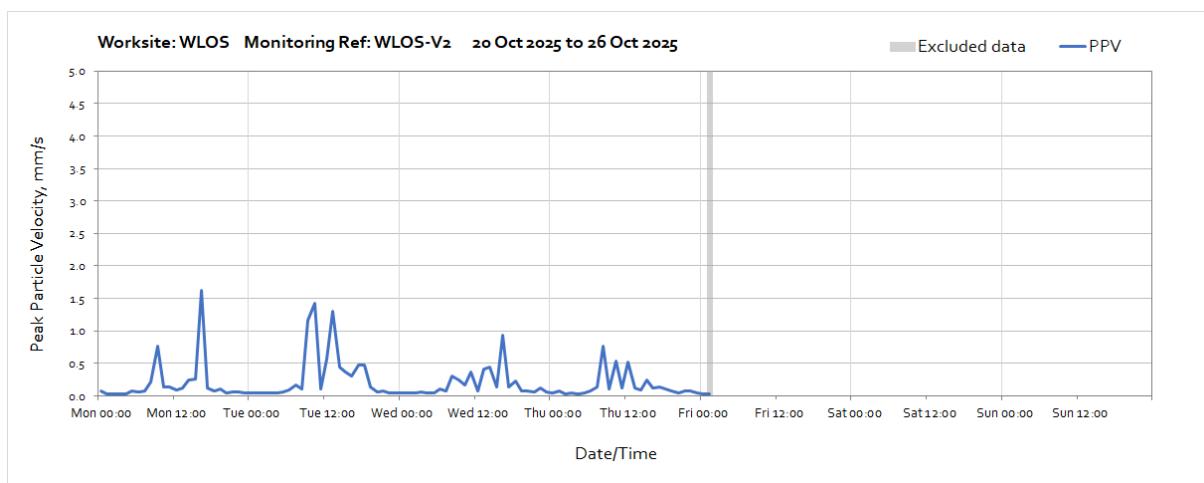
Worksite: WLOS – Monitoring Ref: WLOS-V2

Note: Missing data between 02:00 on Friday 24th October and the end of the month was due to monitoring station power supply issues.
