Air Quality and Dust Monitoring Monthly Report – November 2025

London Borough of Hammersmith and Fulham

A report prepared by EWCs and MWCCs on behalf of HS2 Ltd.

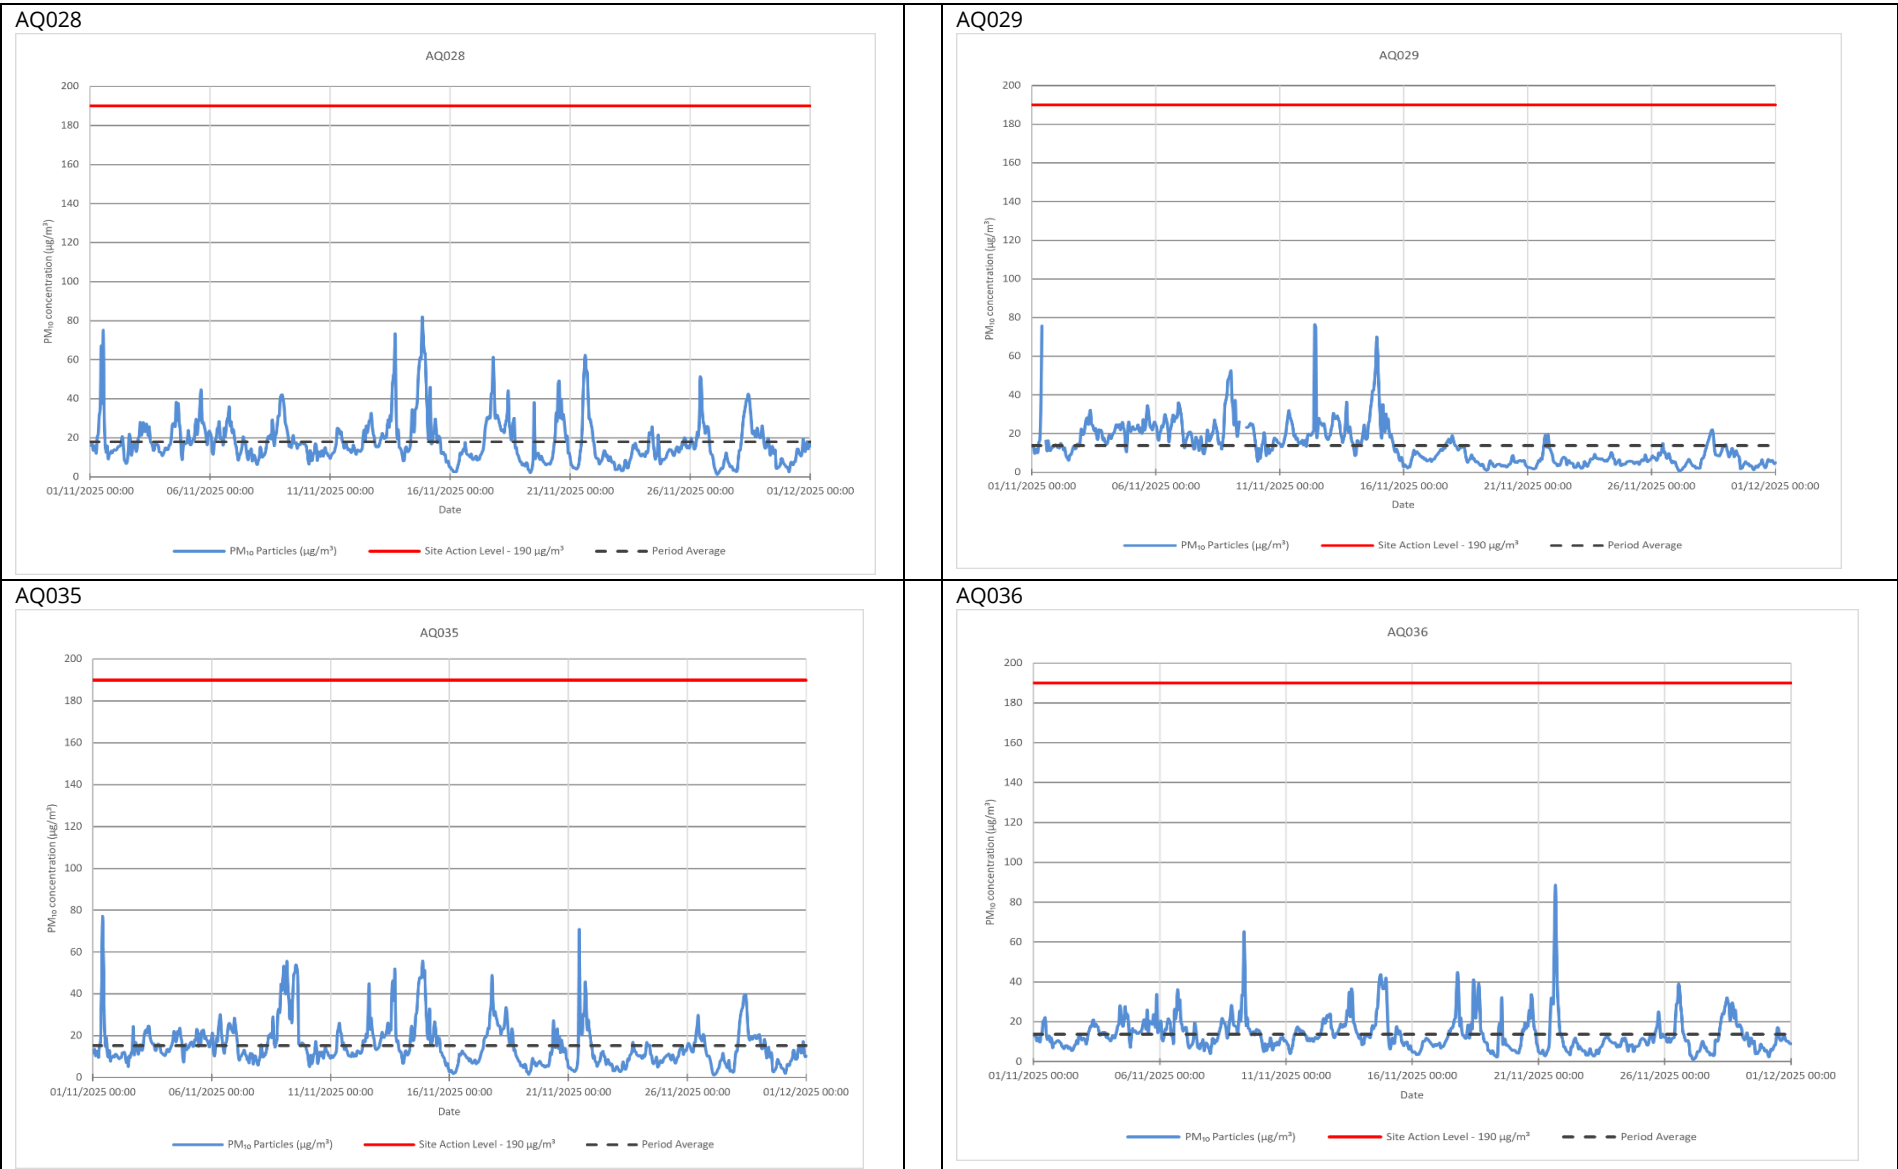
Figure 3: Construction dust 1-hour mean indicative PM₁₀ concentration for all dust monitors

1.1.6 Dust monitoring locations and results are presented in Appendix B, Table 1, together with line charts of monthly data from each dust monitor presented in Figure 3. All continuous dust monitoring is undertaken using indicative monitors. Despite being Environment Agency (MCERTS) certified, indicative monitors carry a higher level of uncertainty than reference monitors, and therefore cannot be strictly compared with Air Quality Standards for human health and the environment. The purpose of the monitoring undertaken is to ensure the effectiveness of the on-site mitigation.

1.1.7 The trigger level for PM₁₀ concentrations of 190 µg/m³, over a 1-hour period, in accordance with the updated guidance document '*Guidance on Monitoring in the Vicinity of Demolition and Construction Sites – (October 2018)*' has been applied.

- 1.1.8 No (0) dust trigger alerts were recorded during the monitoring period (November 2025).
- 1.1.9 Diffusion tube monitoring of Nitrogen Dioxide (NO₂) is undertaken at seven (7) locations around highways within the LBHF as part of the management of air quality where significant effects may occur as a result of the scheme.
- 1.1.10 Diffusion tube monitoring results are as provided from the laboratory analysis, and therefore still require various analysis and adjustments to be undertaken. Final corrected results will be presented and described in the annual report. However, based on the results to date, no unexpected values were recorded during the monitoring period.
- 1.1.11 NO₂ monitoring locations and results are presented in Appendix C, Table 2, together with the 2025 running mean.
- 1.1.12 There were no (0) complaints received during the reporting period (November 2025).
