Thermal exposure to roofs from fires involving photovoltaic panels

Fire engineering research services

Prepared for : The Building Safety Regulator

Prepared by : OFR Consultants Limited

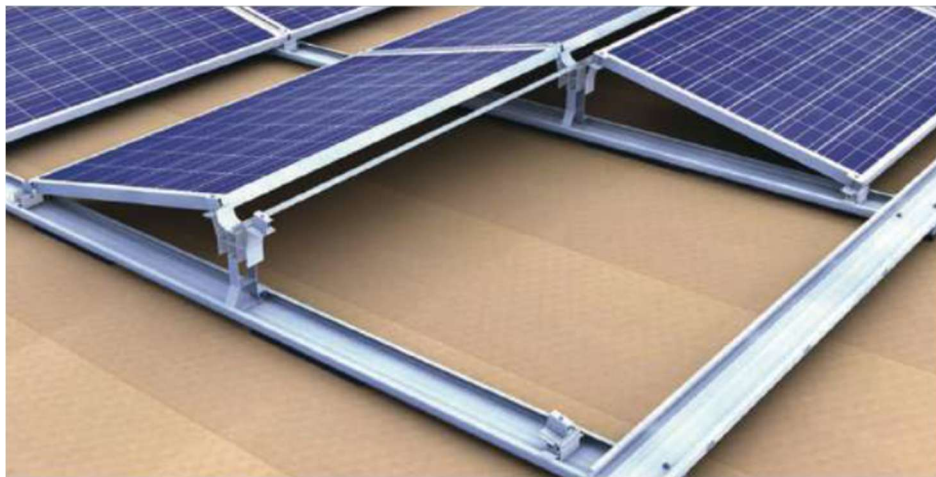
Figure 1. Example of a building-applied photovoltaic system (BAPV) on a flat roof construction

(MW) range. Within the built environment, a distinction is made between BAPV systems (Figure 1), which are retrofitted onto existing structures and present unique fire safety challenges due to their placement and interaction with the existing building design (4), and building-integrated photovoltaic (BIPV) systems, where the PV components form part of the building envelope (e.g. the façade elements as per Figure 2).

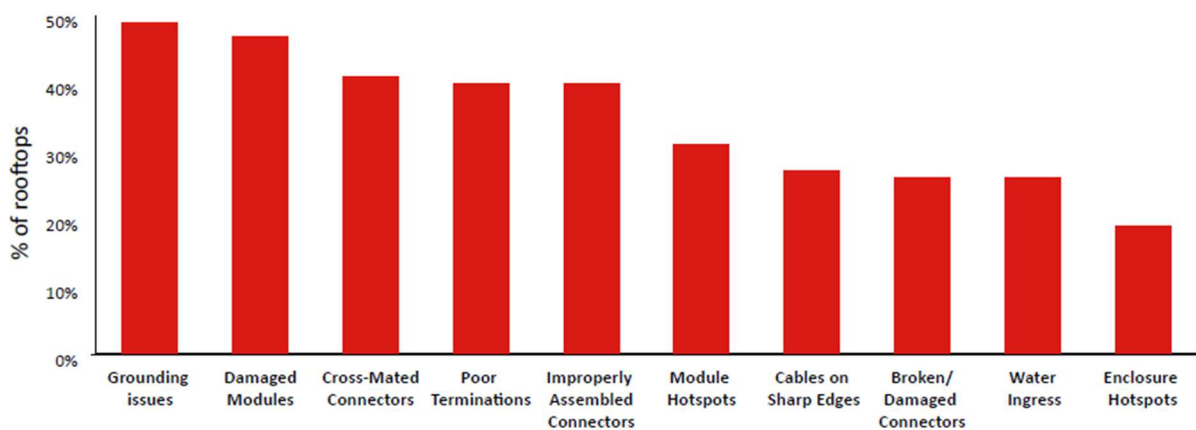
Figure 6. Overview of the failures reported by the Clean Energy Associates (CEA) (<https://www.cea3.com/ceablog/top-10-pv-rooftop-safety-risks>) in 2023.

Clean Energy Associates (CEA) has conducted over 600 safety audits of rooftop PV installations, revealing that 97 percent of the systems presented safety issues linked to ignition hazards. A detailed breakdown of their findings is illustrated in the accompanying bar chart in Figure 6. Given these findings, it can be inferred that the occurrence of at least one ignition event over the lifespan of a PV installation is highly likely. These results align with observations from FM Global, which has reported ongoing instances of ignition and fires even in buildings that adhere to their safety recommendations (7).

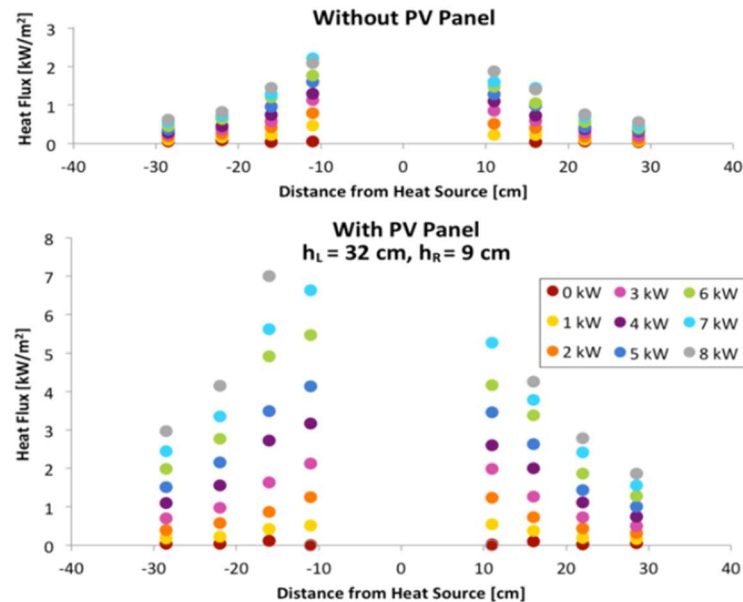
Figure 8. The Heat Flux received as a function of distance to, and HRR from, the heat source. Each colored dot defines a HRR and the gas burner is placed at the distance of 0 cm from the heat source, extracted from (26).

increased the radiative heat flux toward the surface beneath it, as illustrated in Figure 8. Even at lower heat release rates, the damaged length of the bottom surface exceeded the critical length as determined for a $B_{ROOF}(t_2)^1$ (EN 13501-5 (25)) compliant roofing membrane (26).

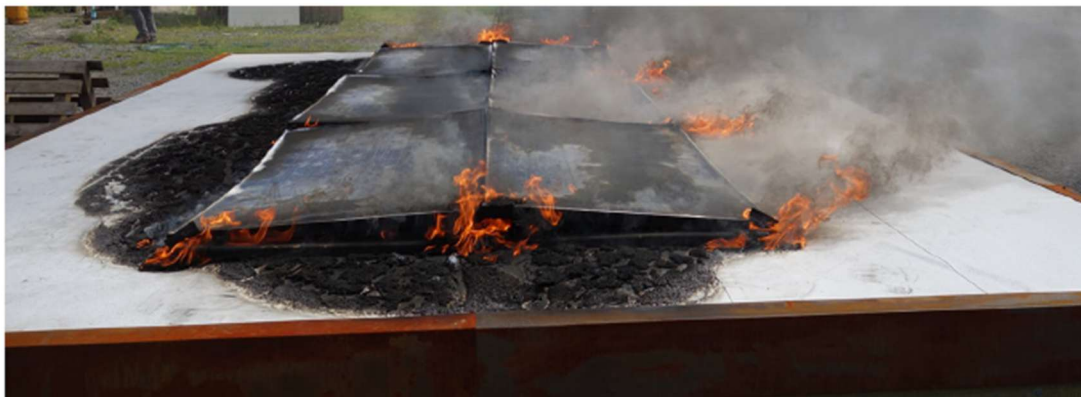
Figure 10. Experiment T3 from (11). The whole area underneath the PV array was affected by the fire, (11).

The results demonstrated that the altered geometry by the presence of the PV module, rather than the fire load of the PV panels or external wind effects, played a dominant role in fire spread. The PV panels facilitated heat retention and re-radiation, contributing to fire propagation over the roof covering. Maximum temperatures of 175°C and 243°C were recorded beneath the PIR insulation and mineral wool, respectively—well below the piloted ignition threshold for EPS. Despite this, EPS ignition occurred in both tests involving PIR insulation after approximately one hour due to thermal degradation and loss of mechanical integrity. In contrast, mineral wool remained stable throughout the experiments, preventing EPS ignition.

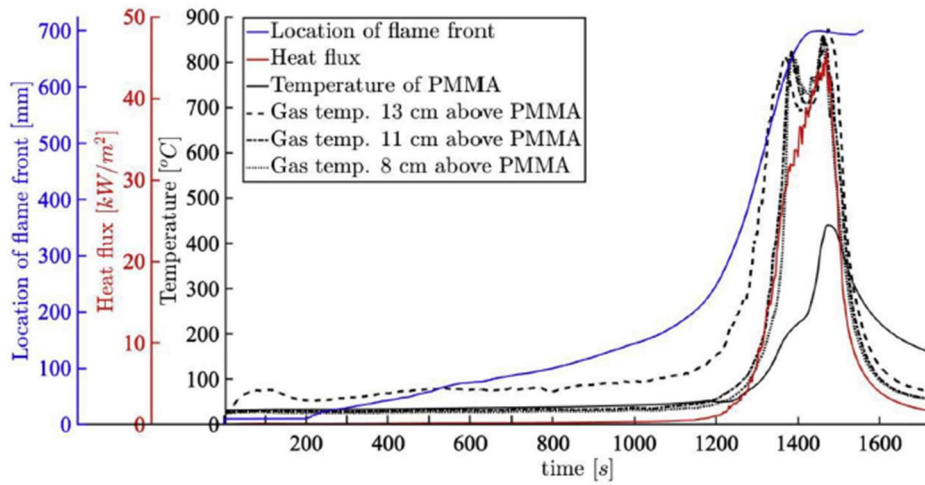
Figure 12. Sample width: 30 cm. Gap height: 15 cm. Plot of flame front location, heat flux, temperature 5 cm in front of the HFG, and gap temperature at three heights above the HFG. Plot extracted from (4).

Figure 12 presents the experimental temperature, flame front location, and heat flux data of an exemplary experiment conducted for this campaign. It is interesting to observe a slow fire growth until approximately second 1200, when the fire starts growing exponentially, triggering incident heat fluxes to the 'roof' surface of almost 50 kW/m^2 and temperatures of approximately $900 \text{ }^\circ\text{C}$.

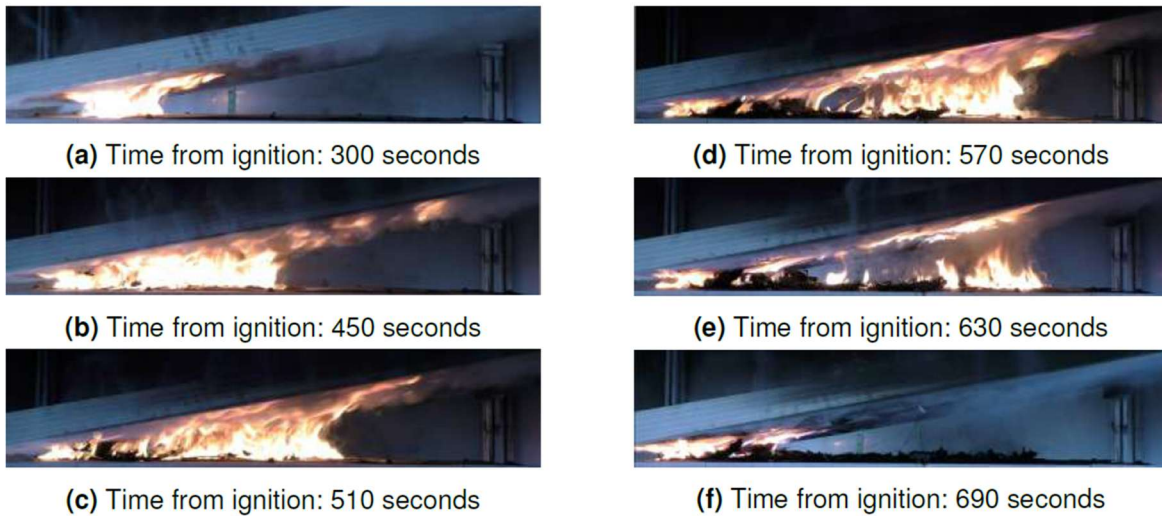
Figure 14. Flame spread on roof construction mock-up with mineral wool below the roofing membrane, a gap height of 8 cm, and an inclination of 10°, from (4).

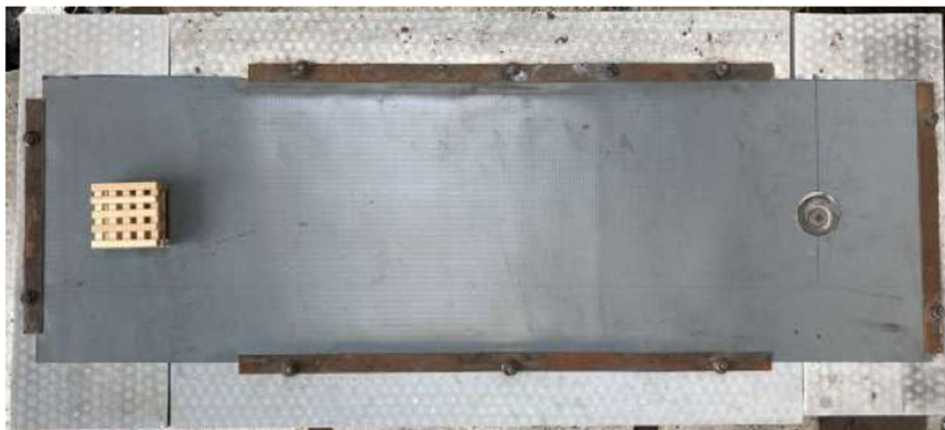
Figure 15. Top view of the mock-up roof construction before ignition of the wood crib. The wood cribs were made of pine sticks with a length of 81 mm and a squared cross-section with a side length of 9 mm, from (4).

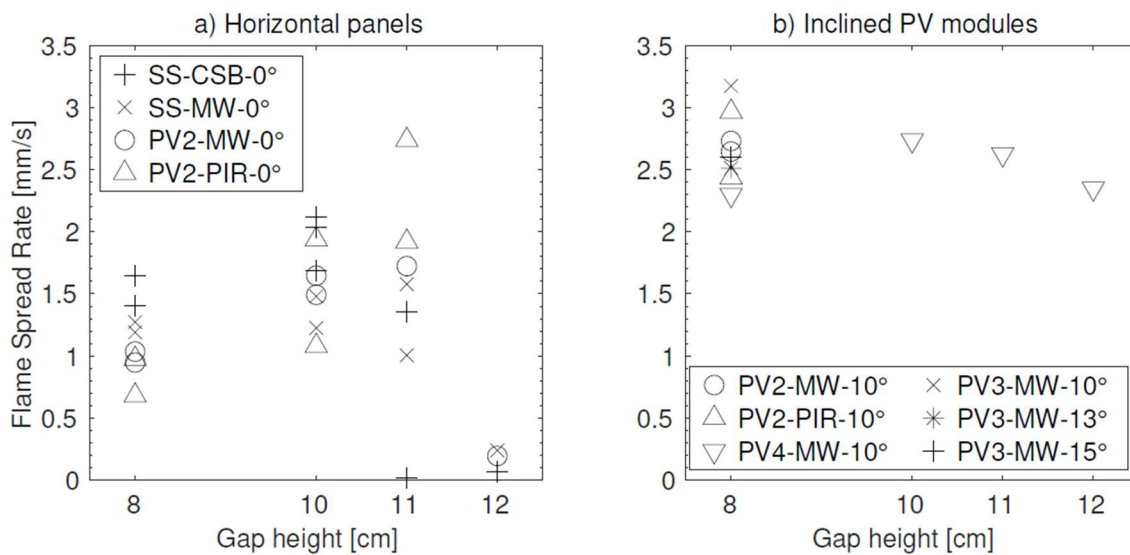
Figure 16. Flame spread rate (FSR) as a function of gap height, panel type (Stainless-steel board (SS) or PV module (PV2, PV3, or PV4)), or insulation material (Calcium silica board (CSB), mineral wool (MW), or PIR insulation) for experiments conducted below: a) Horizontal panels, or b) Inclined PV modules, extracted from (4).

When using the stainless-steel board instead of PV modules, a further reduction to a 10 cm gap was required to achieve consistent flame spread (Figure 16). The polymer back sheet of the PV modules only ignited at points of direct flame impingement, meaning it did not significantly contribute to the fuel load or influence flame spread in the semi-enclosure. Instead, the lower critical gap height observed for PV modules was attributed to their aluminium frame, which blocked the upward movement of buoyancy-driven combustion products. This obstruction created a continuous hot smoke layer underneath the panel, which had two notable effects: (i) enhanced preheating along the entire roof mock-up, promoting flame spread, and (ii) reduced effective gap height, leading to increased airflow velocity and, consequently a decrease in flame spread rate.

When the PV modules were inclined, the effects of the hot smoke layer were no longer observed, as the inclination allowed combustion products to escape upwards along the back of the modules. However, this inclination also intensified heat flux beneath the elevated section of the module, leading to self-sustained flame spread in all cases. Based on these observations, it was concluded that the critical gap height for inclined PV modules exceeded 12 cm, as per Figure 16 (b)

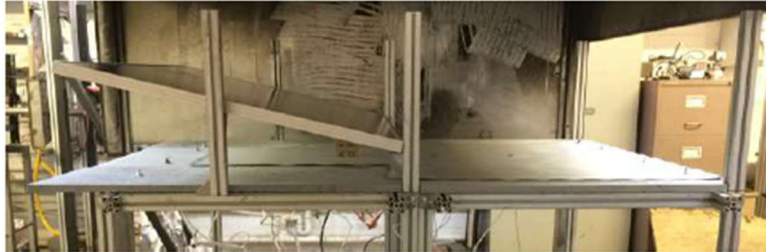
(a) Side view of the experimental set-up with the roofing membrane and wood crib installed in correspondence with the sectional top view in Figure 3.10b.

(b) Sectional top view of the experimental set-up with a 700 mm times 700 mm (shaded), or 450 mm times 450 mm (marked with dashed red lines) area of roofing membrane below the PV module and 10 cm displacement of the wood crib from the edge of the PV module similar to the setups C7 to C10 in Table 3.8. HFG: Heat Flux Gauge. WC: Wood Crib.

Figure 17. Visual overview of the medium-scale experimental set-up used to analyse the influence of flow and heat flux in and outside the semi-enclosure formed by the PV module and the subjacent surface, extracted from (4).

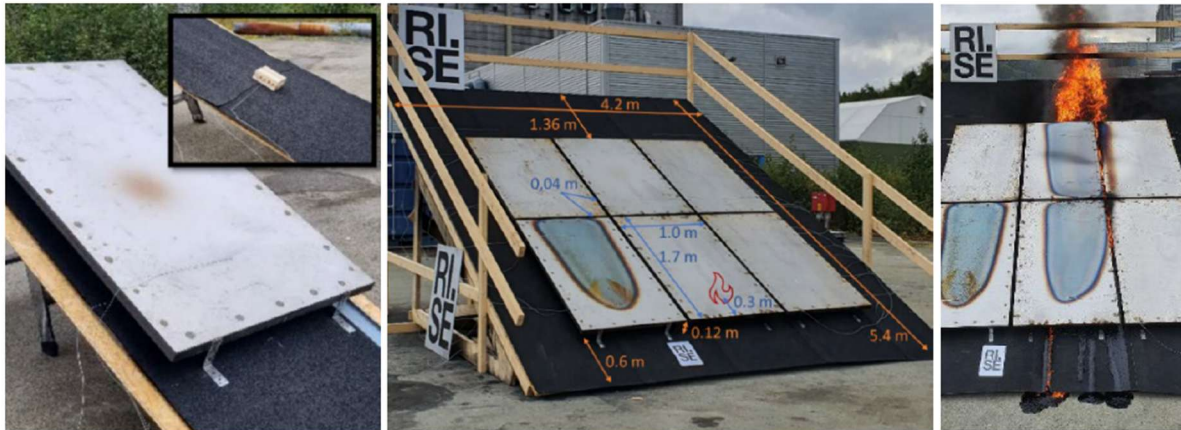
Figure 18. Medium-scale experiments with a wood crib placed on top of a roofing membrane with a steel plate (left) and without a steel plate (left inserted). Large-scale experiment with steel plate on a roof measuring 4.2 × 5.4 m (middle). Fire propagation in large-scale approximately 20 minutes after ignition where the fire has spread up to the top of the roof (red arrow) and down to the lower edge in the flowing melted bitumen roofing membrane (white arrow) (right), extracted from (13).

Figure 18 presents three pictures of their largest-scale experiment.

The roof structure featured a bitumen roofing membrane over a wooden chipboard substrate. To simulate the influence of BAPV modules, steel plates were positioned at varying distances above the roof. The fire development within the gap between the roof and the steel plate was analysed using different wood cribs as ignition sources.
