Air Quality and Dust Monitoring Monthly Report – December 2025

London Borough of Ealing

A report prepared by EWCs and MWCCs on behalf of HS2 Ltd.

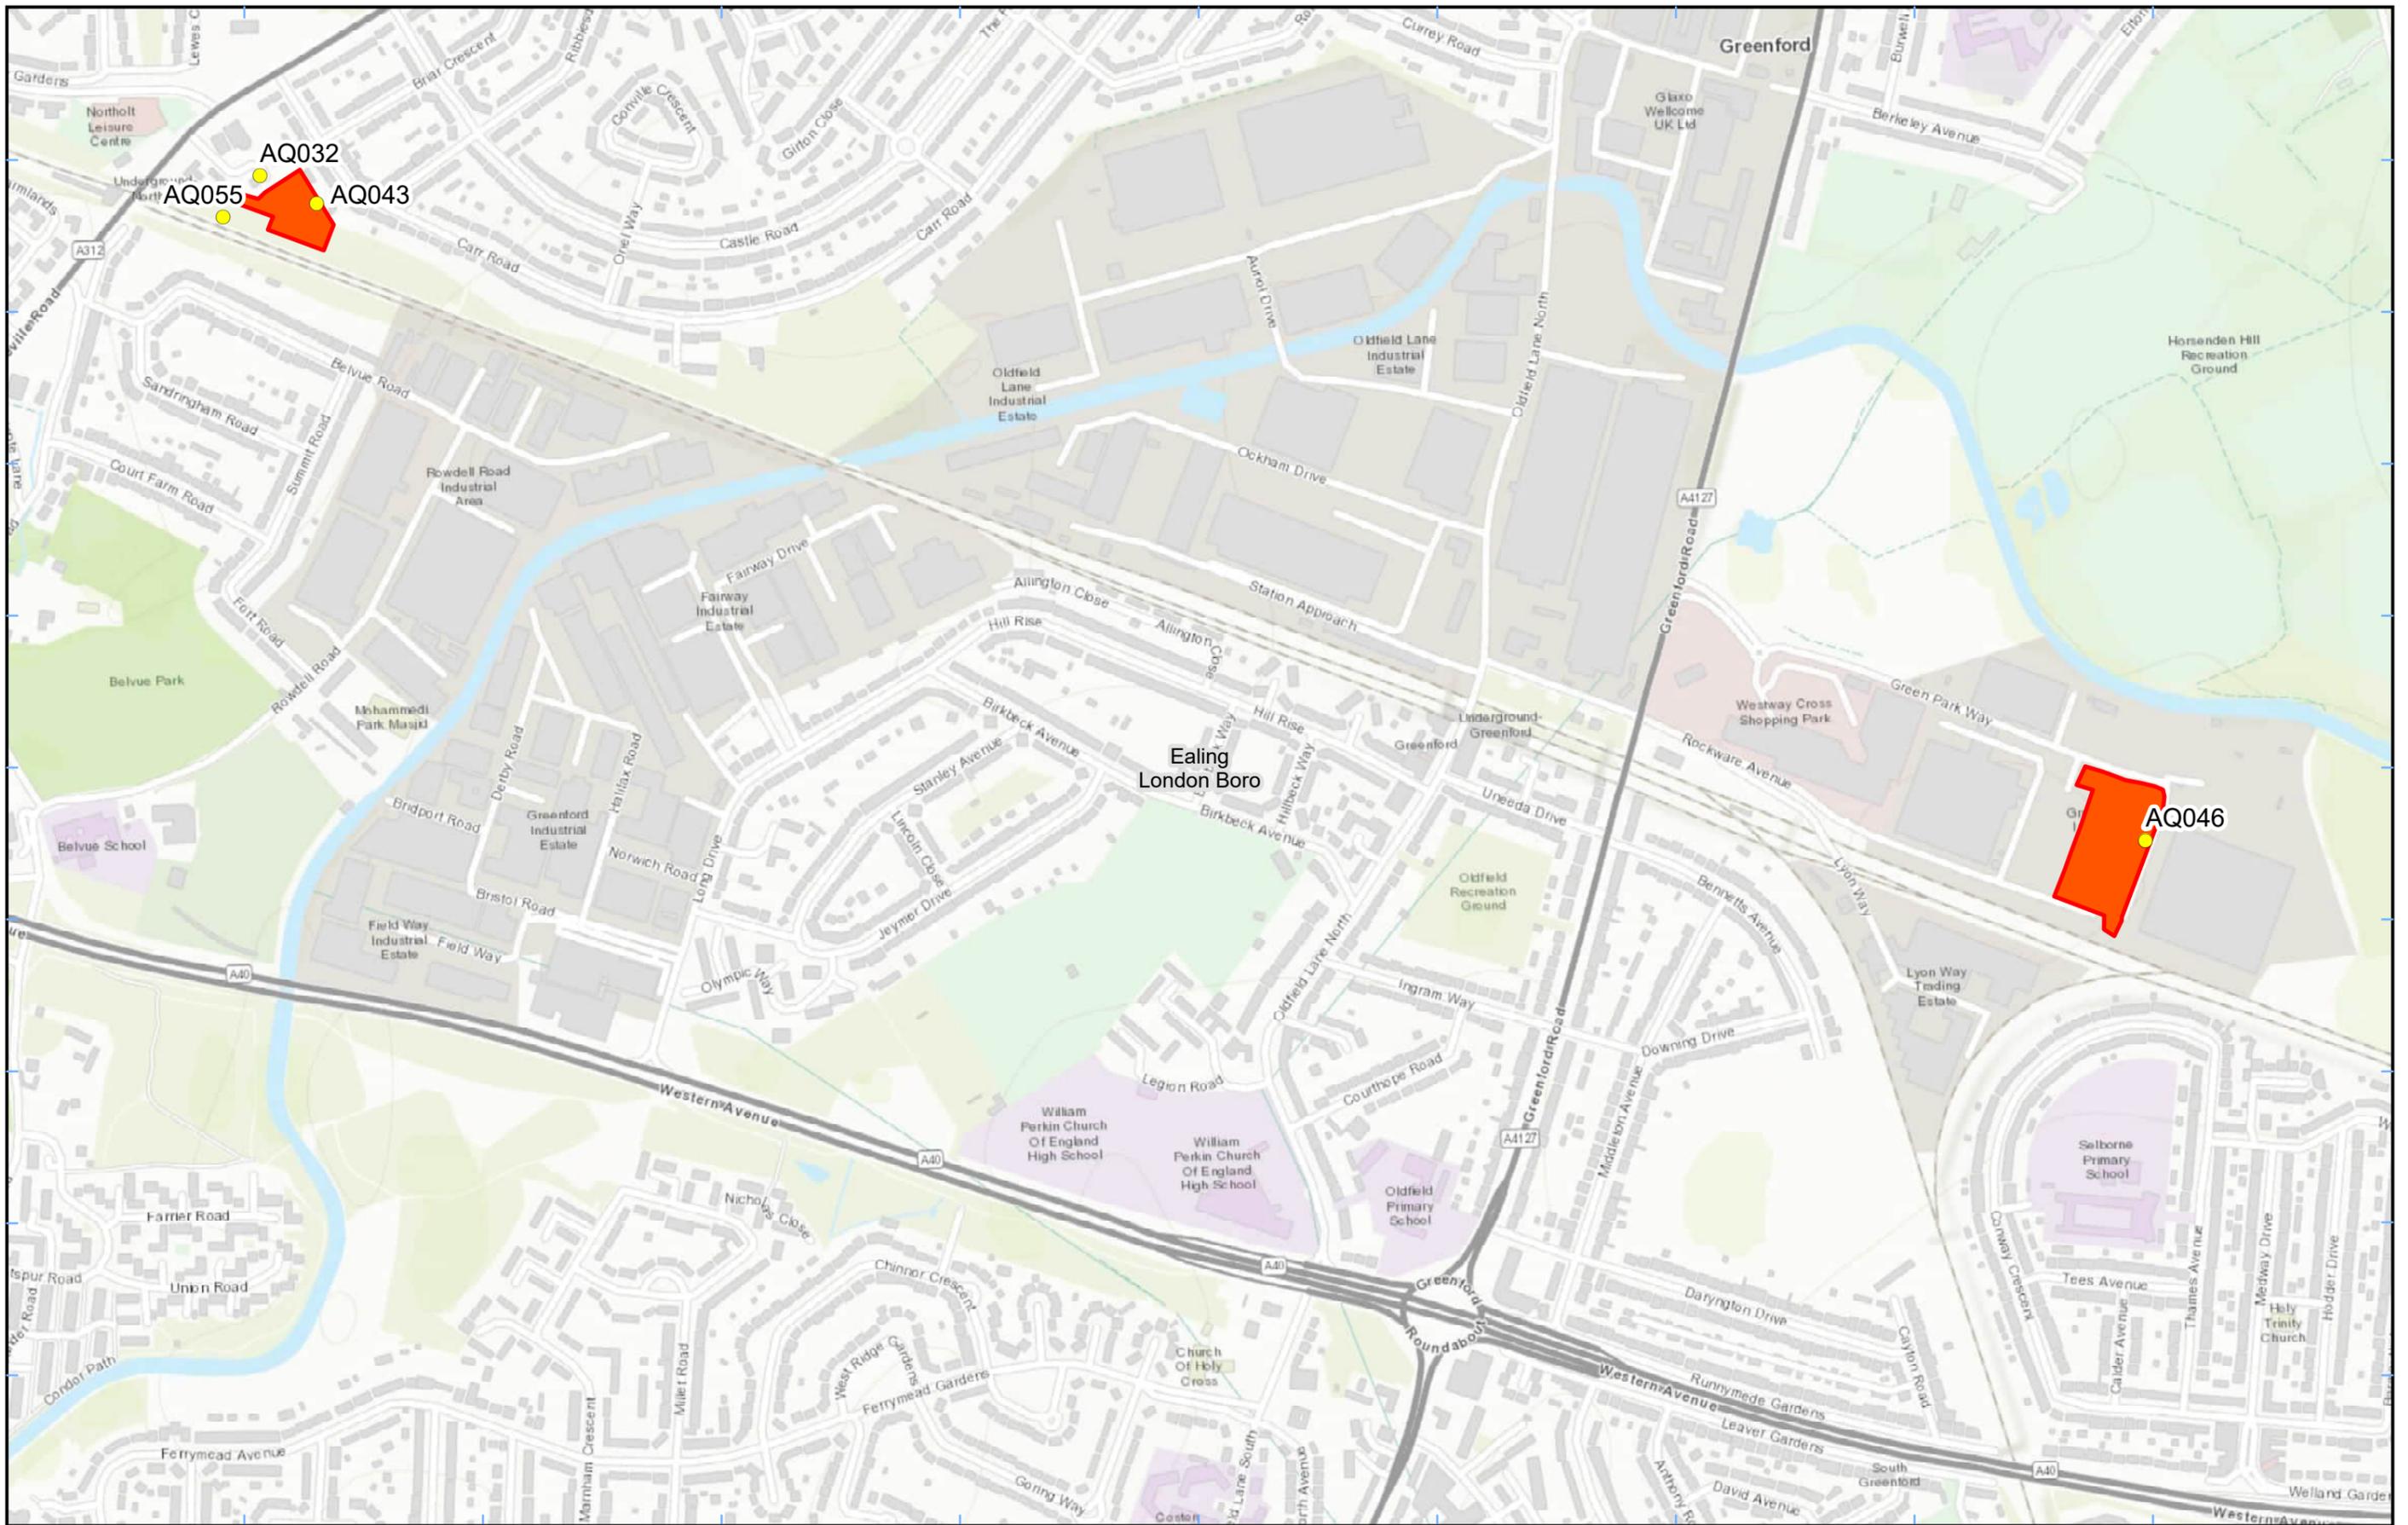
**Worksite & Monitoring Locations
 In LBE (Sheet 1)**

- 1.1.2 Figure 1 to Figure 3 in Appendix A present the current worksites together with air quality and dust monitoring locations.
- 1.1.3 This summary should be read in conjunction with the overview monitoring report available from www.gov.uk/government/collections/monitoring-the-environmental-effects-of-hs2, which highlights: the applicable standards and guidance, as well as the air quality and dust monitoring methodologies to be implemented by nominated undertakers throughout construction.

- 1.1.4 The current worksites, as presented in Appendix A, Figure 1 to Figure 3, include:

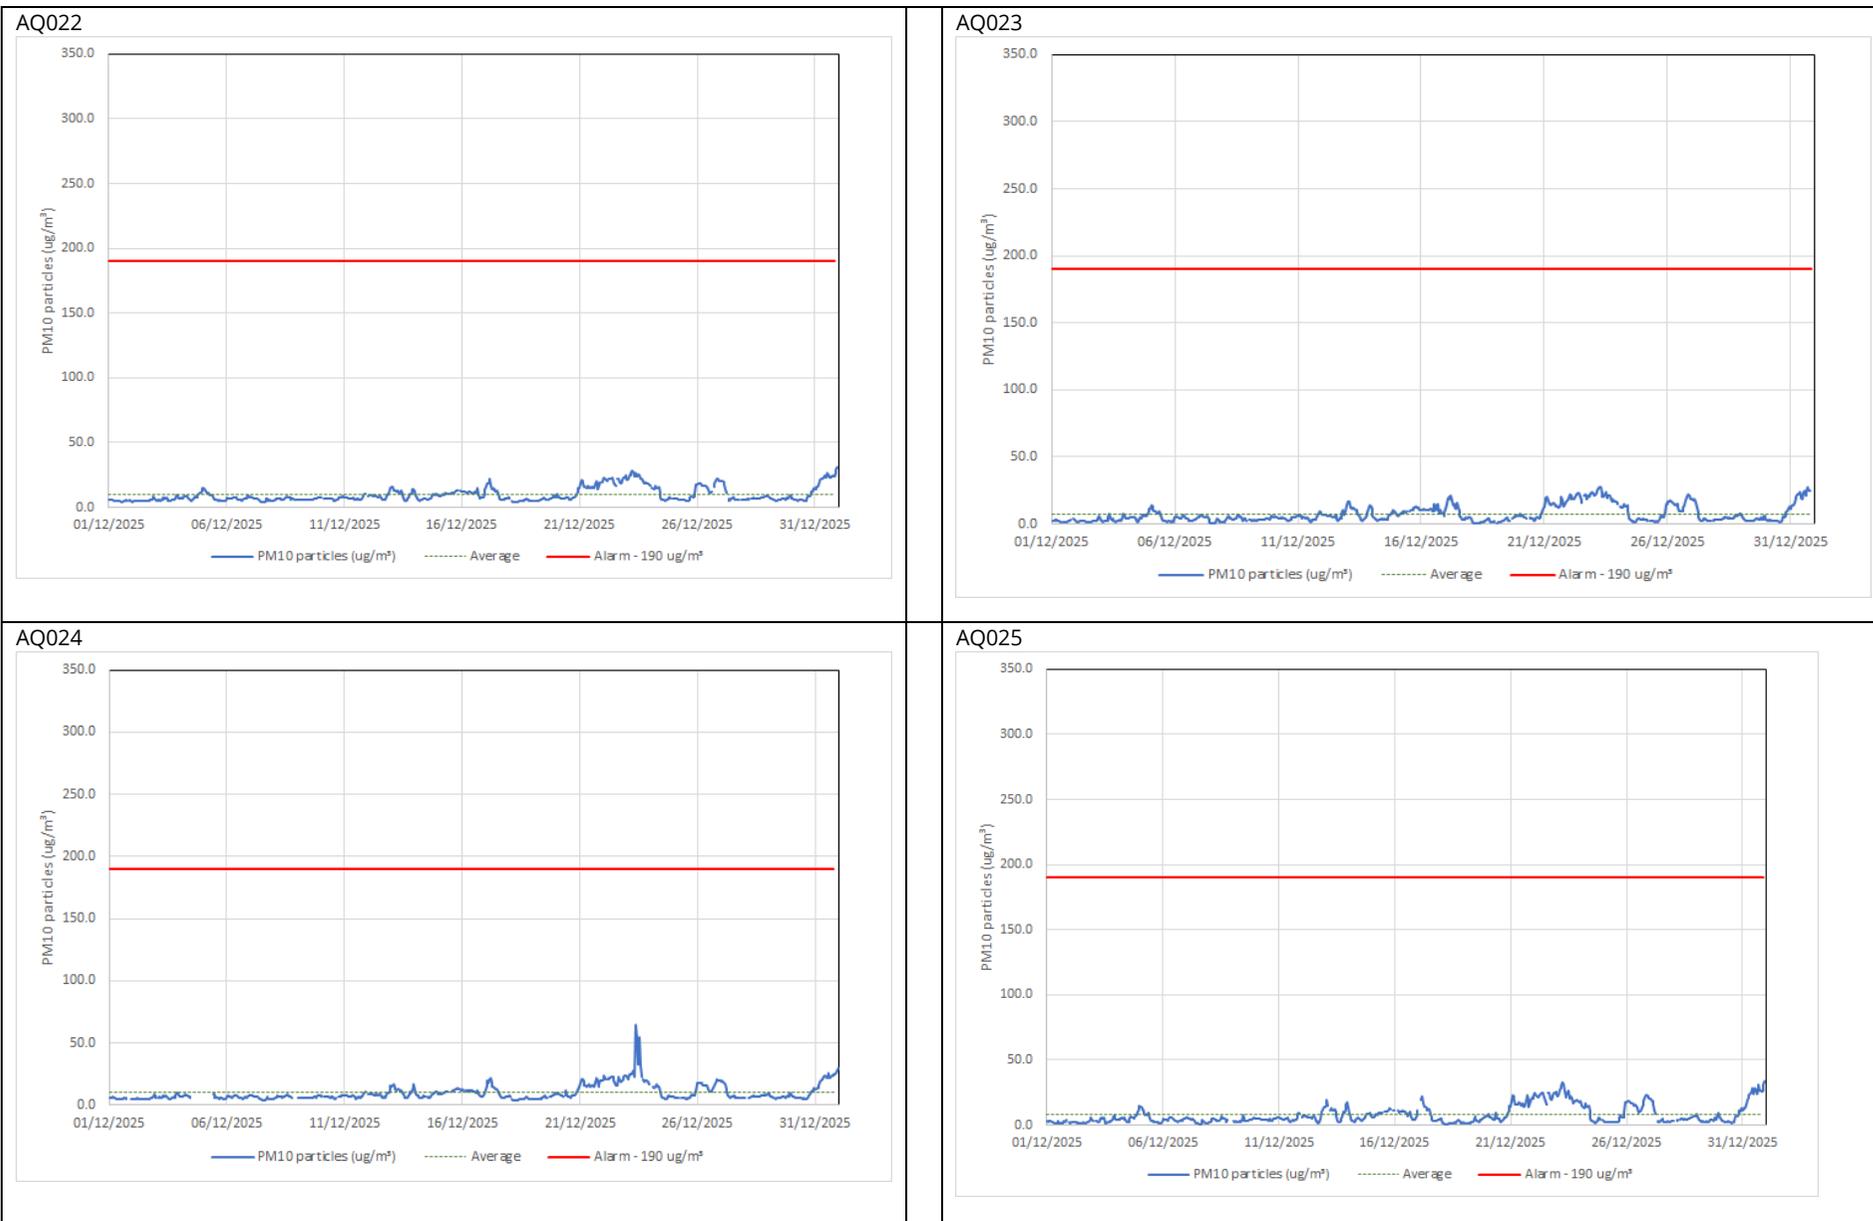
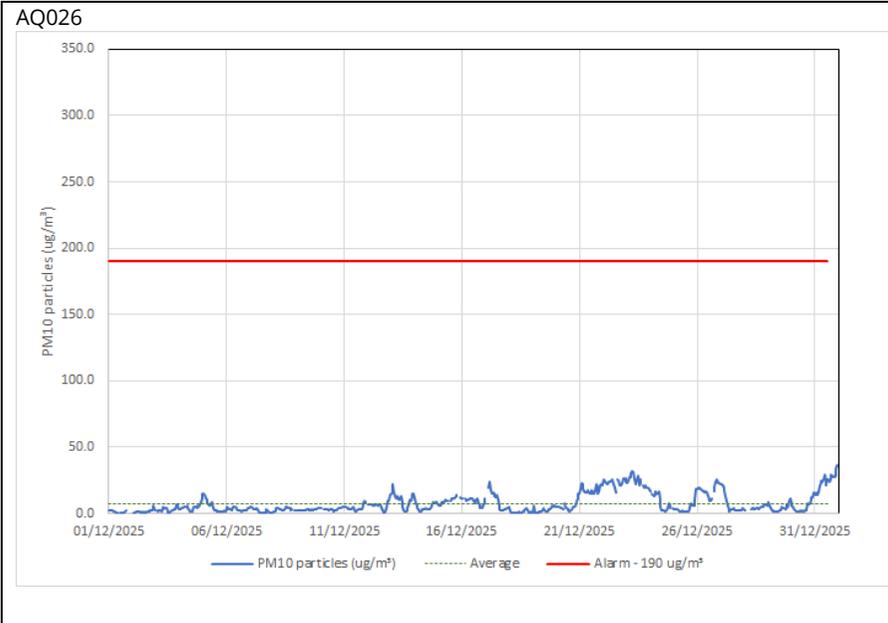
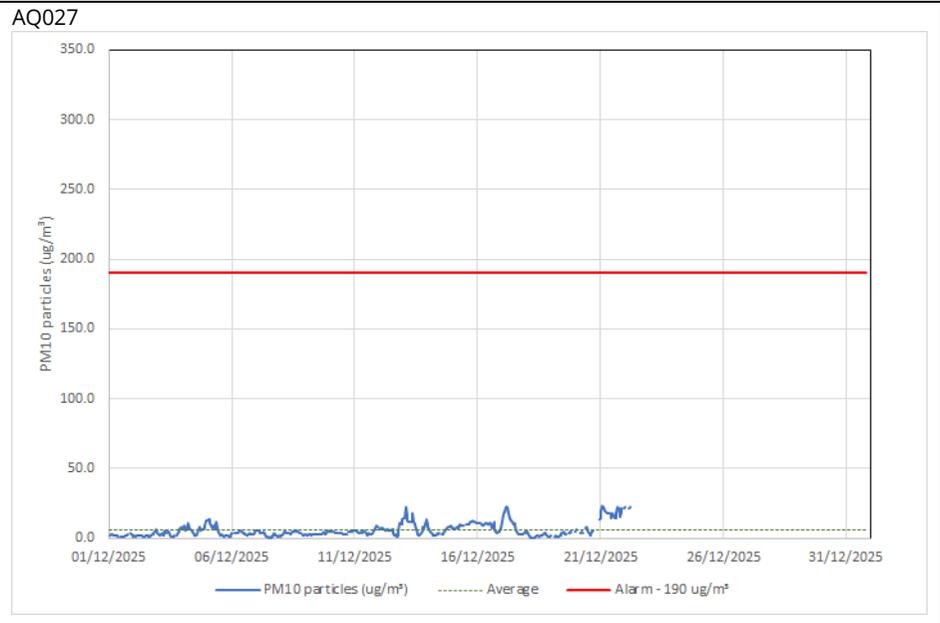
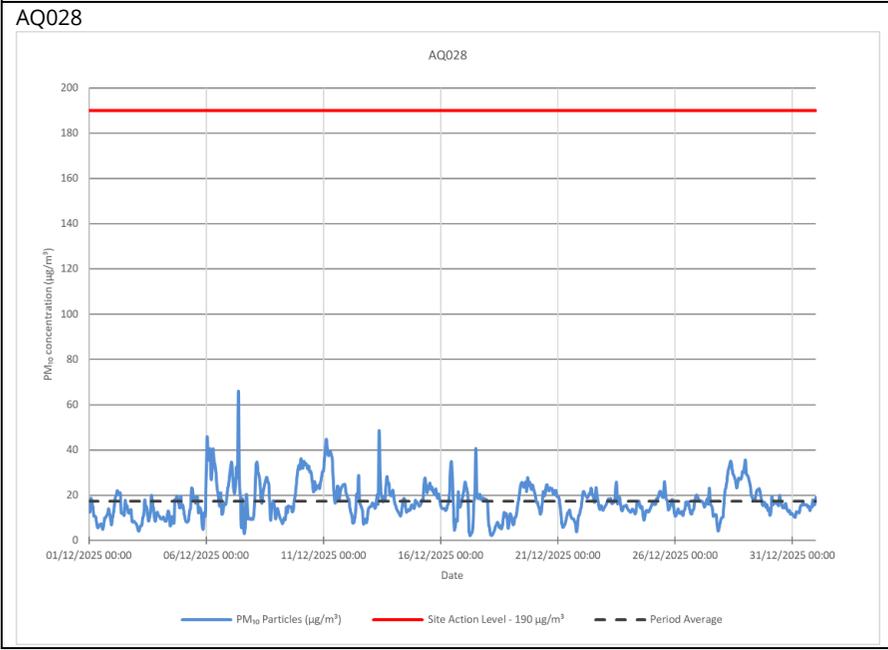
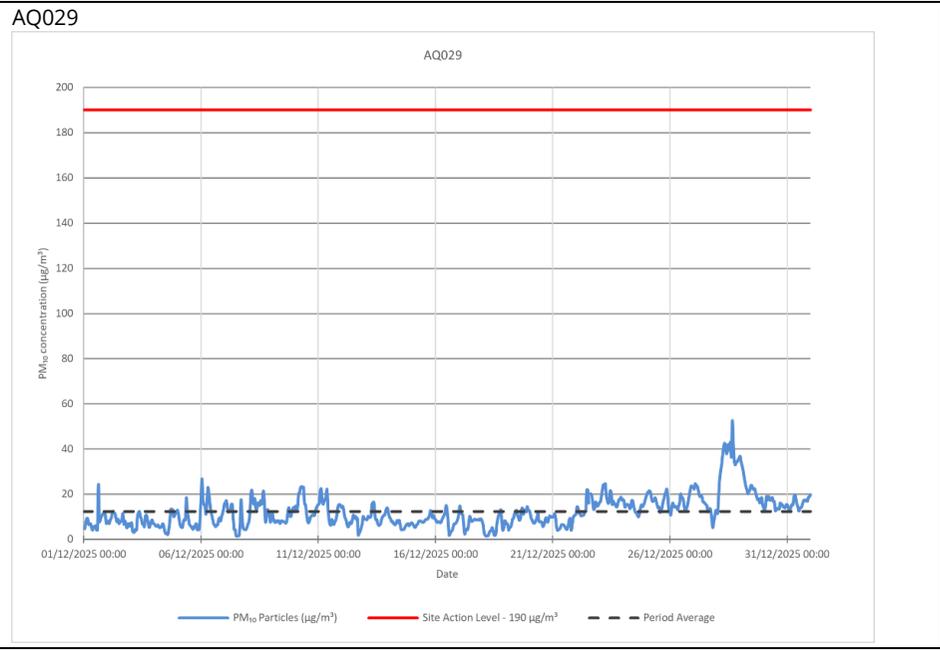
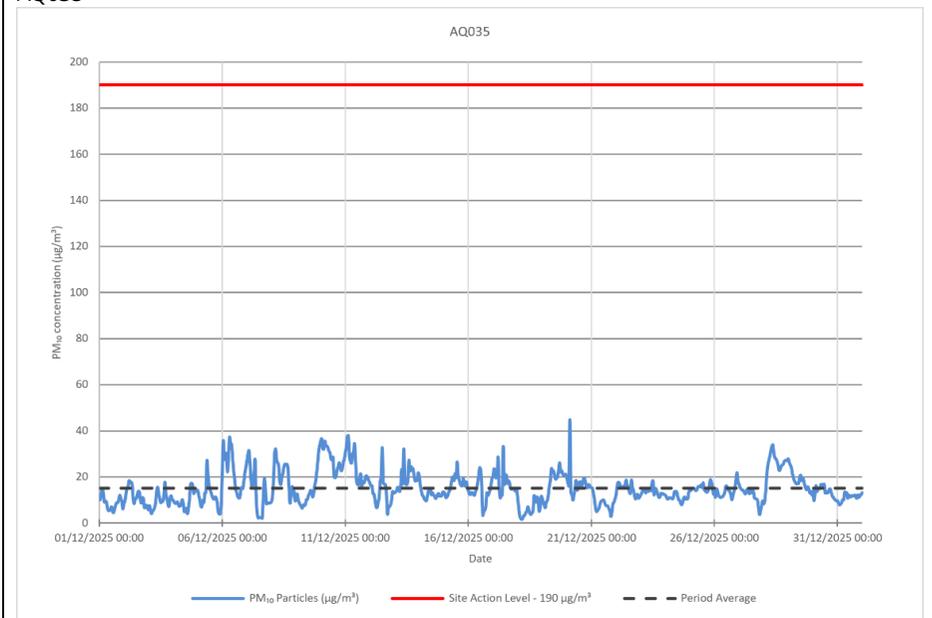
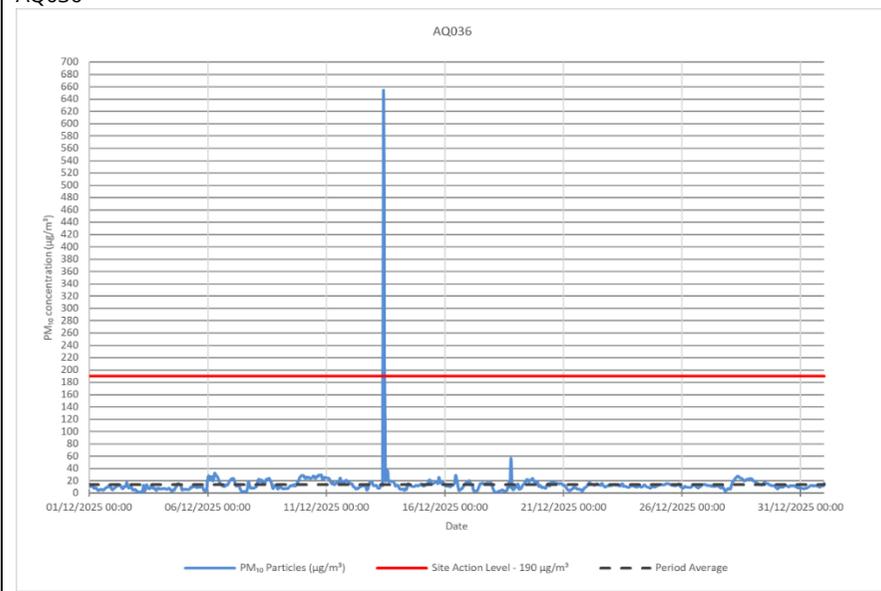
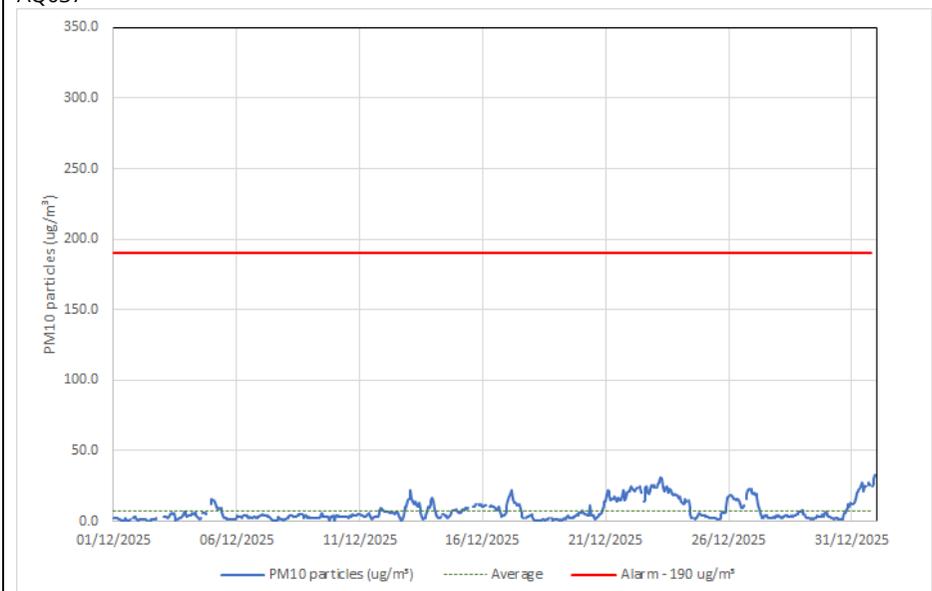
Figure 4: Construction dust 1-hour mean indicative PM₁₀ concentration for all dust monitors

1.1.6 Dust monitoring locations and results are presented in Appendix B, Table 1, together with line charts of monthly data from each dust monitor presented in Figure 4. All continuous dust monitoring is undertaken using indicative monitors. Despite being Environment Agency (MCERTS) certified, indicative monitors carry a higher level of uncertainty than reference monitors, and therefore cannot be strictly compared with Air Quality Standards for human health and the environment. The purpose of the monitoring undertaken is to ensure the effectiveness of the on-site mitigation.

1.1.7 The trigger level for PM₁₀ concentrations of 190 µg/m³, over a 1-hour period, in accordance with the updated guidance document '*Guidance on Monitoring in the Vicinity of Demolition and Construction Sites – (October 2018)*' has been applied.

AQ035	521353, 181959	Old Oak Common	H	Yes	N	15.1	1.6	44.9	0	100.0
AQ036	521482, 181668	UTX South – Triangle Site	M	Yes	N	14.1	1.5	652.3	2	100.0
AQ037	521304, 182464	Atlas Road	M	Yes	N	7.3	0.2	33.3	0	94.6

Monitoring site ID	Period exceeding trigger level	Investigation	Outcomes / Resolution / Remedial measures implemented
AQ036	13/12/2025 09:01 – 10:00; 652.3 µg/m ³ 10:01 – 11:00; 204.4 µg/m ³	An investigation confirmed that there were no dust generating activities being undertaken within the UTX site at the time of the exceedances. With no activities occurring on site, it's postulated these exceedances were caused by an off-site source.	CCTV was checked and confirmed no site activity at the time of the exceedance. The site team continued to monitor measured PM ₁₀ levels, though no further exceedances were observed during the day.
