Construction Noise and Vibration Monthly Report – December 2025

London Borough of Ealing

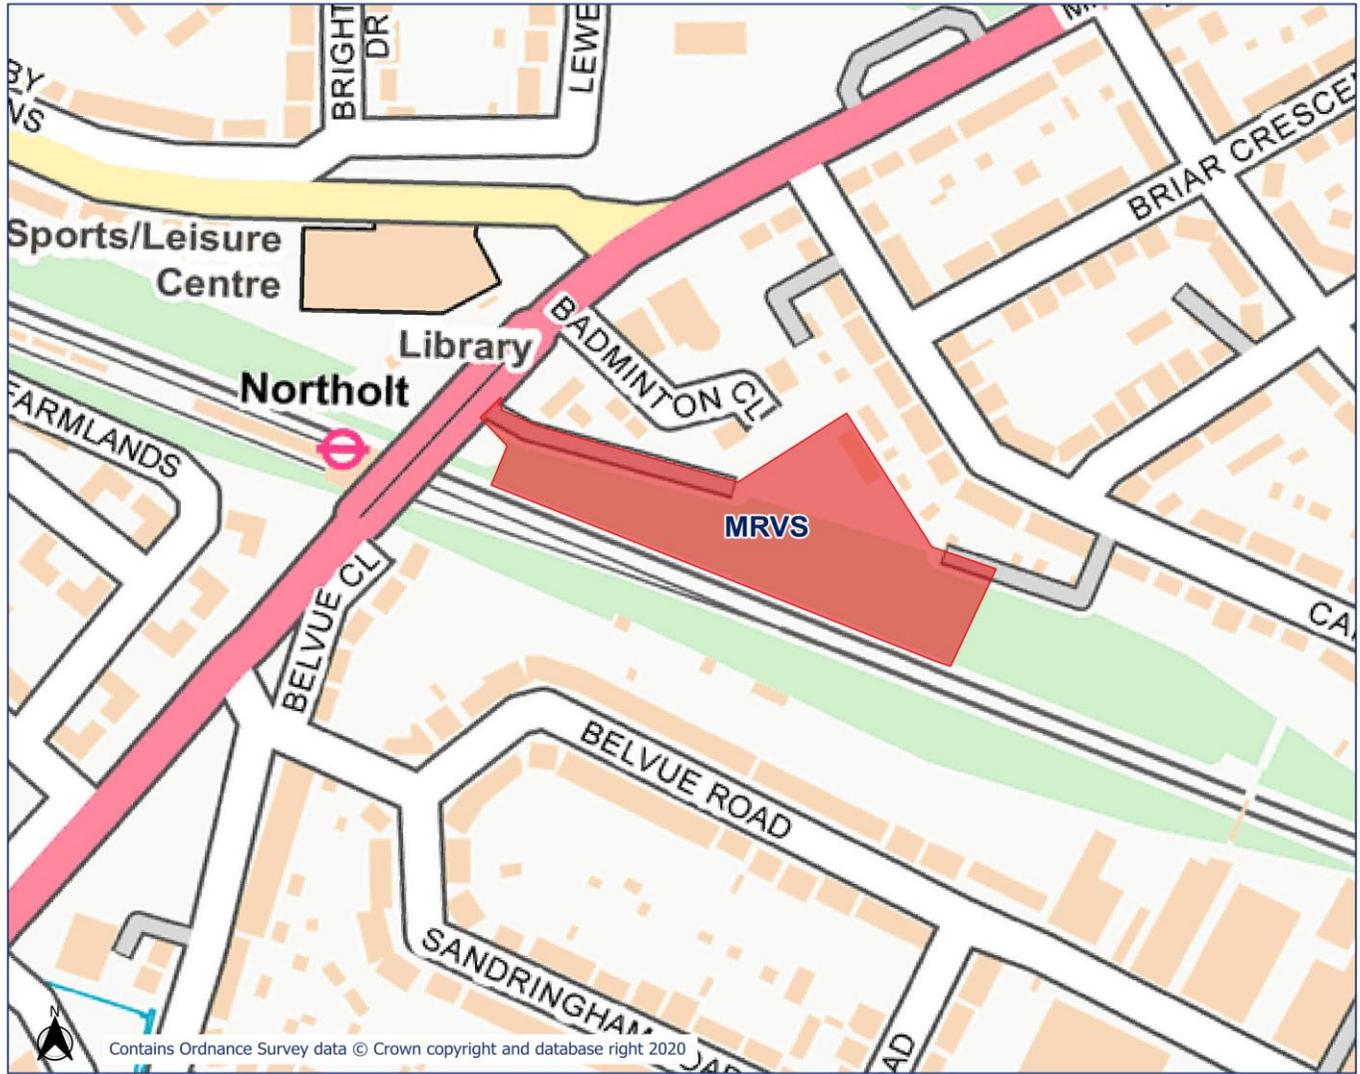
Worksite Identification Plan - 1

- Mandeville Road Ventilation Shaft worksite, reference MRVS (see plan 1 in Appendix A), where work activities included:
 - Pile trimming.
 - Excavation.
 - Earthworks.
 - Concrete element construction.
 - Installation of steel elements.
 - Ventilation Basement works.
 - Shaft and tunnel connection works.

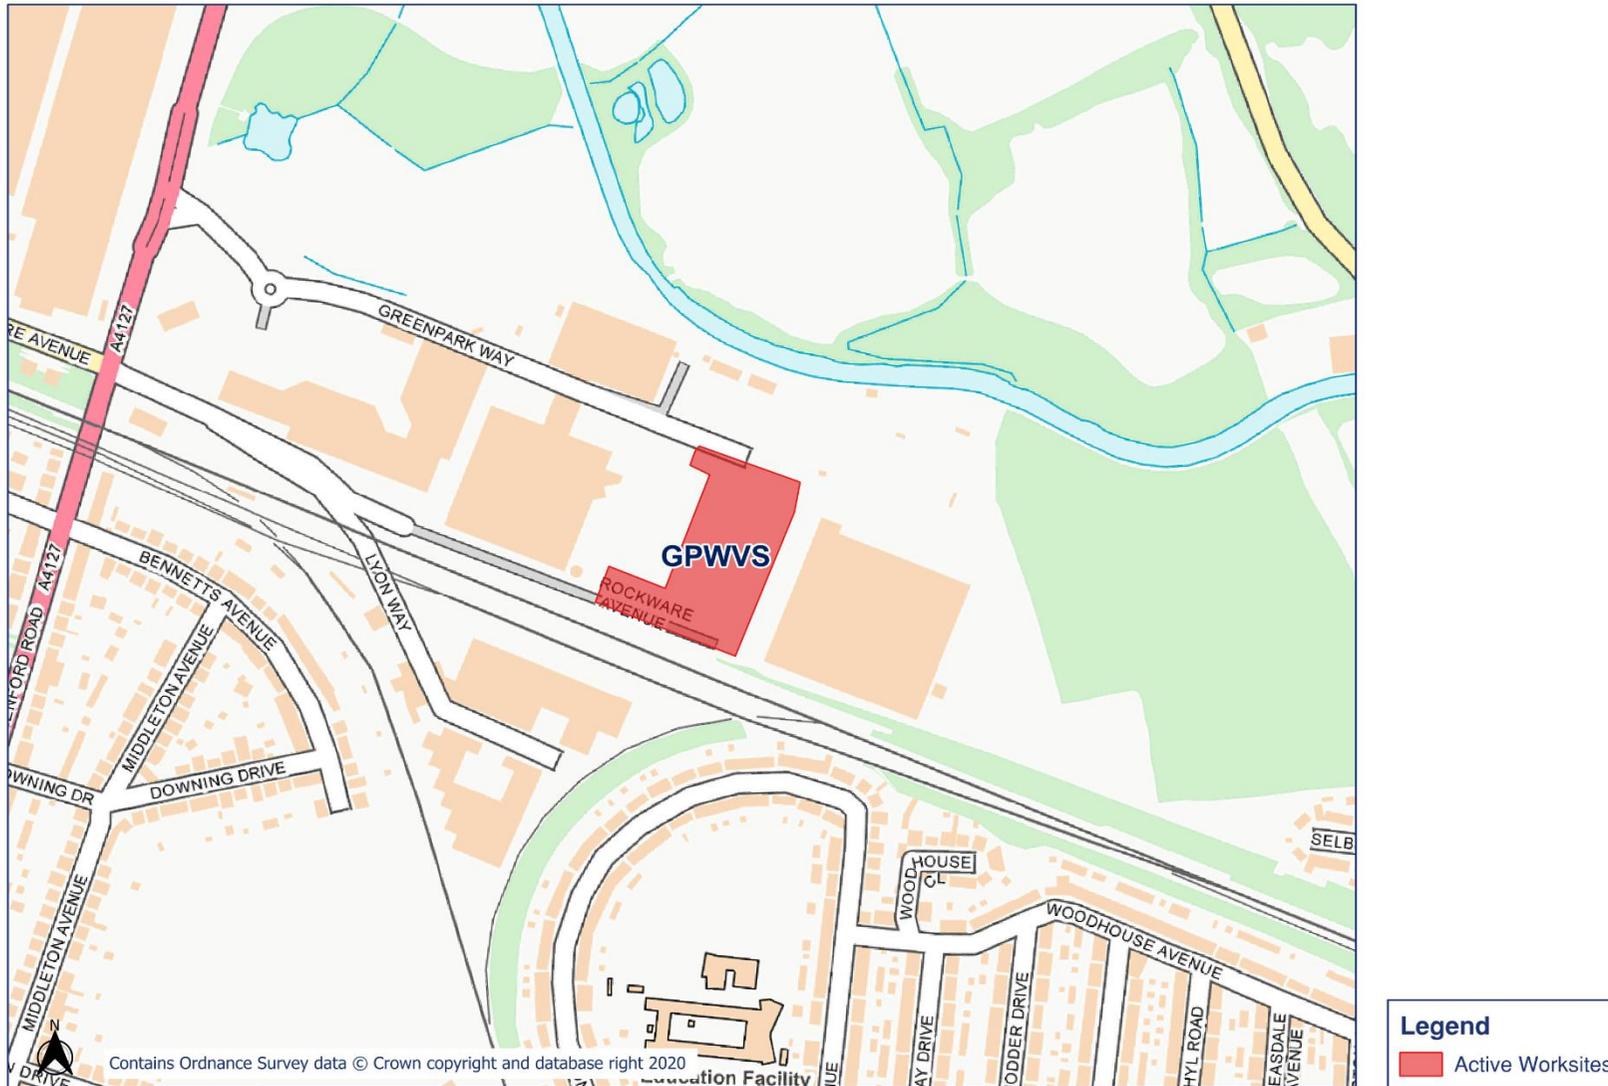
Worksite Identification Plan - 2

- Compound operation works.
- Green Park Way Ventilation Shaft worksite, reference GPWVS (see plan 2 in Appendix A), where work activities included:
 - General site operations, including maintenance and road sweeping.

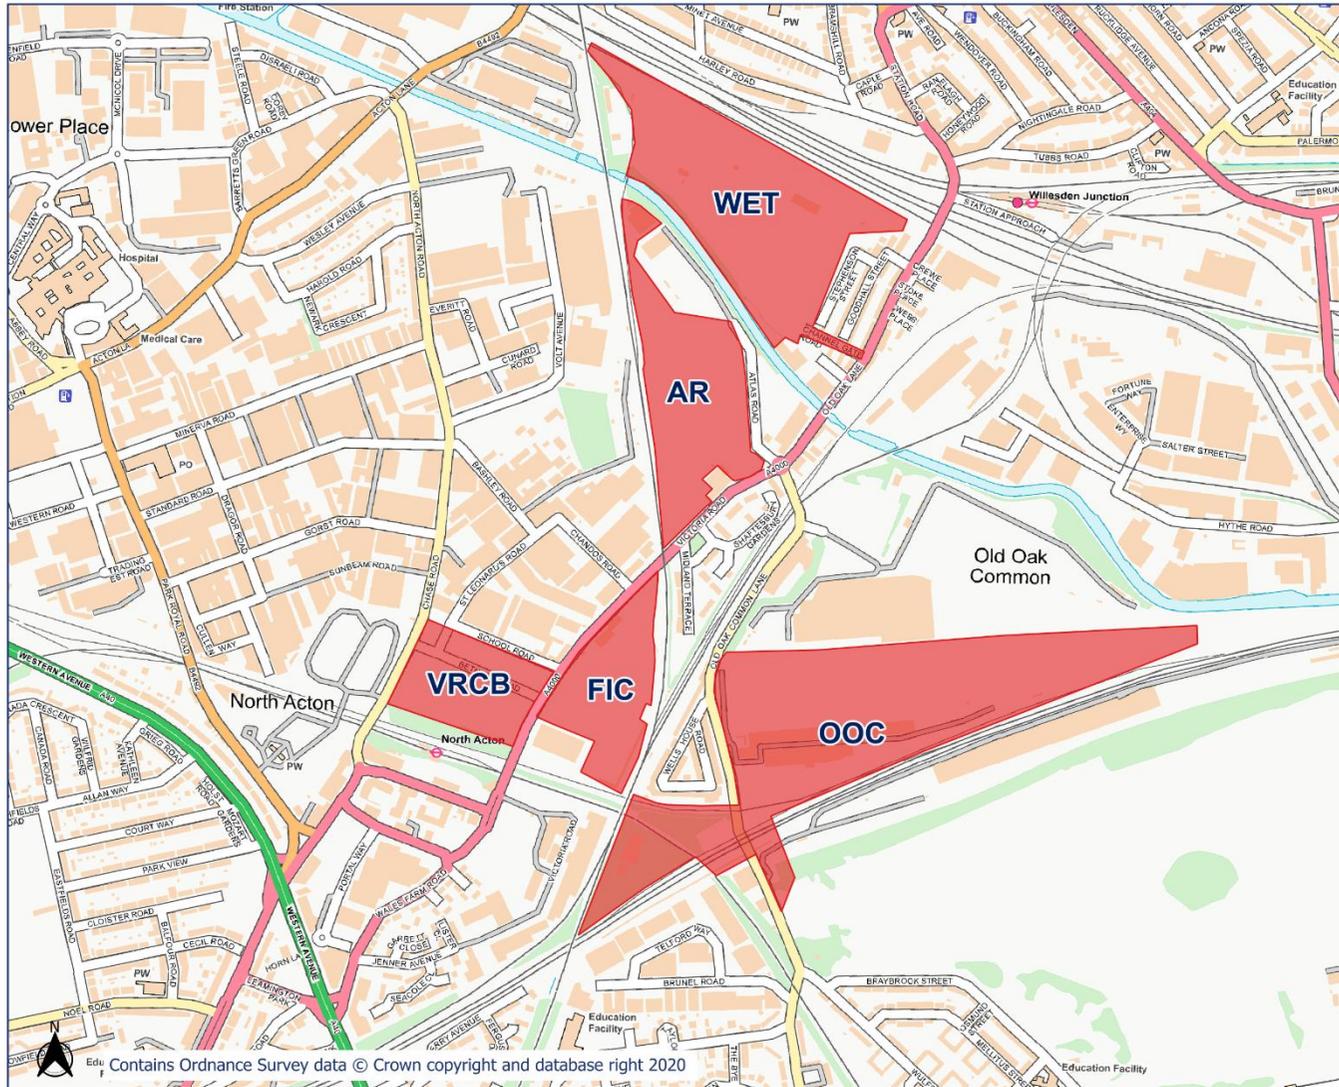
Worksite Identification Plan - 4

- Atlas Road worksite, ref. AR (see plan 4 in Appendix A), where work activities included:
 - General maintenance works.
 - Tunnel bore machine construction support.

- Delivery of tunnel segments and conveyor components.
 - General support tasks including site security.
- Willesden EuroTerminal worksite, ref. WET (see plan 4 in Appendix A), where work activities included:

- General site maintenance.
 - Tunnel segments delivery and collection.
 - General support tasks including site security.
- Victoria Road Crossover Box worksite, ref. VRCB (see plan 4 in Appendix A), where work activities included:

- Flat Iron compound, worksite ref. FIC (see plan 4 in Appendix A), where work activities included:
 - Operation of batching plant.
 - Tunnel bore works including stripping and scraping of sections.

- Old Oak Common depot worksite, located in the London Borough of Hammersmith and Fulham (LBHF), ref. OOC (see plan 4 in Appendix A), where work activities included:

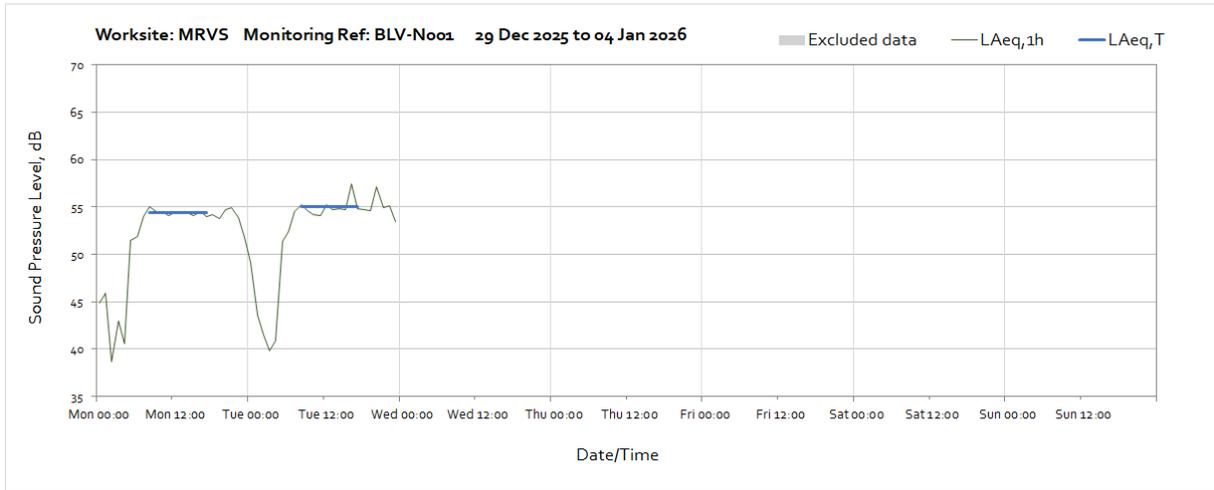
Worksite: MRVS – Monitoring Ref: BLV-N001

Note: Missing data between 00:00 on Wednesday 31st December and the end of the month was due to a depleted battery at the monitoring station.

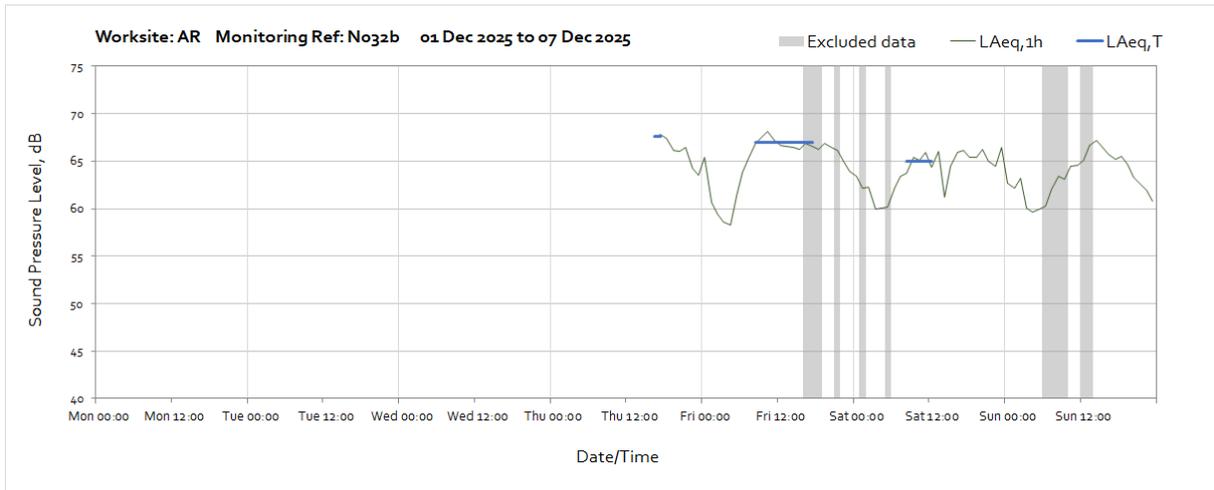
Worksite: AR – Monitoring Ref: N032b

Note: Noise monitor installed at 16:00 on Thursday 4th December.

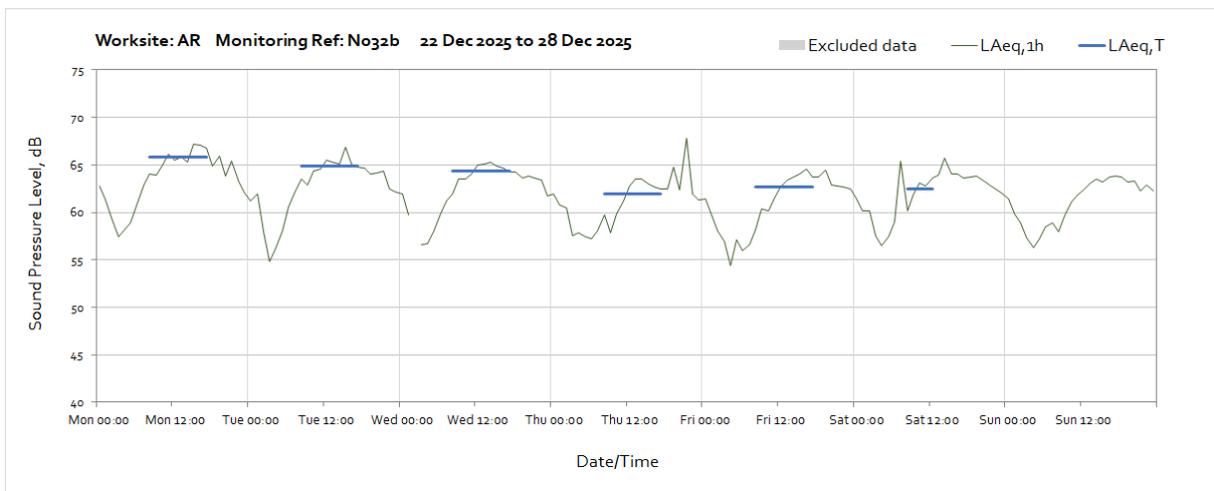
Note: Missing data between 02:00 and 03:00 on Wednesday 24th December is due to a power supply issue.

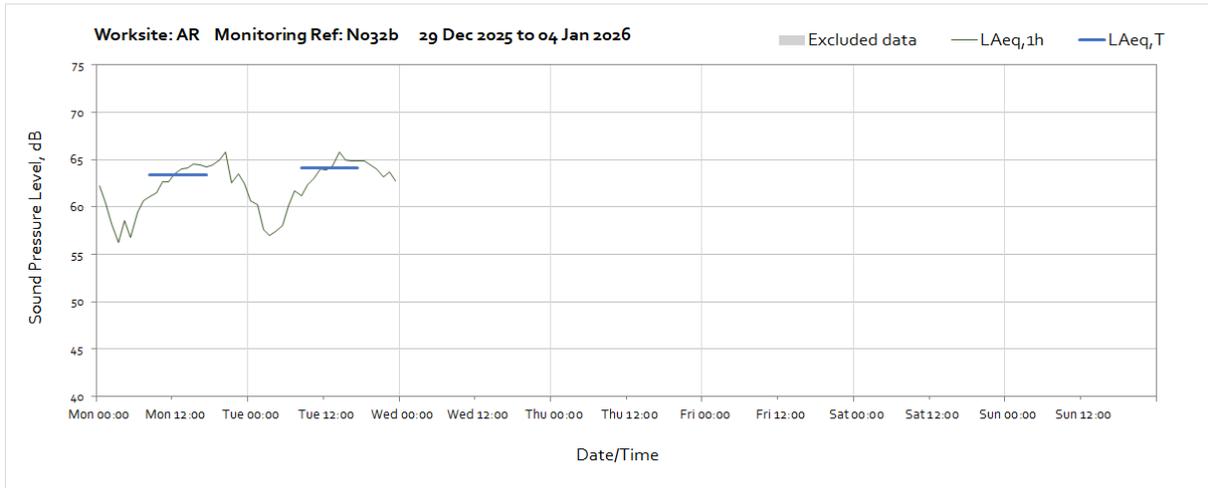
Note: Missing data between 00:00 Wednesday 31st December and end of the month is due to a power supply issue.

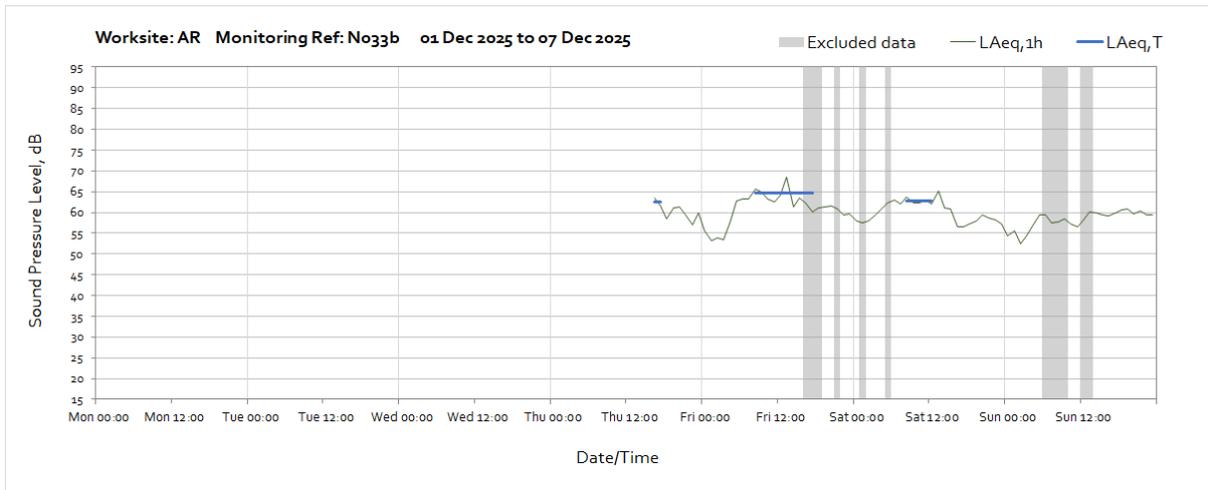
Worksite: AR – Monitoring Ref: N033b

Note: Noise monitor installed at 16:00 on Thursday 4th December.

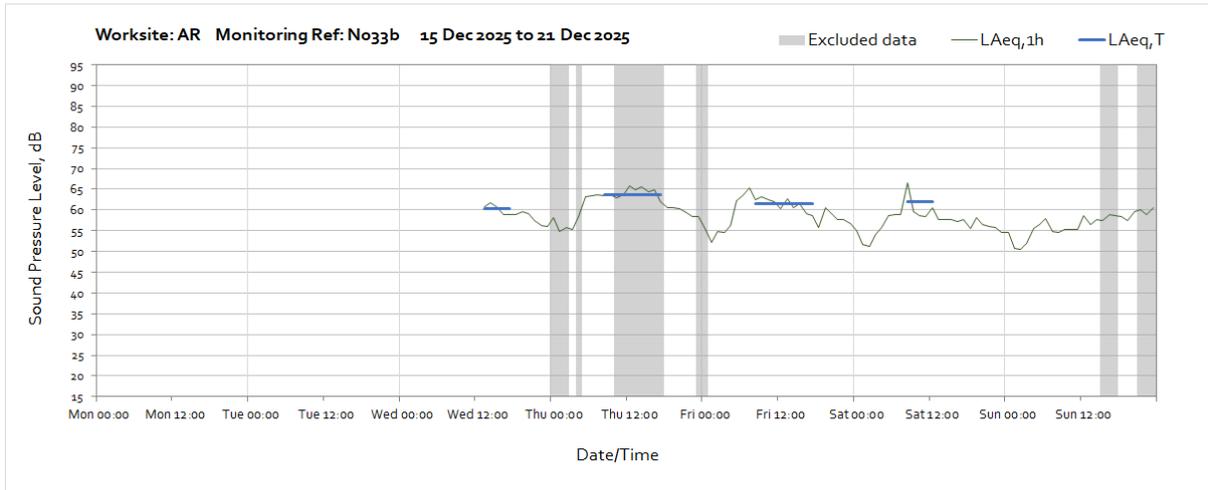
Note: Missing data between 00:00 on Monday 8th December and 13:00 on Wednesday 17th December due to a power supply issue.

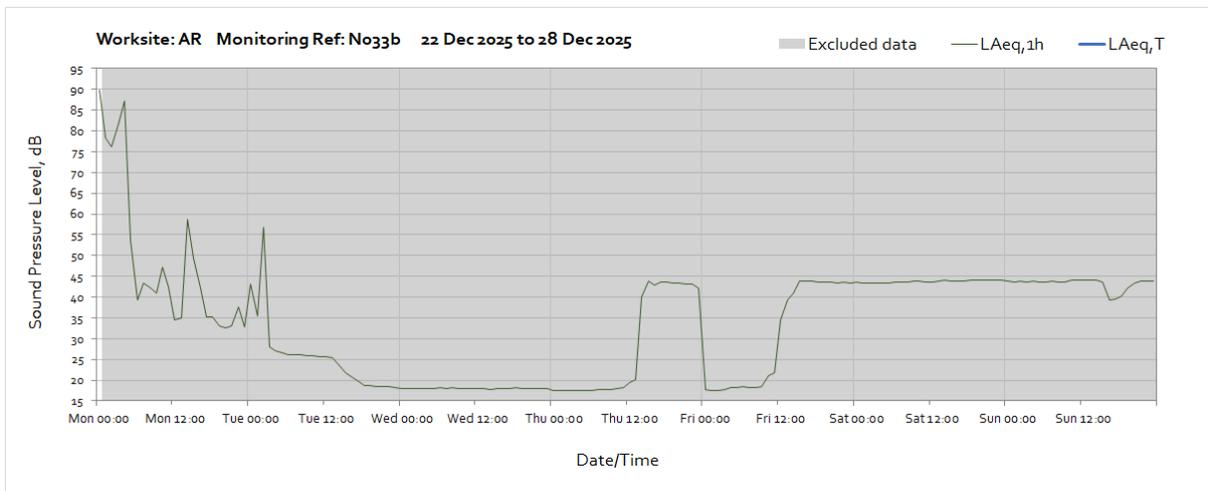
Note: The data is erroneous and has been excluded due to a monitoring station fault. The monitoring station is scheduled for replacement with an alternative unit.

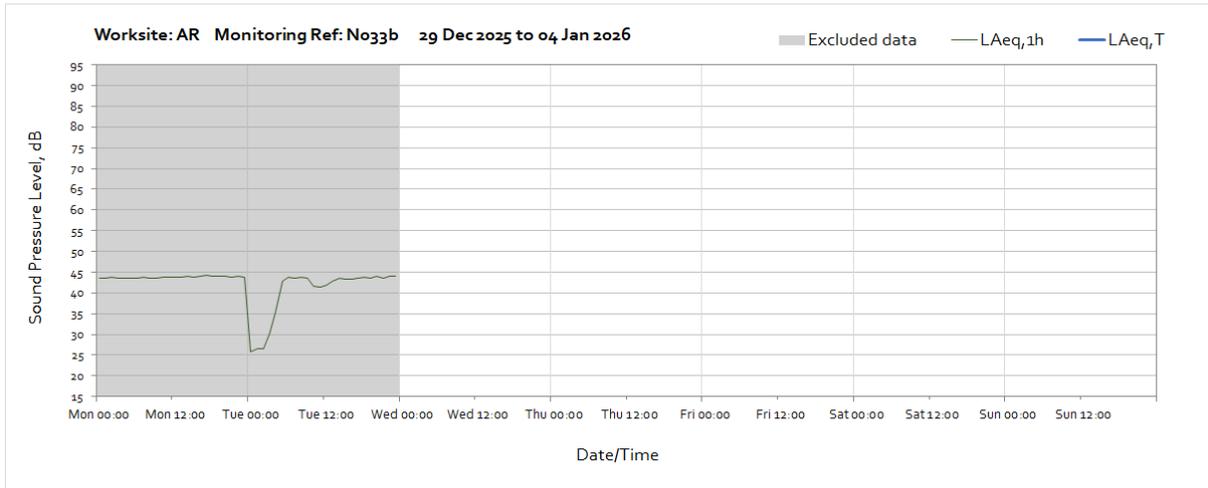
Note: The data is erroneous and has been excluded due a monitoring station fault . The monitoring station is scheduled for replacement with an alternative unit. Missing data between 00:00 Wednesday 31st December and end of the month due to a power supply issue.

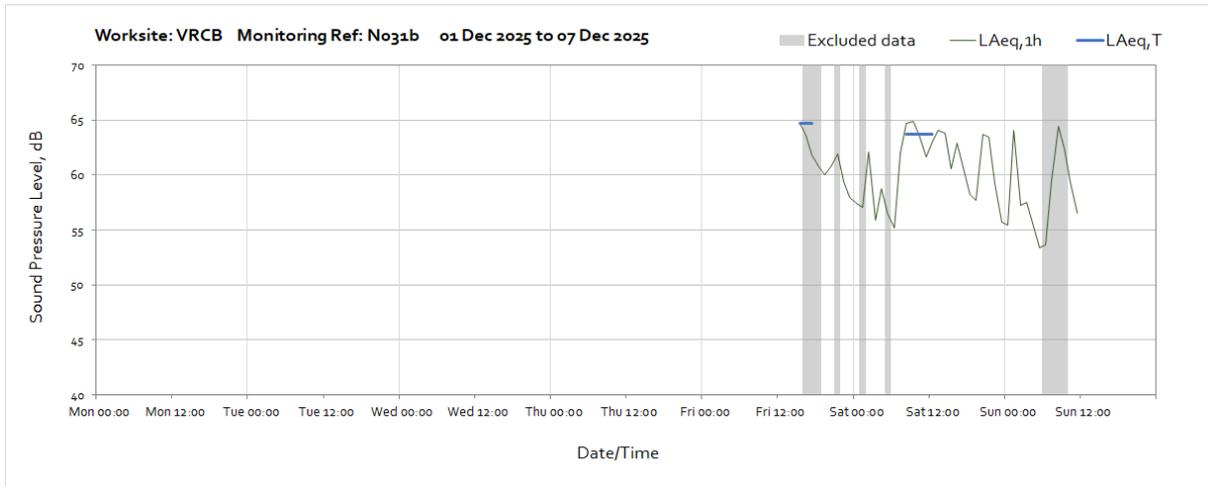
Worksite: VRCB – Monitoring Ref: N031b

Note: Noise monitor installed at 15:00 on Friday 5th December 2025. Missing data between 07:00 Sunday on 7th December and 14:00 on Wednesday 17th December due to a power supply issue.

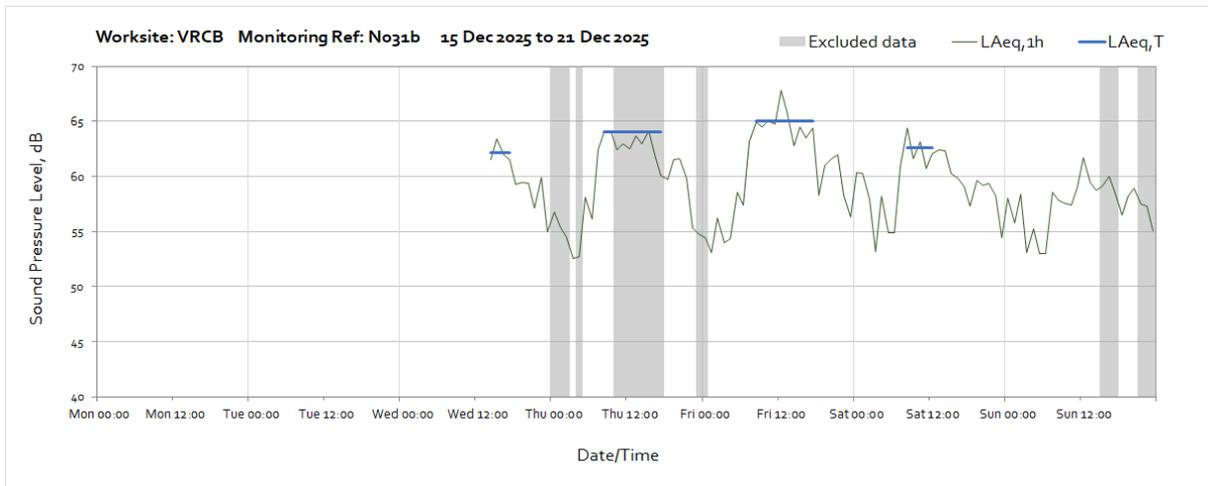
Note: Missing data between 07:00 Sunday on 7th December and 14:00 on Wednesday 17th December due to a power supply issue.

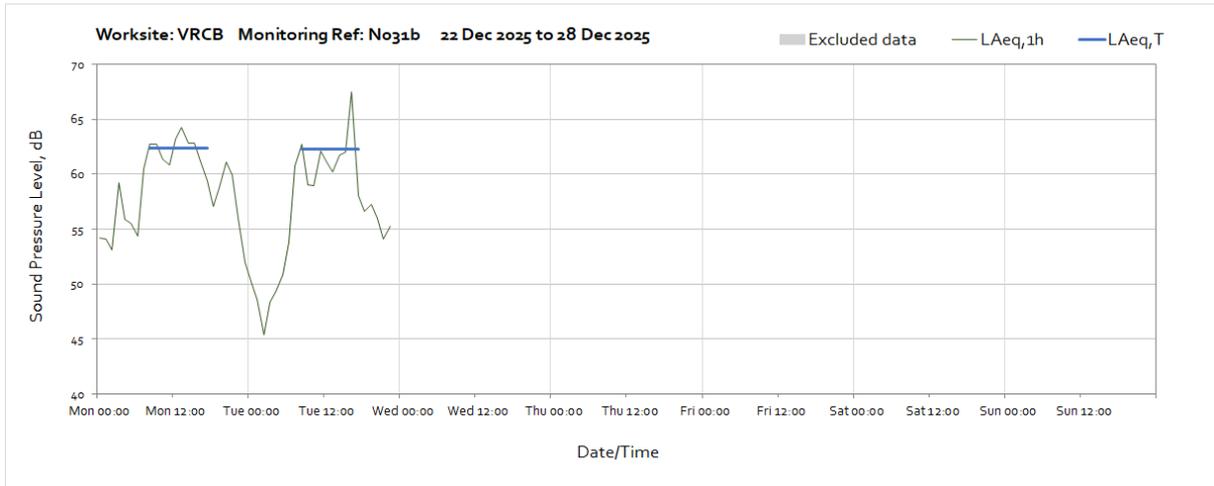
Note: Missing data between 22:00 Tuesday 23rd December and end of the month due to a power supply issue.

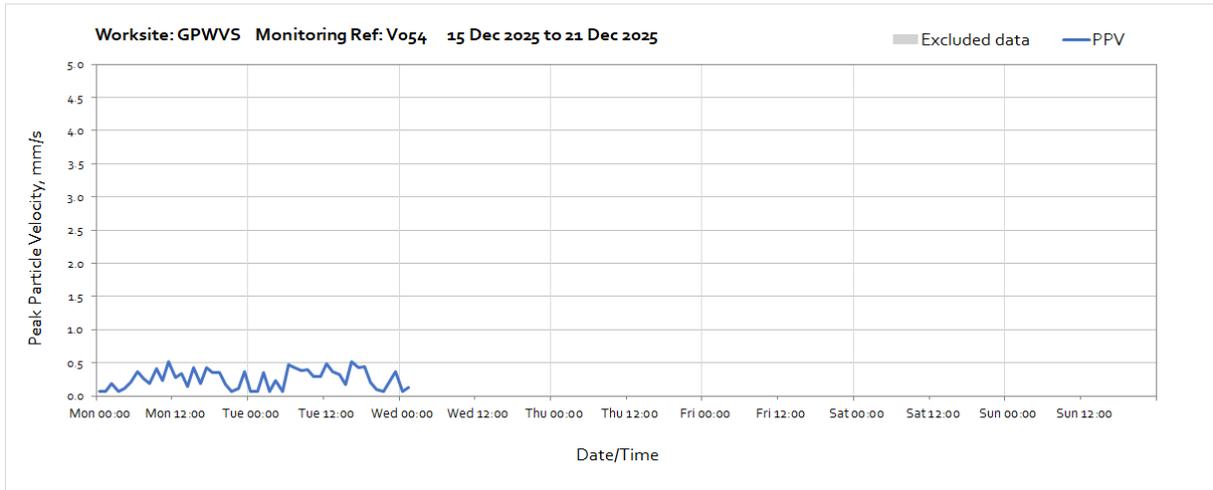
Worksite: GPWVS – Monitoring Ref: V054

Note: Missing data between 02:00 on Wednesday 17th December and the end of the month was due to a depleted battery at the monitoring stations.

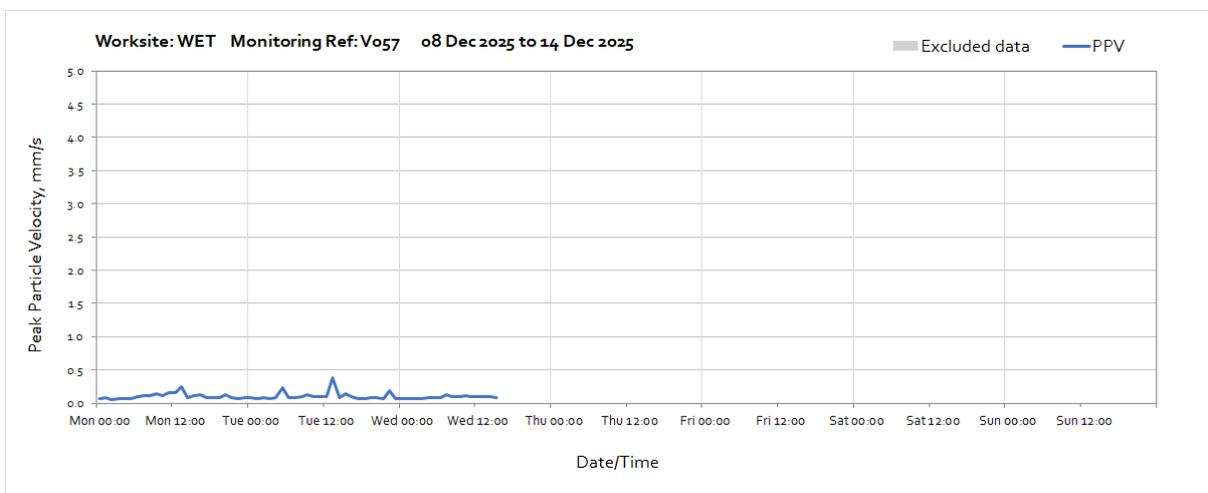
Worksite: WET – Monitoring Ref: V057

Note: Missing data between 16:00 on Wednesday 10th December and 10:00 on Monday 15th December was due to a depleted battery at the monitoring station.

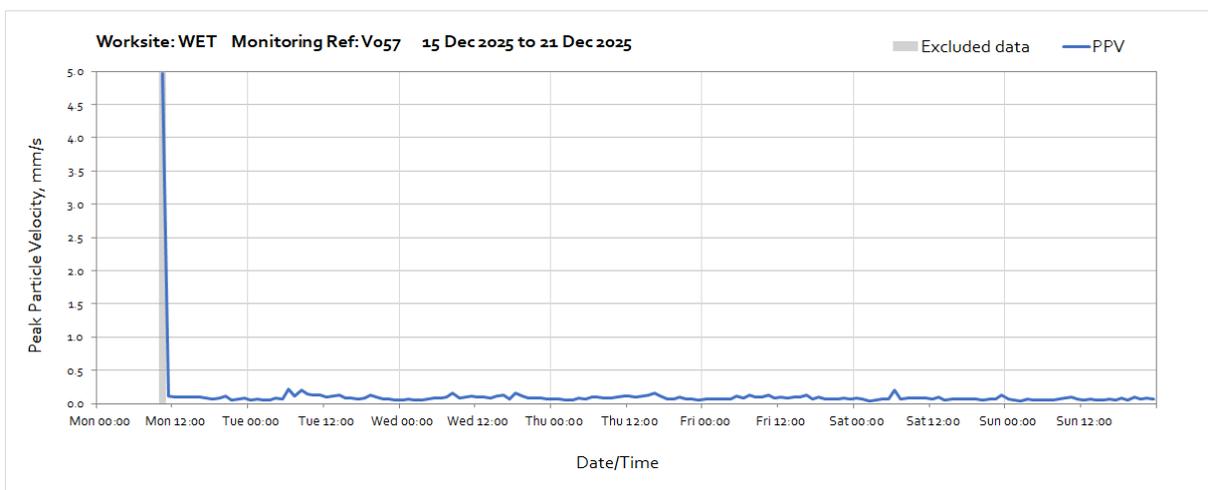
Note: Missing data between 16:00 on Wednesday 10th December and 10:00 on Monday 15th December was due to a depleted battery at the monitoring station.
