Construction Noise and Vibration Monthly Report – December 2025

North Warwickshire Borough Council

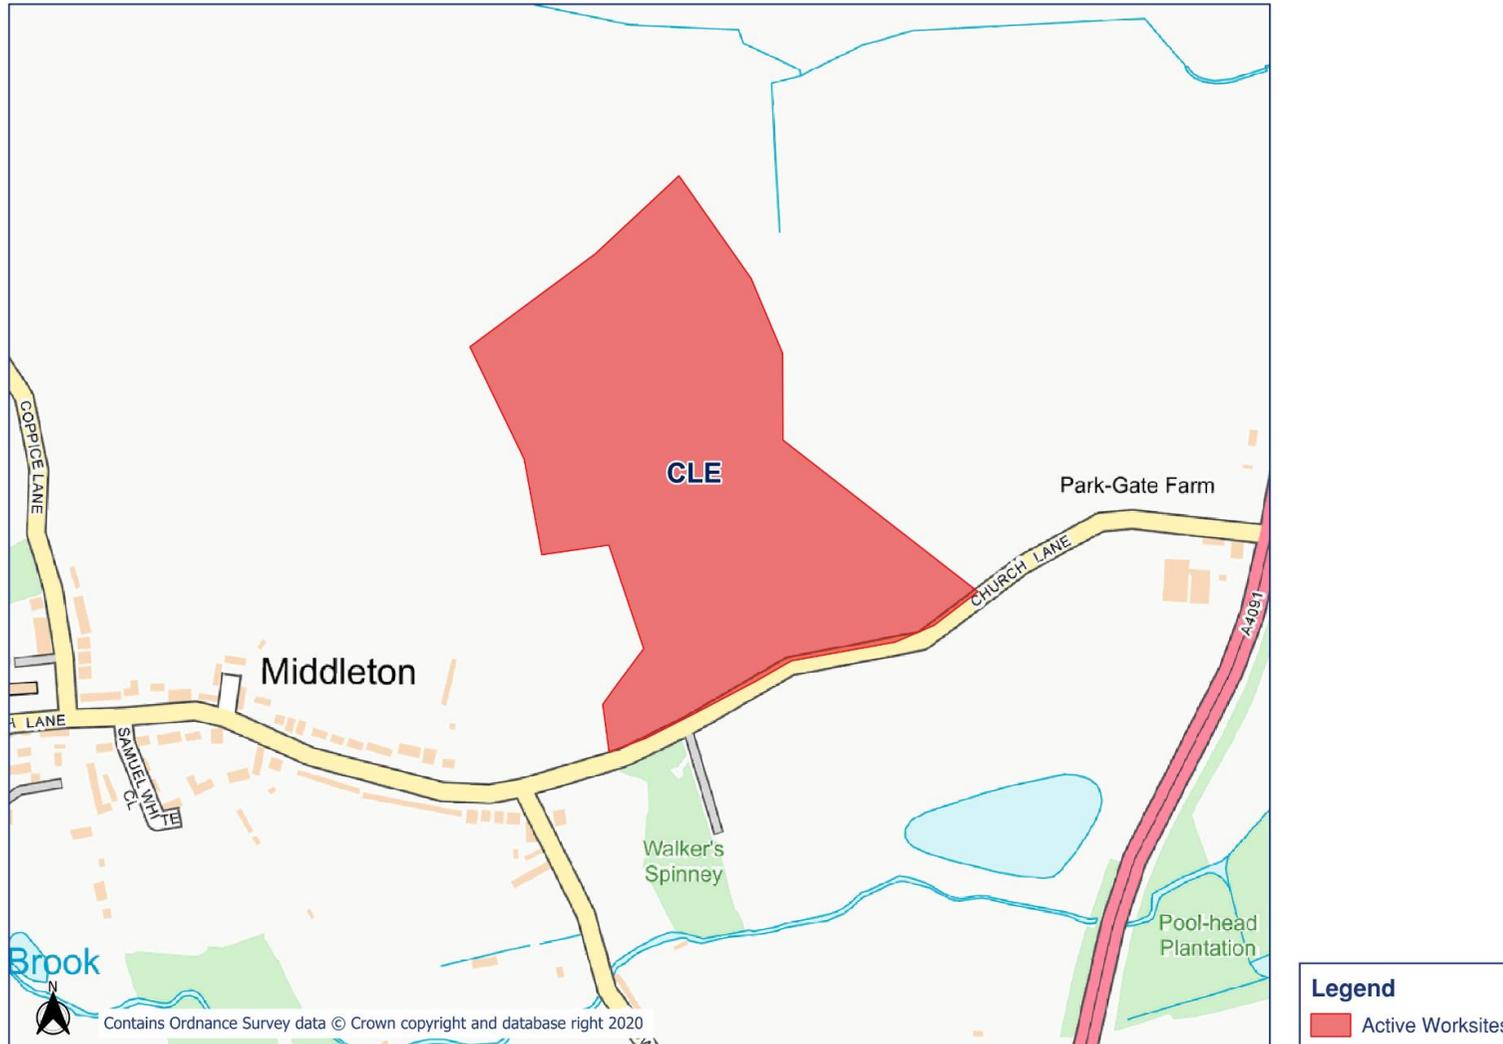
Worksite Identification Plan - 1

- Church Lane Embankment worksite, ref.: CLE (see Plan 1 in Appendix A), where work activities included:
 - Kerbing works including drainage installation.
 - Utilities installation.
 - Concrete pours.
- Kingsbury Main Compound worksite, ref.: KMC (see Plan 2 in Appendix A), where work activities included:
 - Material deliveries.
 - Operation of precast yard.
 - Operation of offices and welfare facilities.
- Marston Box/Marston Lane worksite, ref.: MB (see Plan 2 in Appendix A), where work activities included:

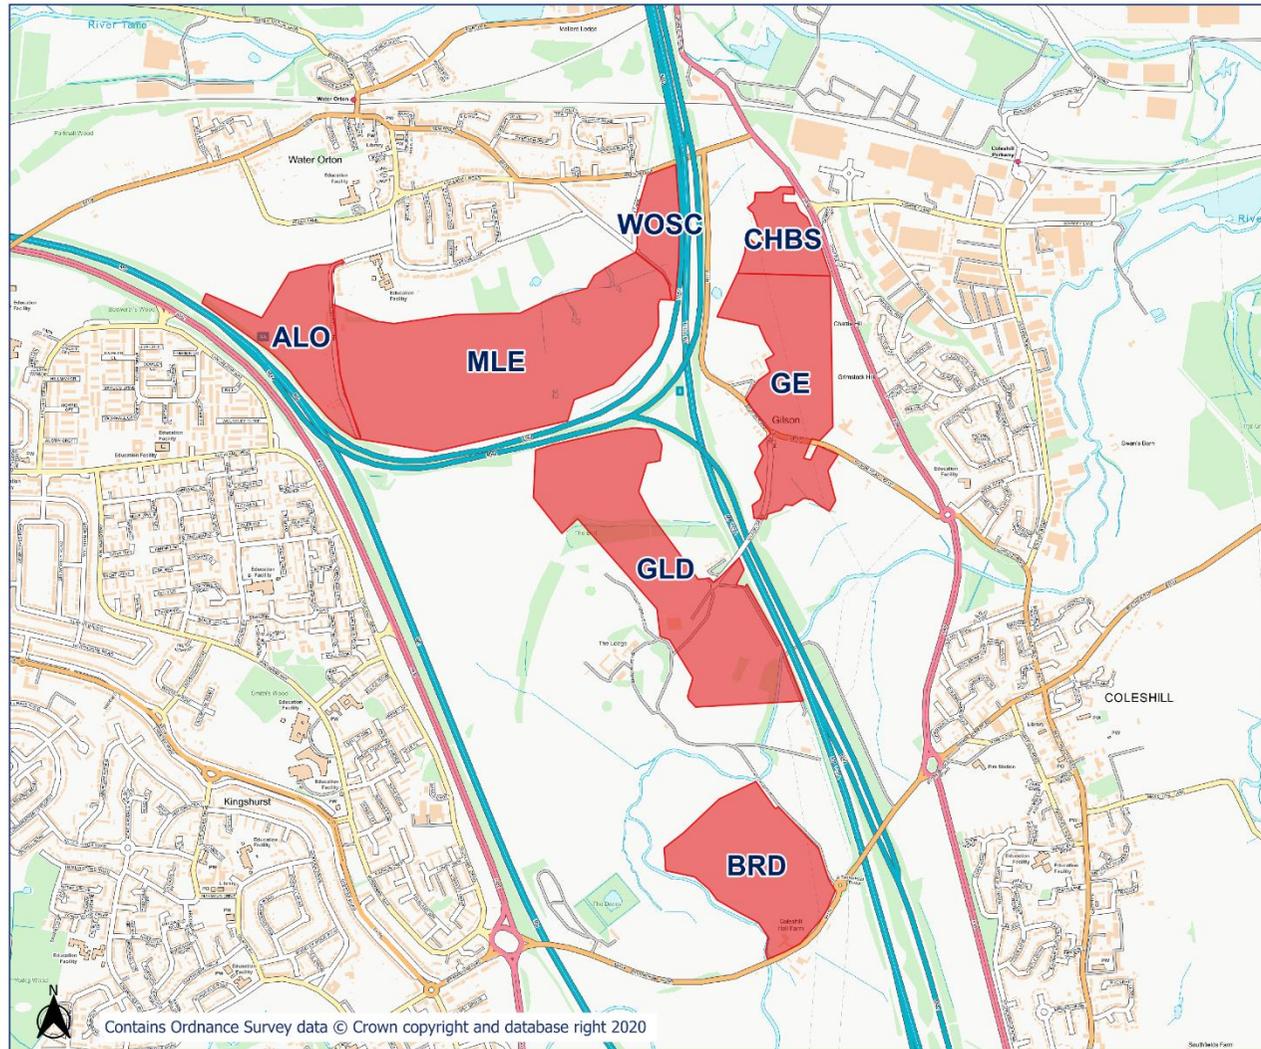
Worksite Identification Plan - 4

- Material deliveries.
- Chattle Hill Box Structure worksite, ref.: CHBS (see Plan 4 in Appendix A), where work activities included:
 - Rigid inclusion, including piling, drilling and pile load testing.

- Attleboro Lane Overbridge worksite, ref.: ALO (See Plan 4 in Appendix A), where work activities included:
 - Pile installation.
 - Sheet piling.
 - Retaining wall construction, including base slab, capping beams, walls and roof slab installation.

- Marsh Lane Embankment worksite, ref: MLE (See Plan 4 in Appendix A), where work activities included:
 - Dig and replace.
 - Stockpiling.
 - Embankment construction.

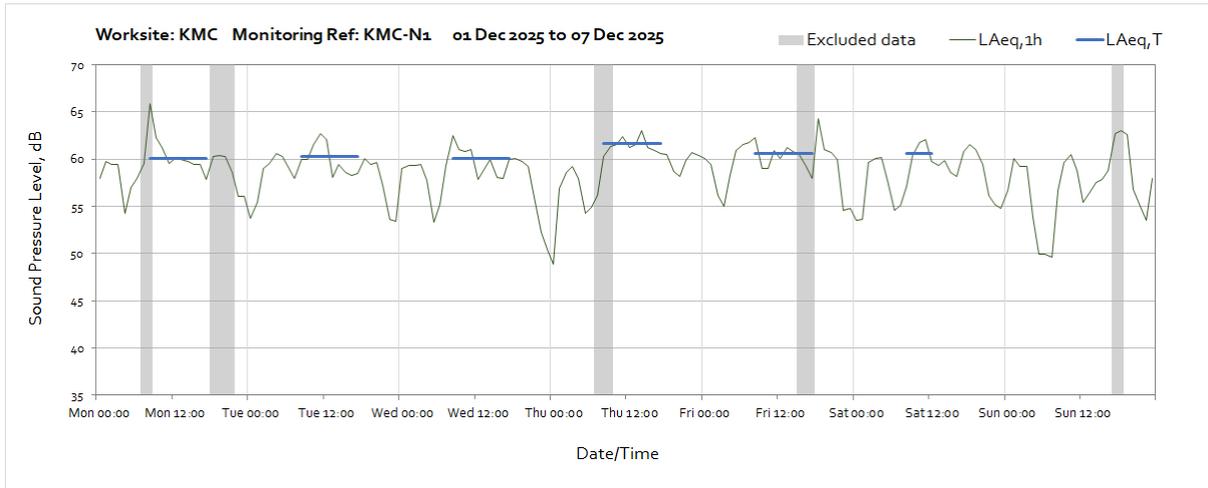
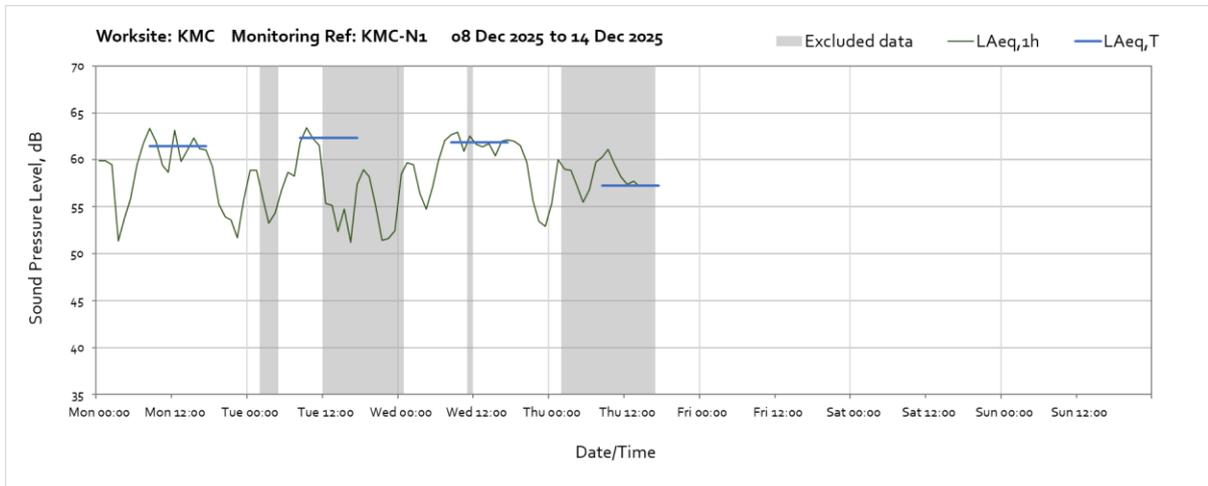
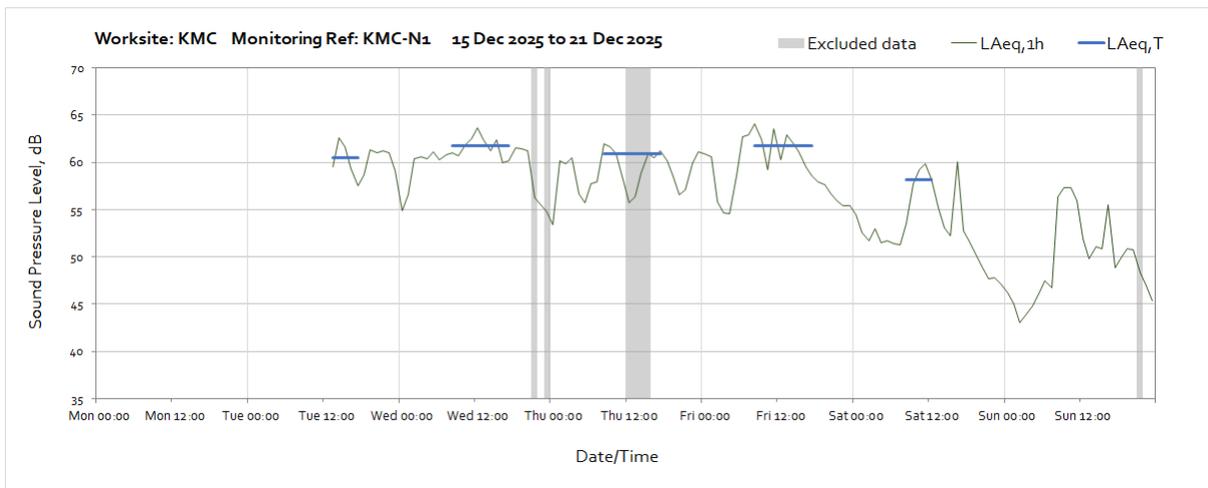
Worksite: KMC – Monitoring Ref: KMC-N1

Note: Missing data between 18:00 on Thursday 11th and 13:00 on Tuesday 16th December was due to a system error at the monitoring station.

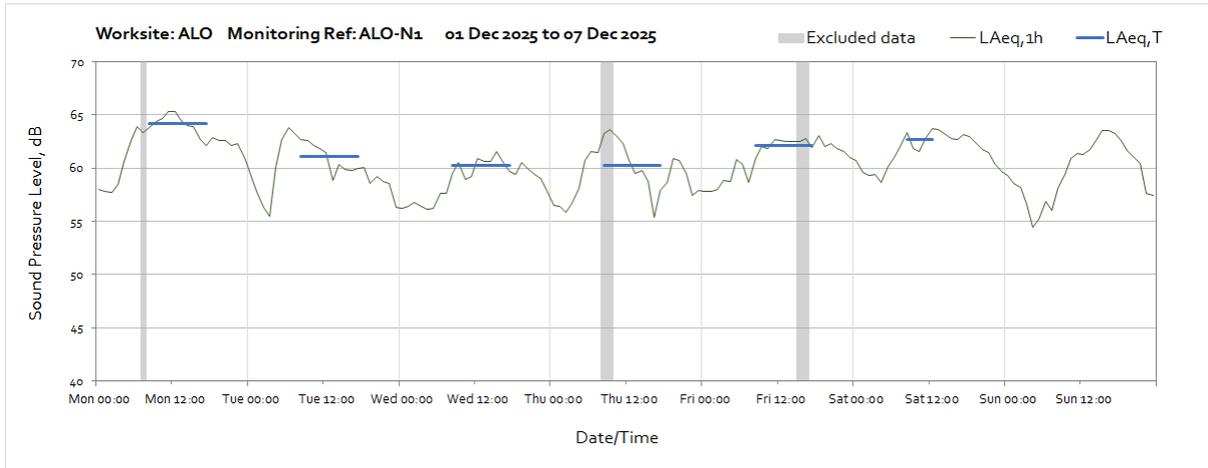
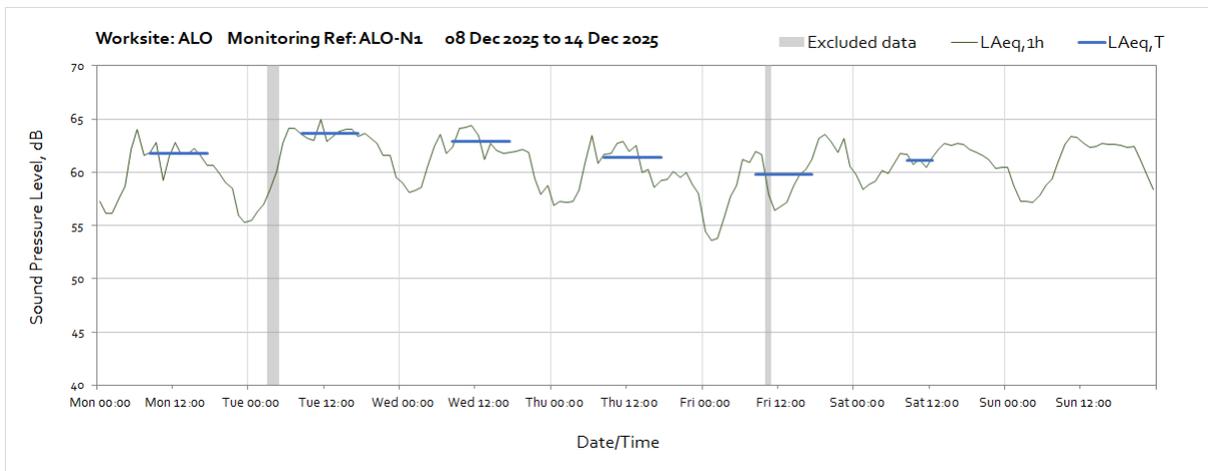
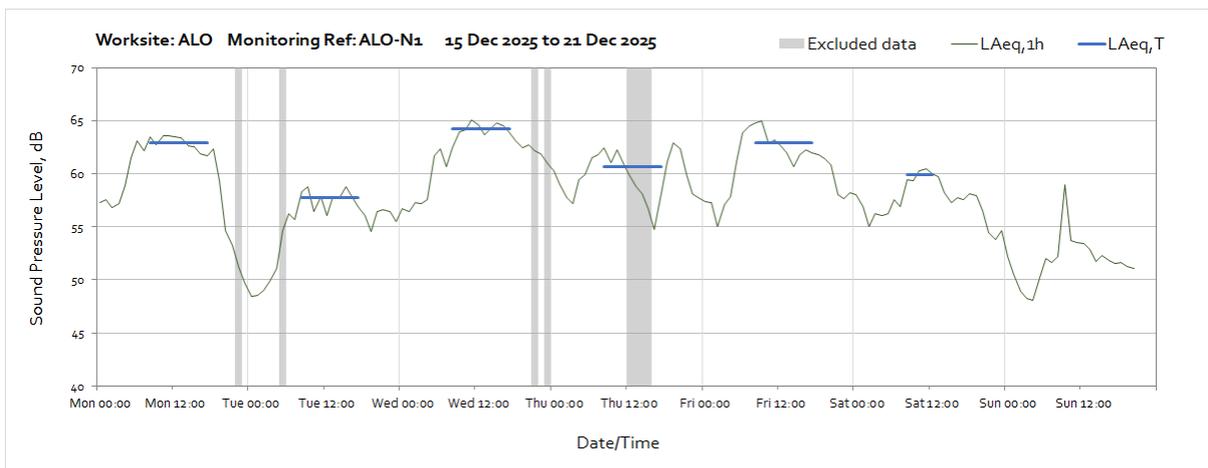
Worksite: ALO – Monitoring Ref: ALO-N1

Note: Missing data from 21:00 on Sunday 21st December until the month end was due to a loss of power to the monitoring station caused by poor weather conditions preventing sufficient light reaching the solar panel.

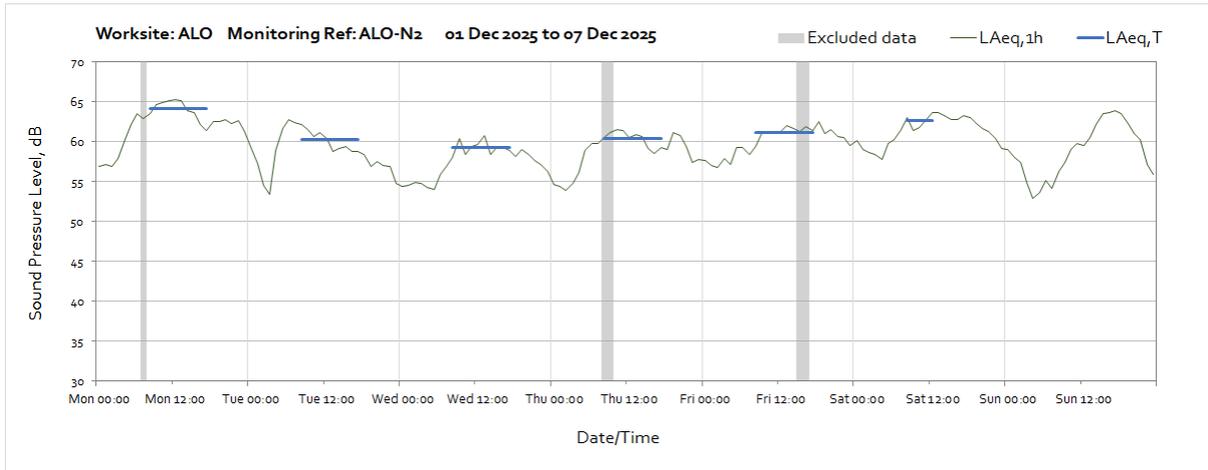
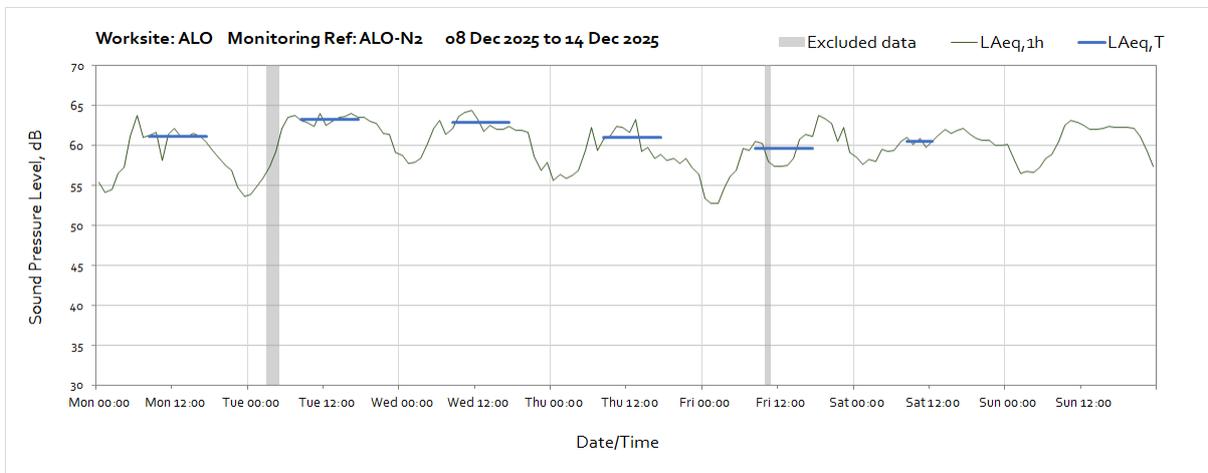
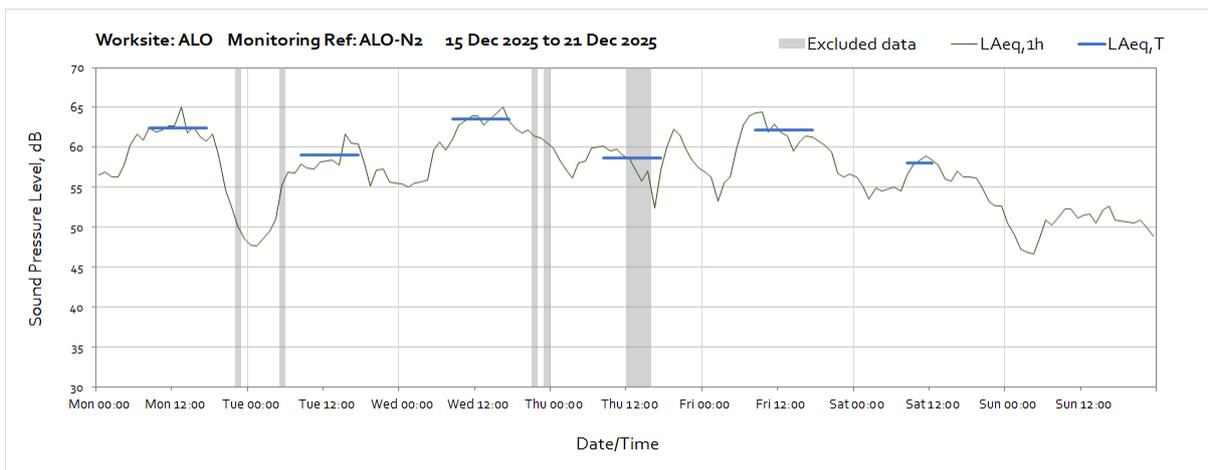
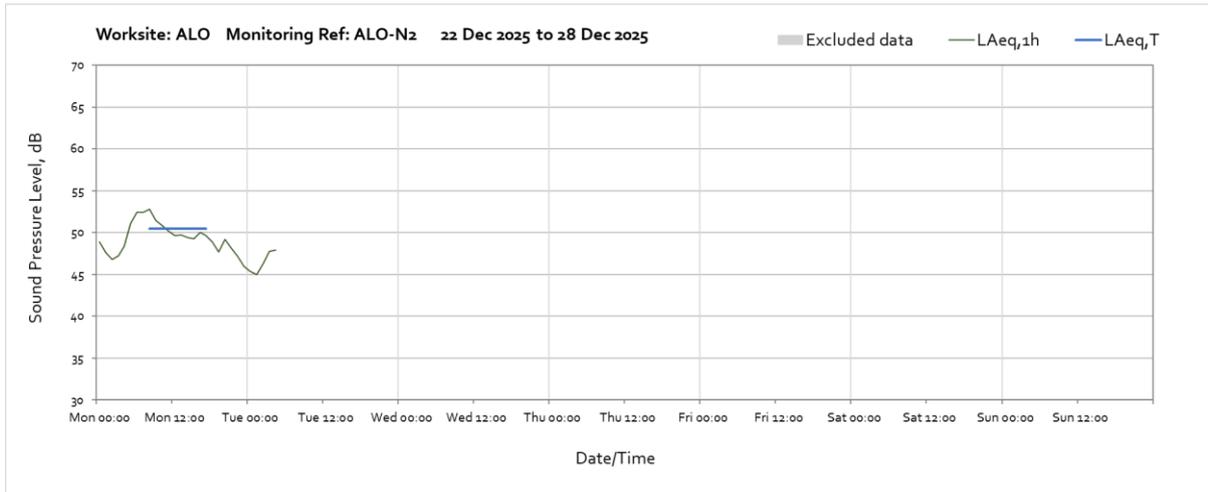
Worksite: ALO - Monitoring Ref: ALO-N2

Note: Missing data from 05:00 on Tuesday 23rd December until the end of the month was due to a loss of power to the monitoring station caused by poor weather conditions preventing sufficient light reaching the solar panel.

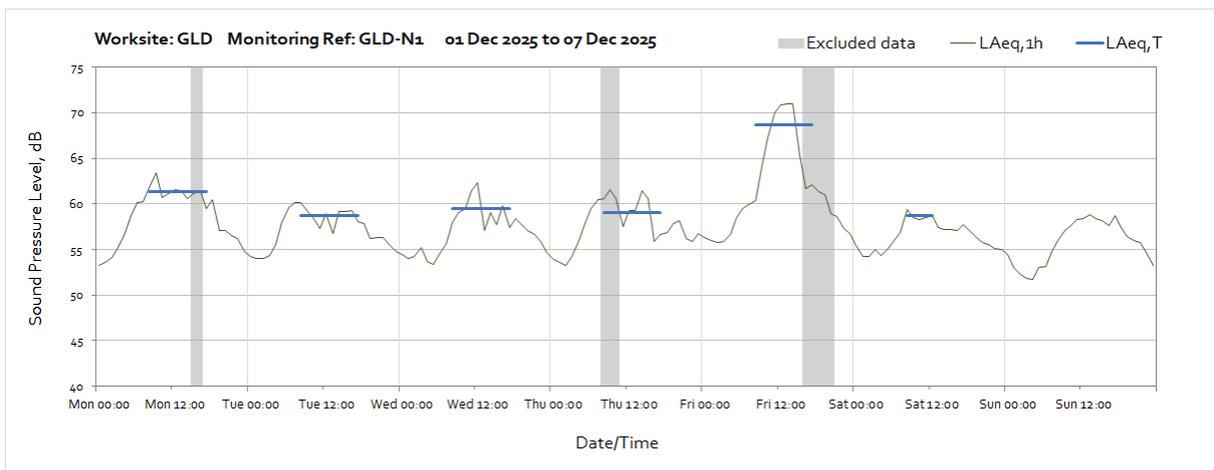
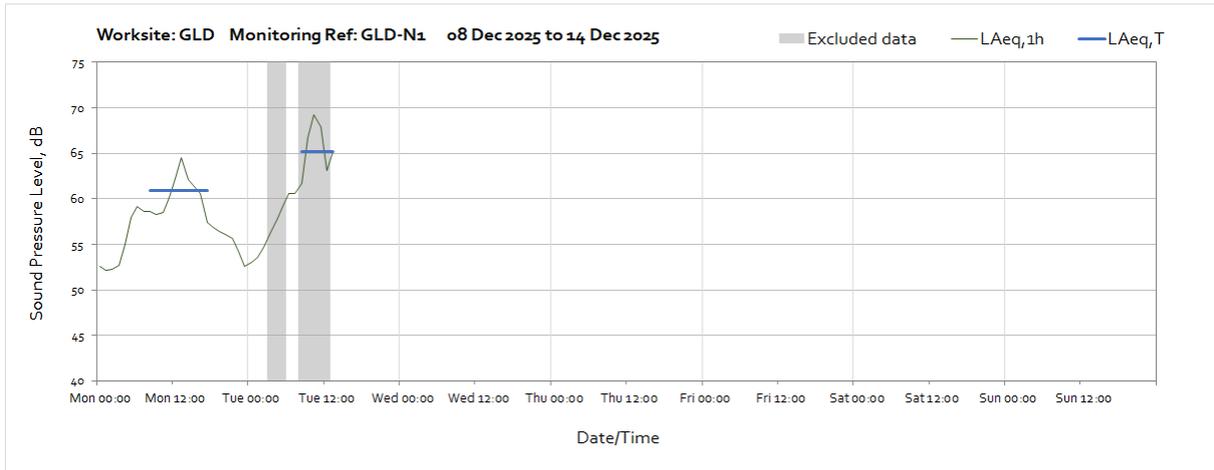
Worksite: GLD - Monitoring Ref: GLD-N1

Note: Missing data from 14:00 on Tuesday 9th December until the end of the month was due to a mains power issue at the monitoring station.

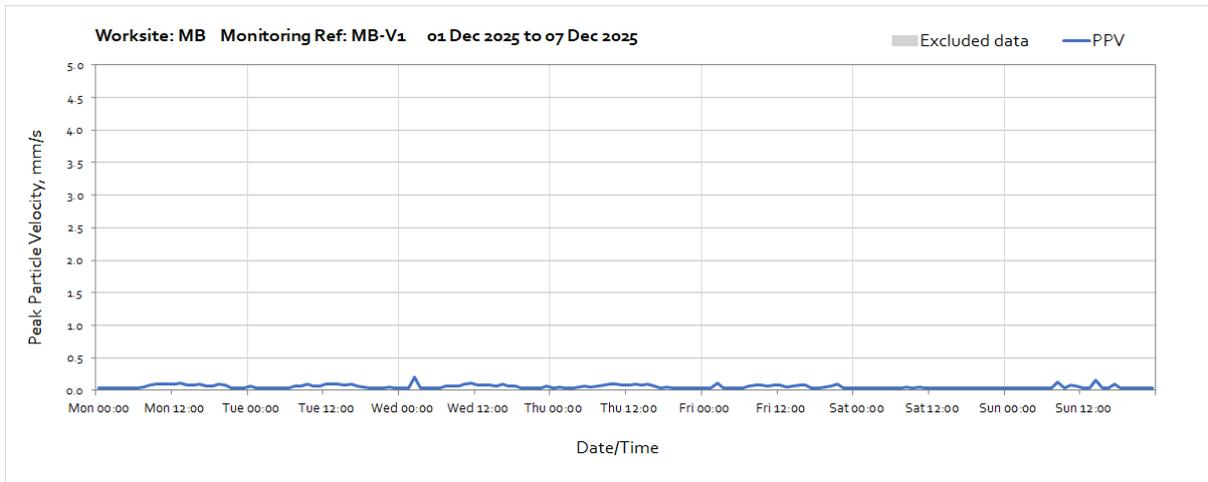
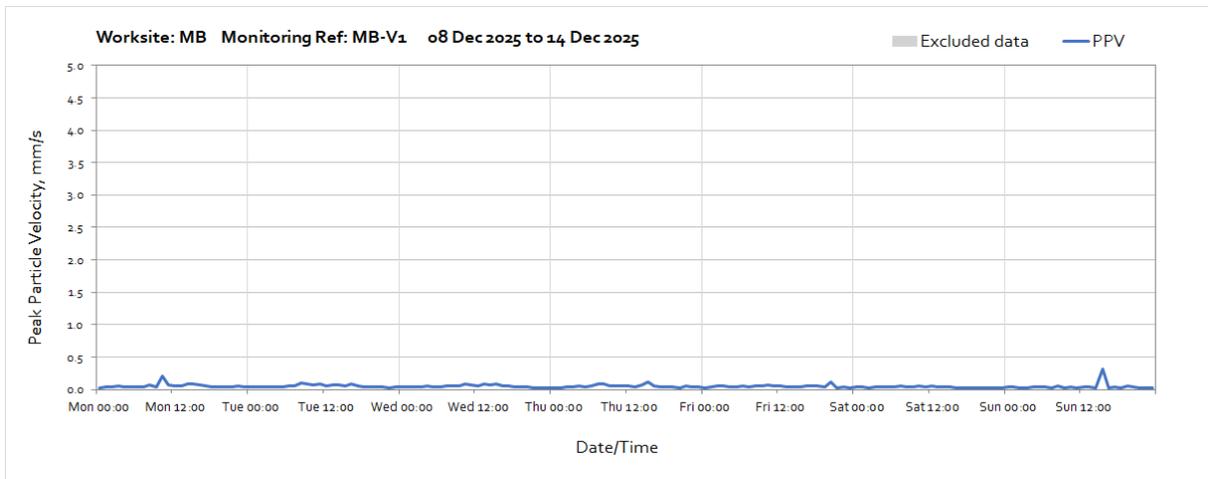
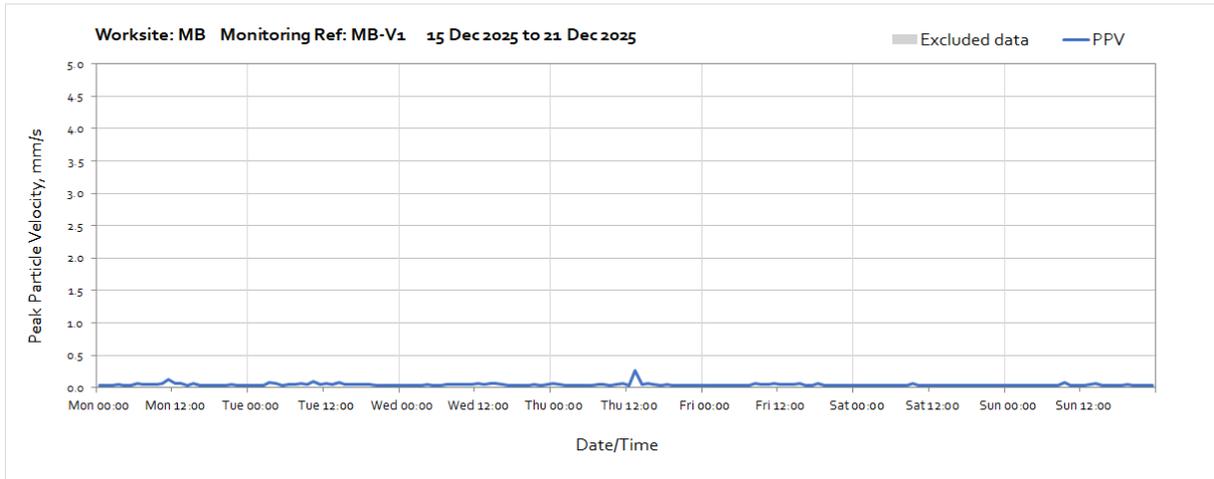
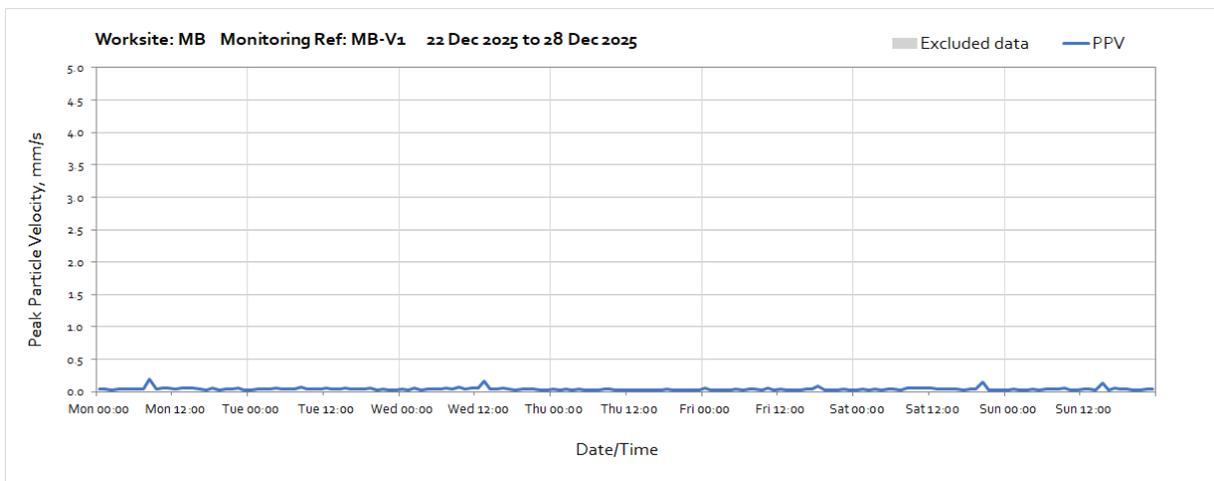
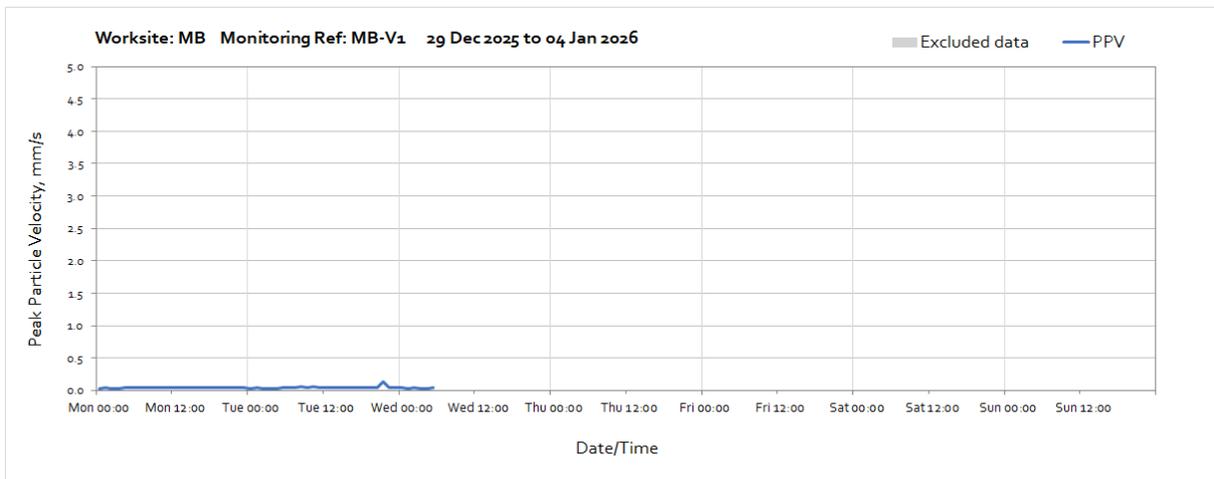
Worksite: MB – Monitoring Ref: MB-V1

Note: Missing data from 06:00 on Wednesday 31st December until the end of the month was due to a loss of power to the monitoring station caused by poor weather conditions preventing sufficient light reaching the solar panel.

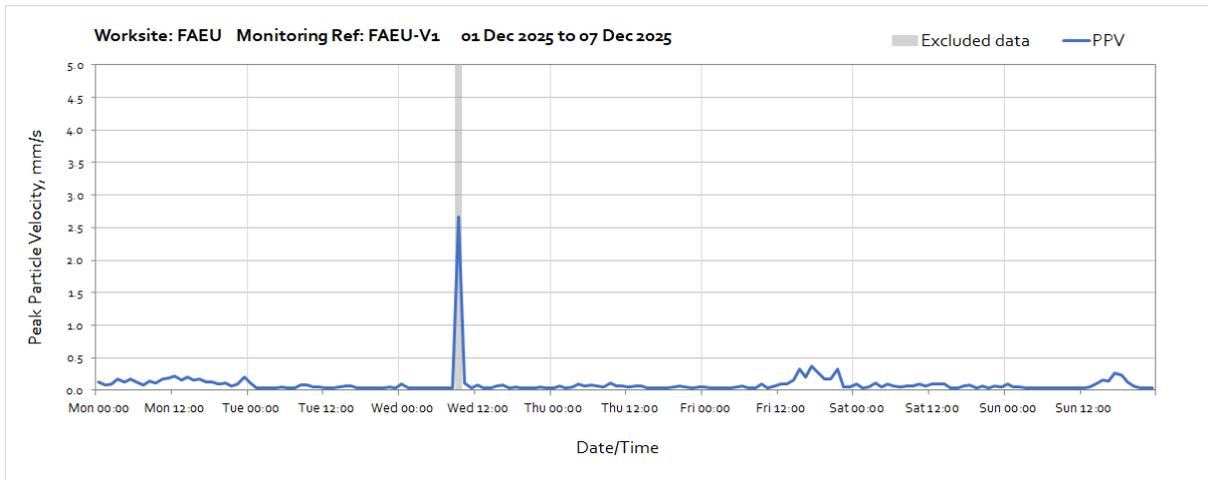
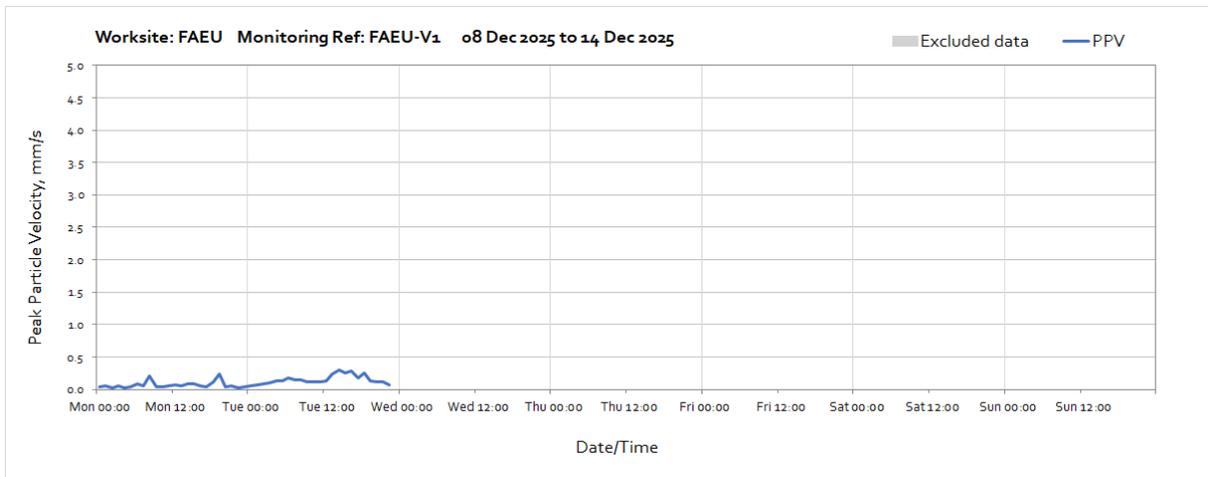
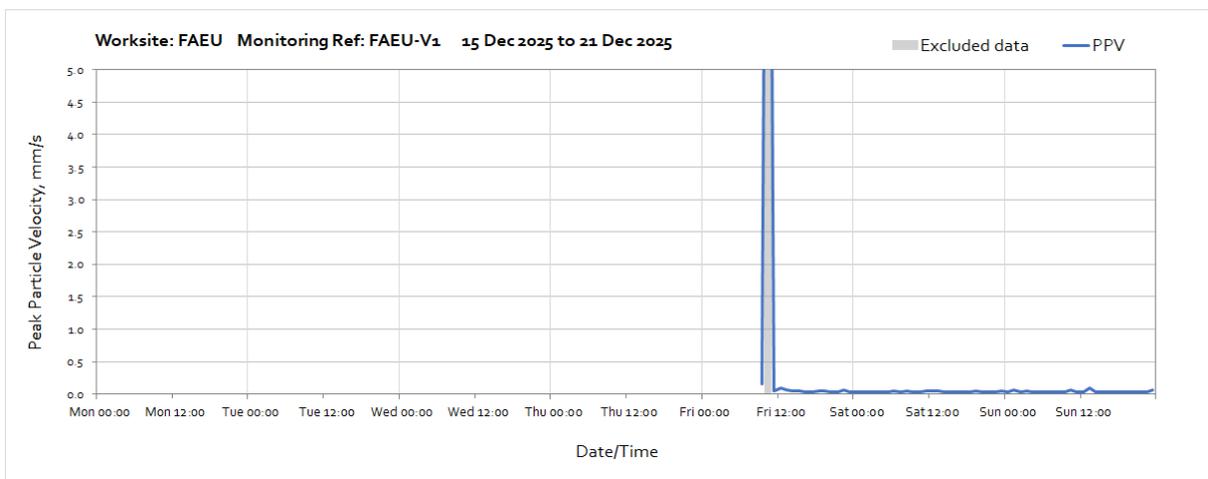
Worksite: FAEU – Monitoring Ref: FAEU-V1

Note: Missing data between 23:00 on Tuesday 9th and 09:00 on Friday 19th December was due to a loss of power to the monitoring station caused by poor weather conditions preventing sufficient light reaching the solar panel.

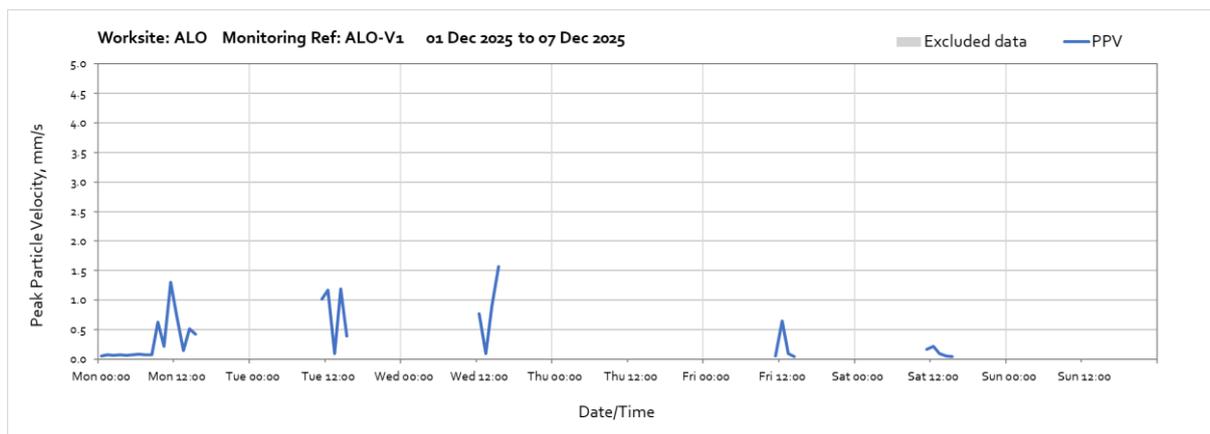
Worksite: ALO - Monitoring Ref: ALO-V1

Note: Missing data throughout the month was due to a loss of power to the monitoring station caused by poor weather conditions preventing sufficient light reaching the solar panel.

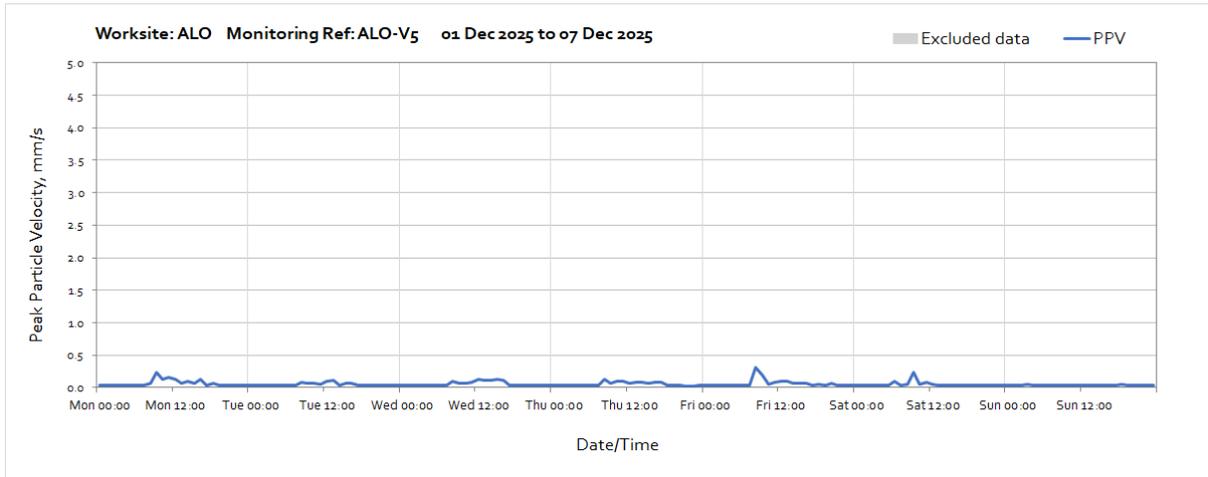
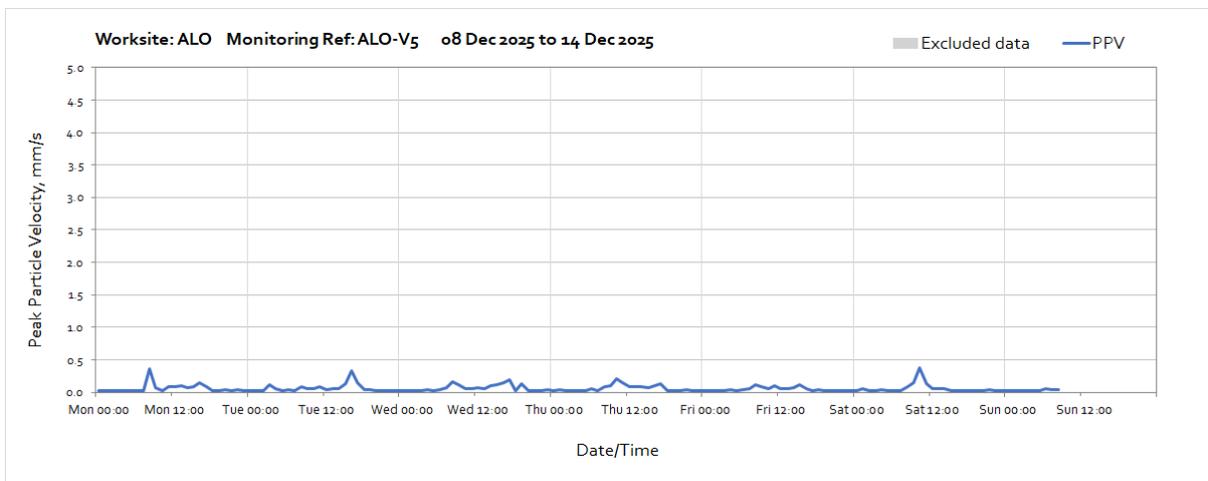
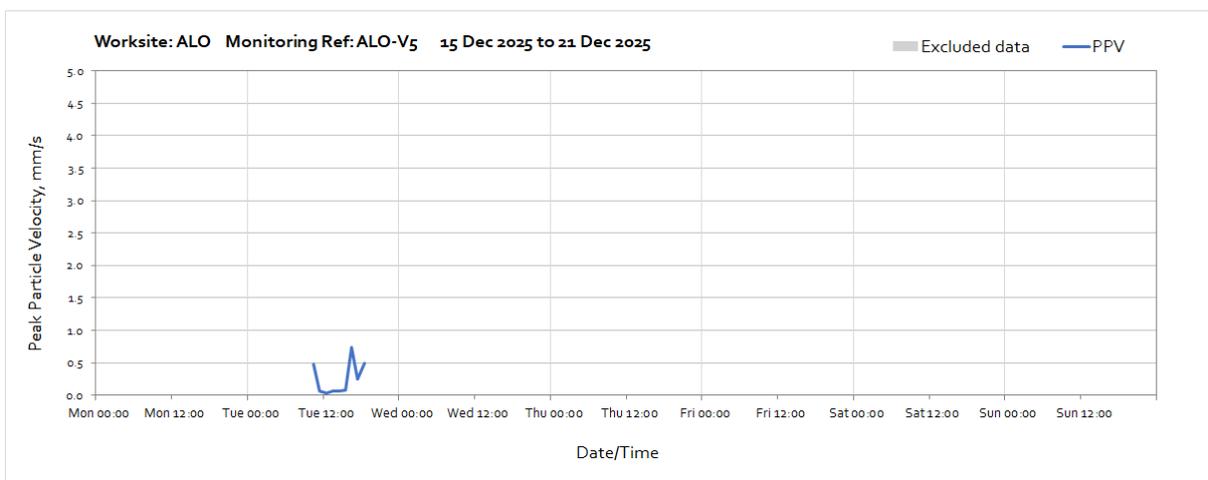
Worksite: ALO – Monitoring Ref: ALO-V5

Note: Missing data throughout the month was due to a loss of power to the monitoring station caused by poor weather conditions preventing sufficient light reaching the solar panel.
