Construction Noise and Vibration Monthly Report – December 2025

Solihull Metropolitan Borough Council

Non-Technical Summary

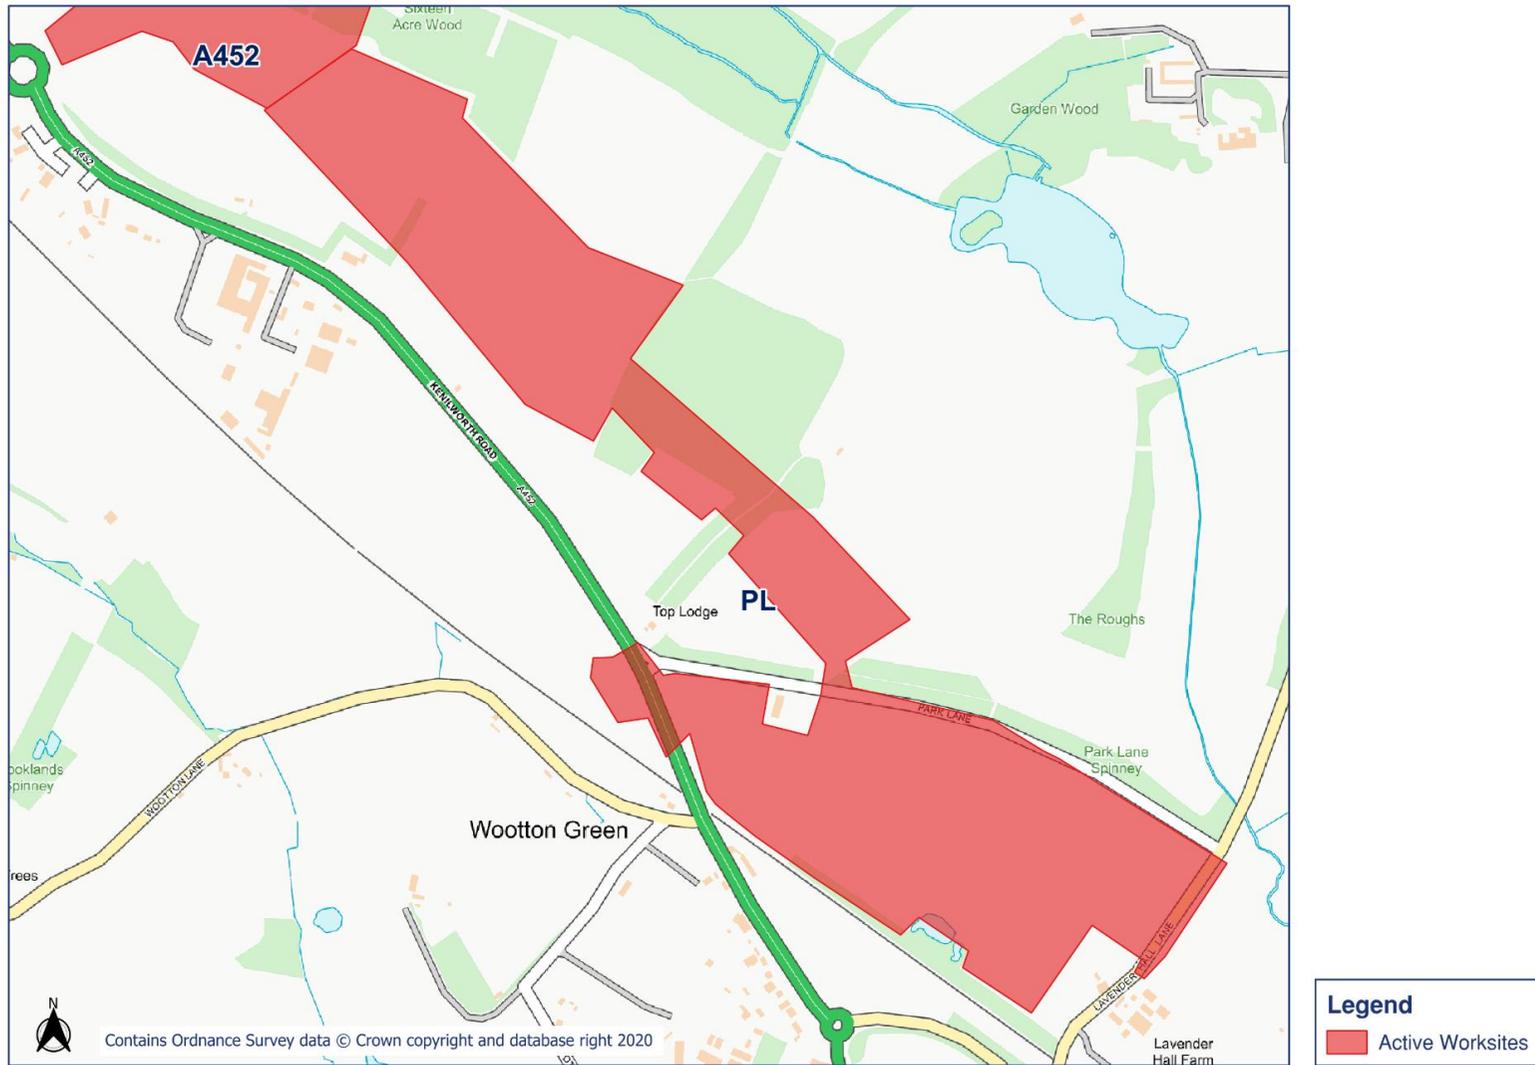
Worksite Identification Plan - 5

- A452 worksite, reference - A452 (see plan 5 in Appendix A), where work activities included:
 - Embankment works.
- Park Lane worksite, reference - PL (see plan 6 in Appendix A), where work activities included:

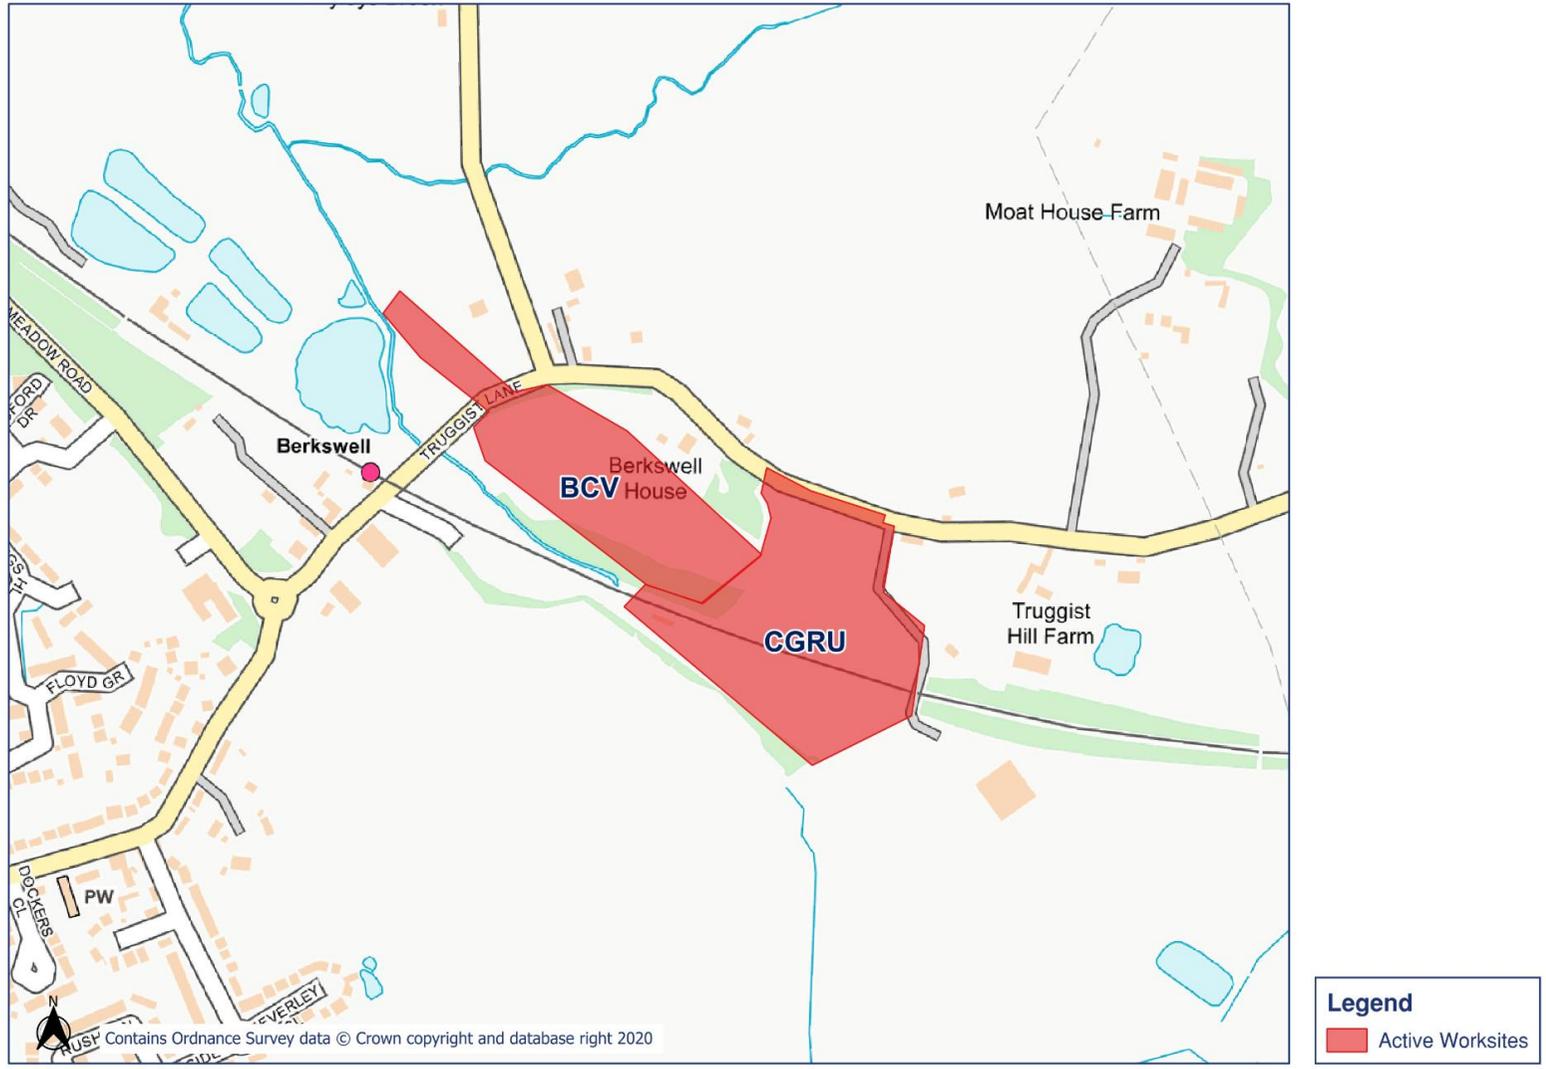
Worksite Identification Plan - 6

- Scaffold erection.
 - Road diversion works.
 - Trimming batters.
 - Embankment works.
- Balsall Common Viaduct worksite, reference - BCV (see plan 7 in Appendix A), where no works were underway.

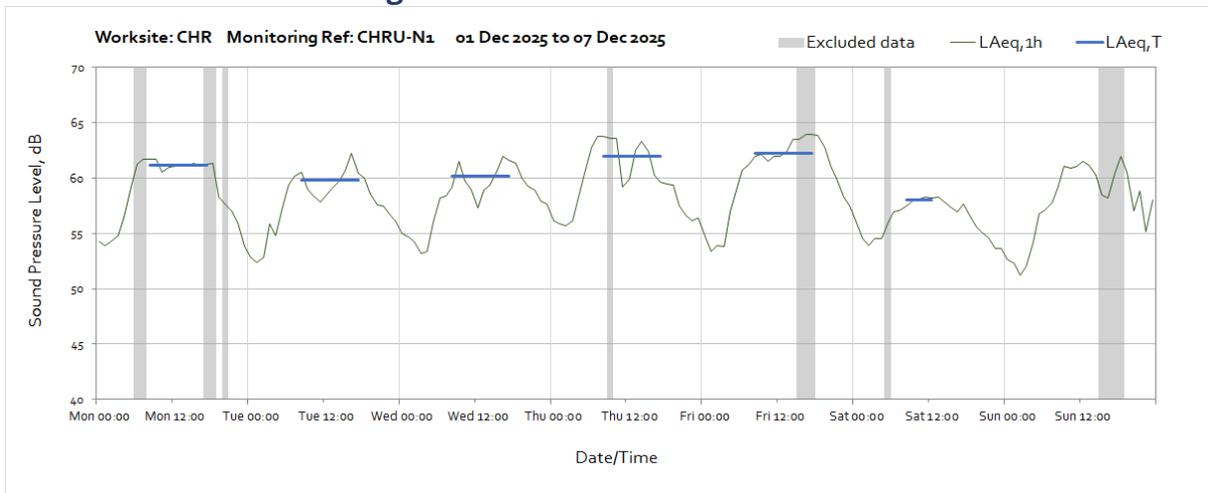
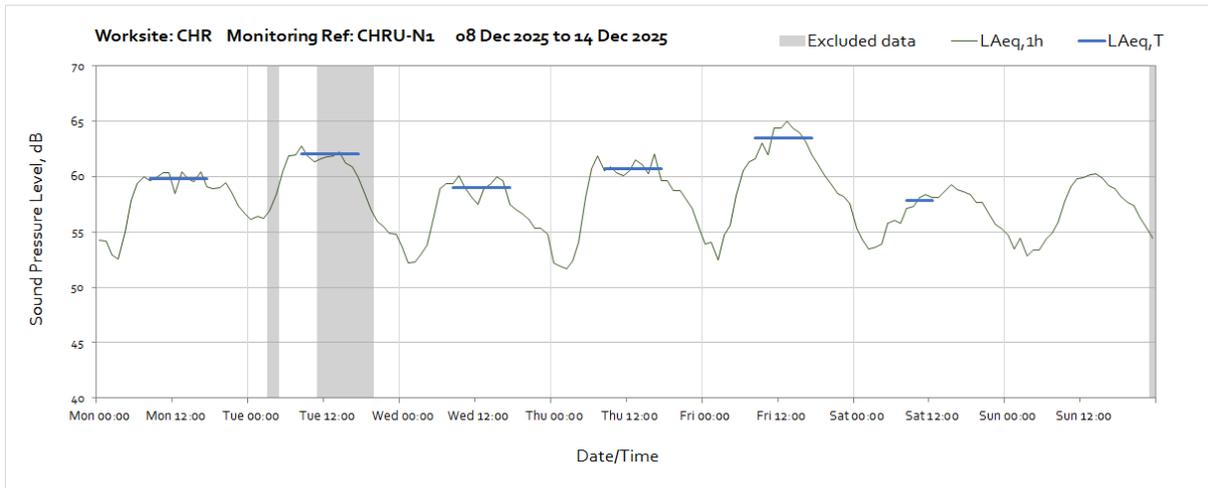
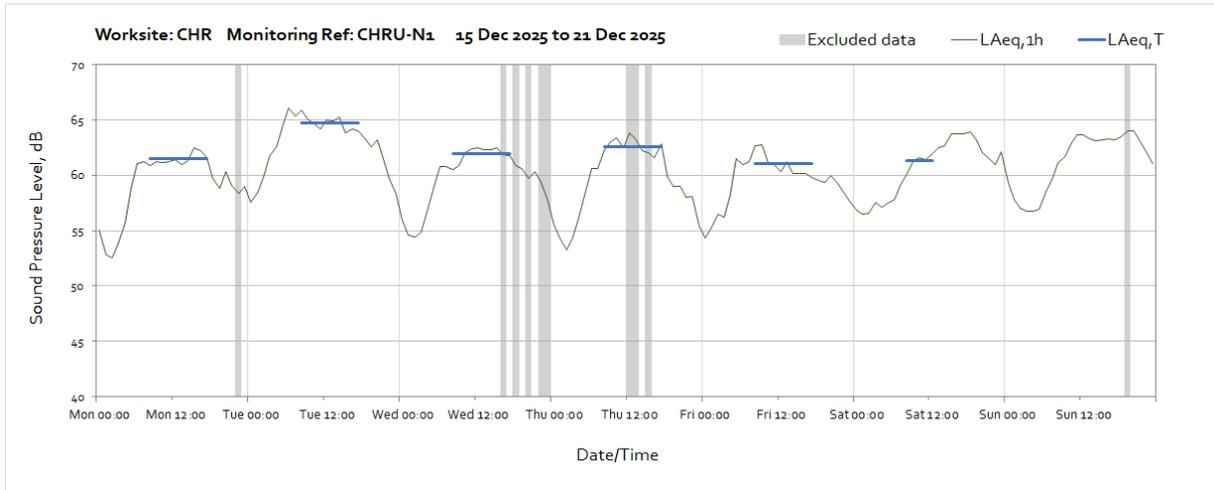
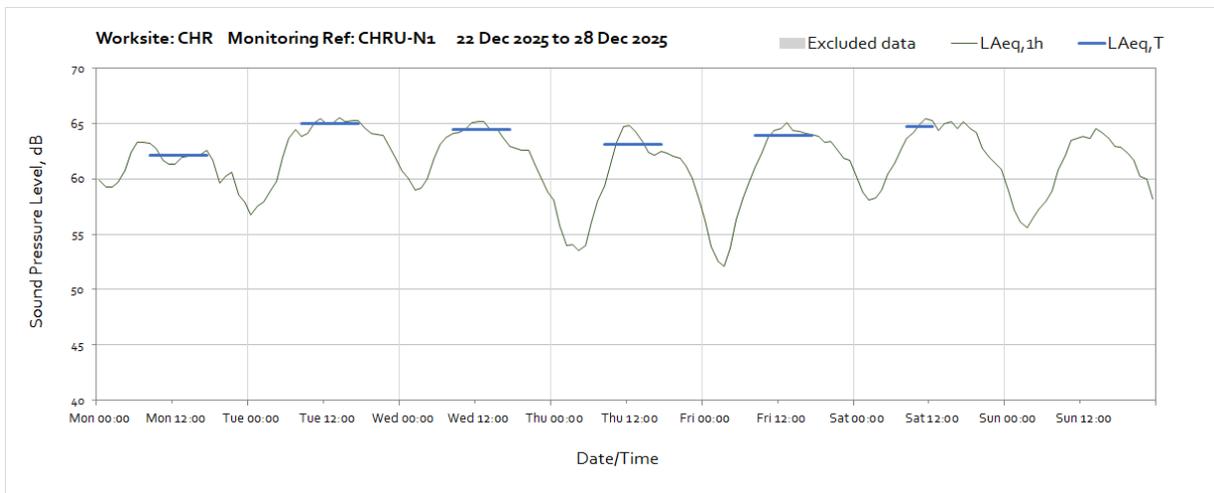
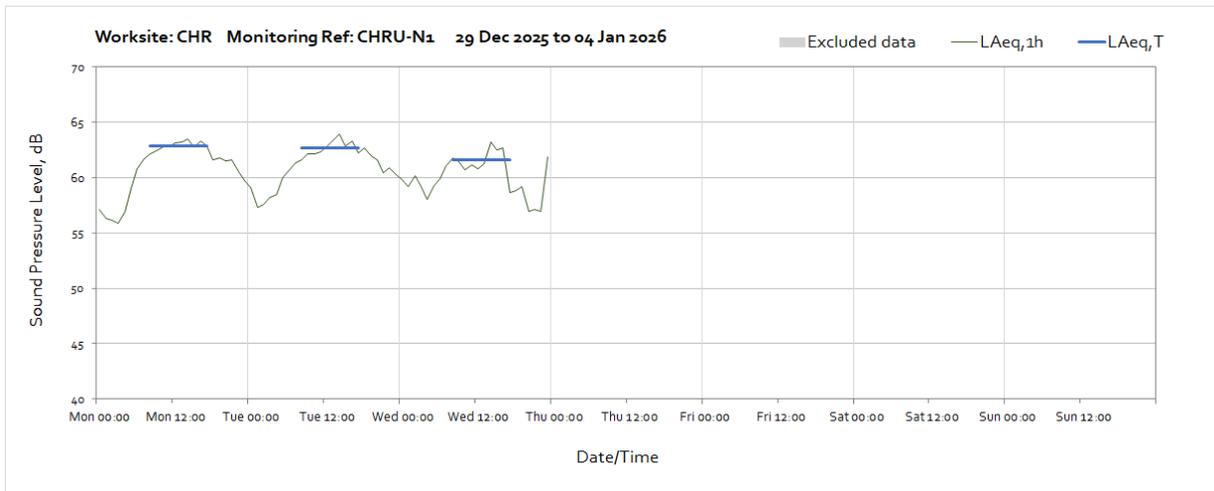
Worksite: CHR - Monitoring Ref: CHRU-1

The following graphs show the hourly measured ambient noise level $L_{Aeq,1h}$ and, where relevant, the averaged noise level $L_{Aeq,T}$ values, where the time period T is as specified in Table 1 of HS2 Information Paper E23. Periods where noise levels are adversely affected by weather or only measured for part of the period, which are not representative of HS2 construction works, have been greyed out and excluded from the calculation of the $L_{Aeq,T}$ values in of the main report.

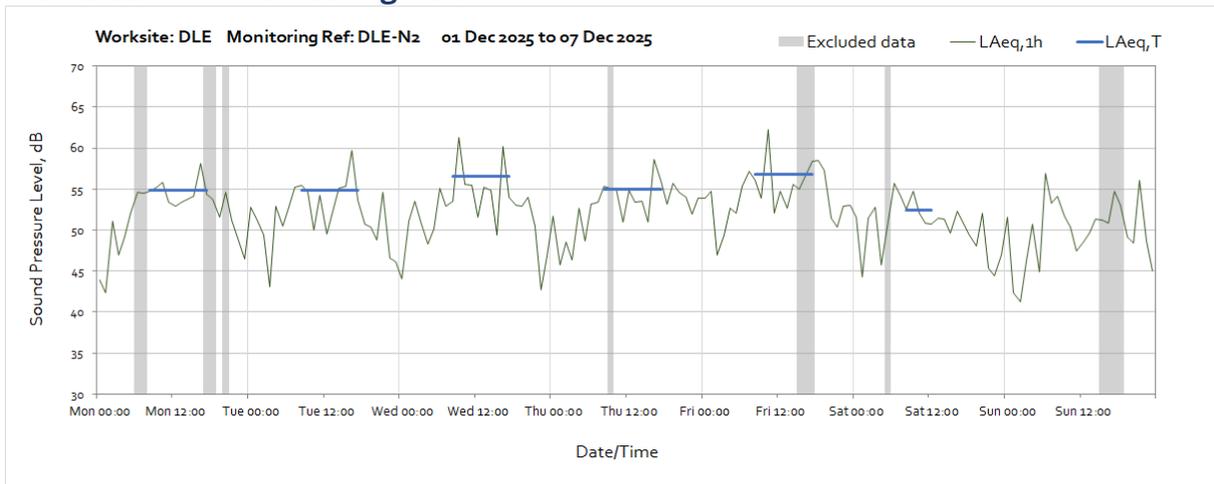
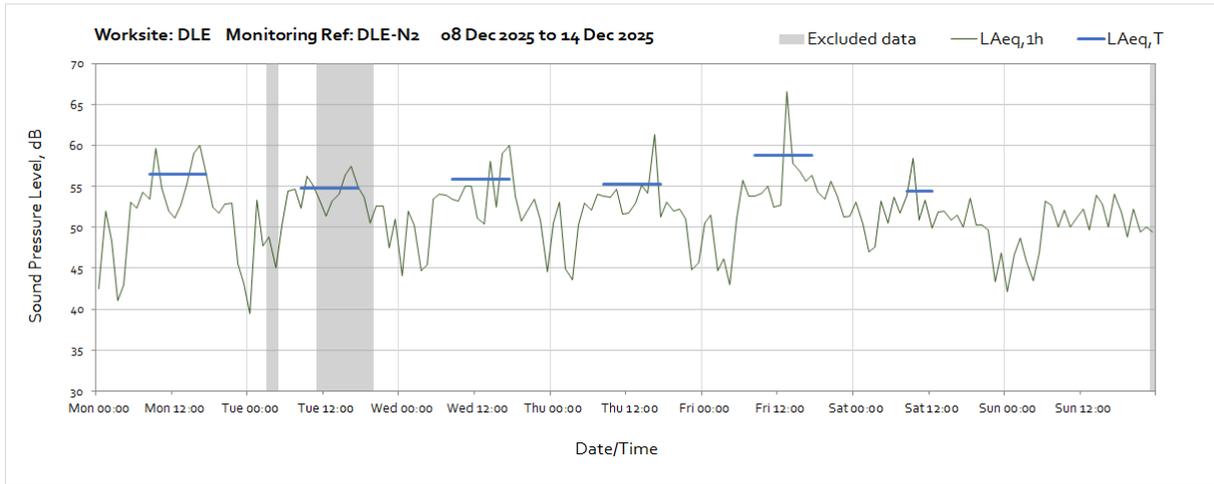
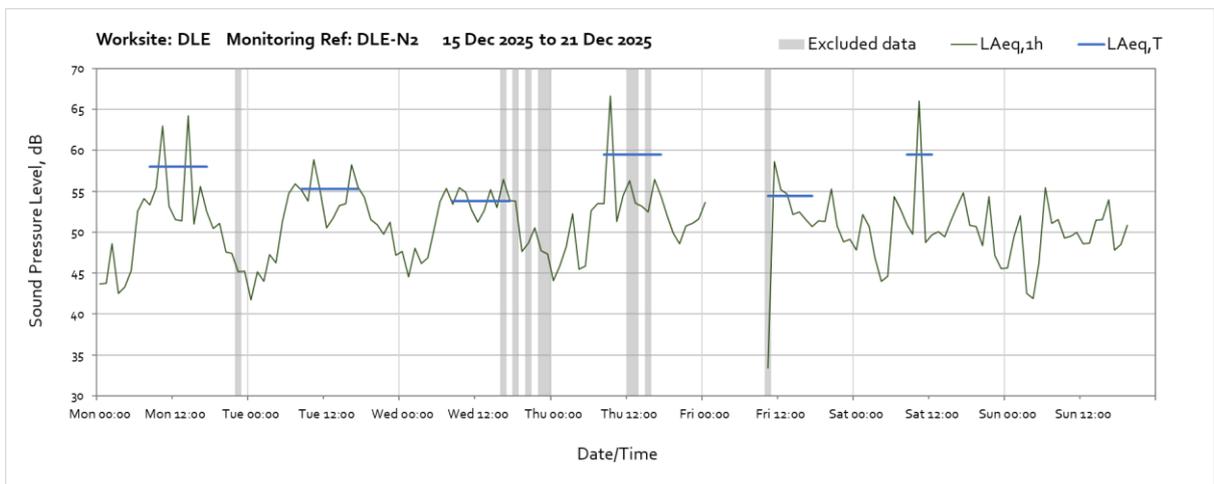
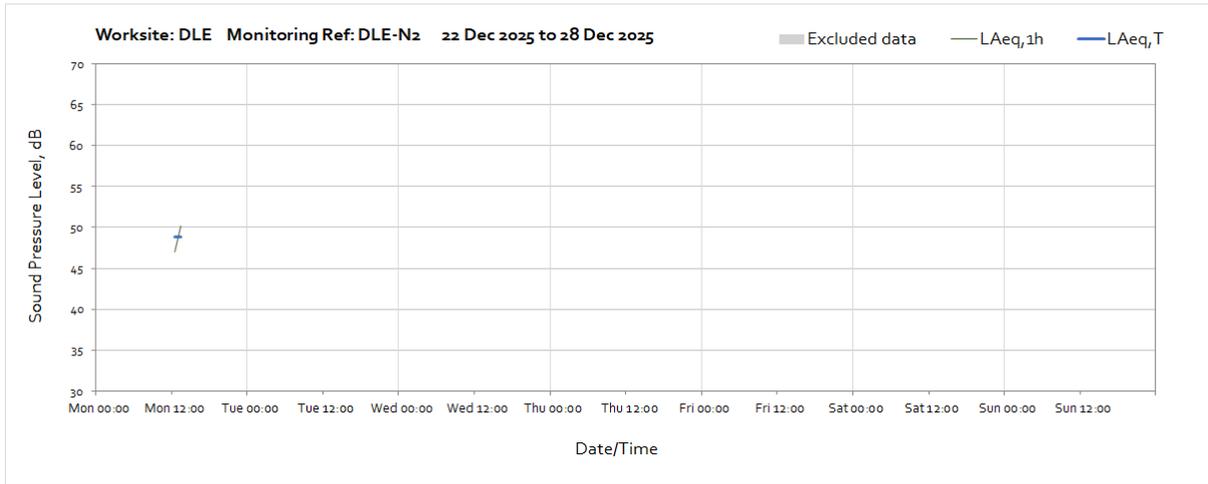
Worksite: DLE - Monitoring Ref: DLE-2

Note: Missing data throughout the month was due to a loss of power to the monitoring station caused by poor weather conditions preventing sufficient light reaching the solar panel.

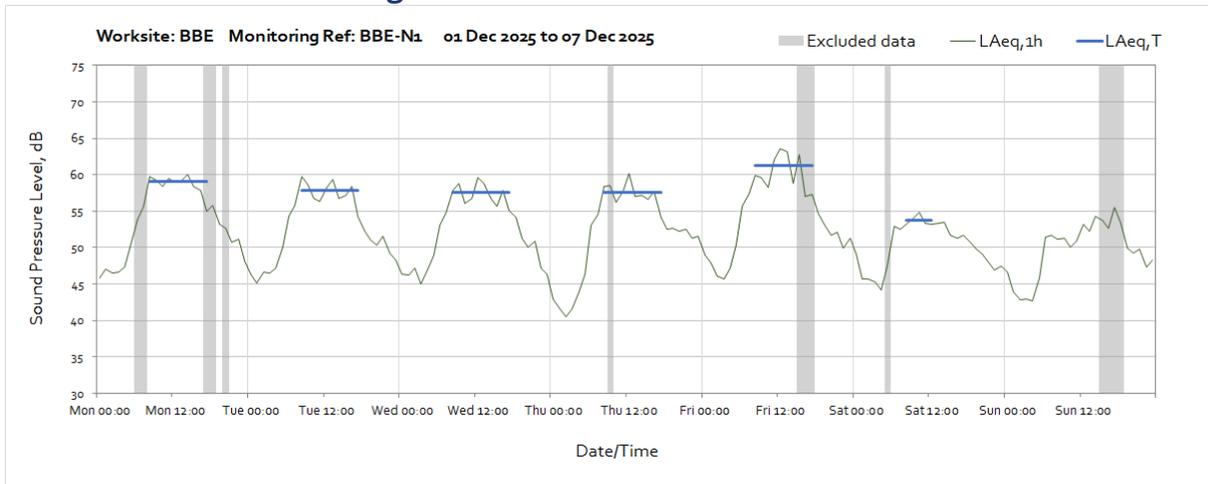
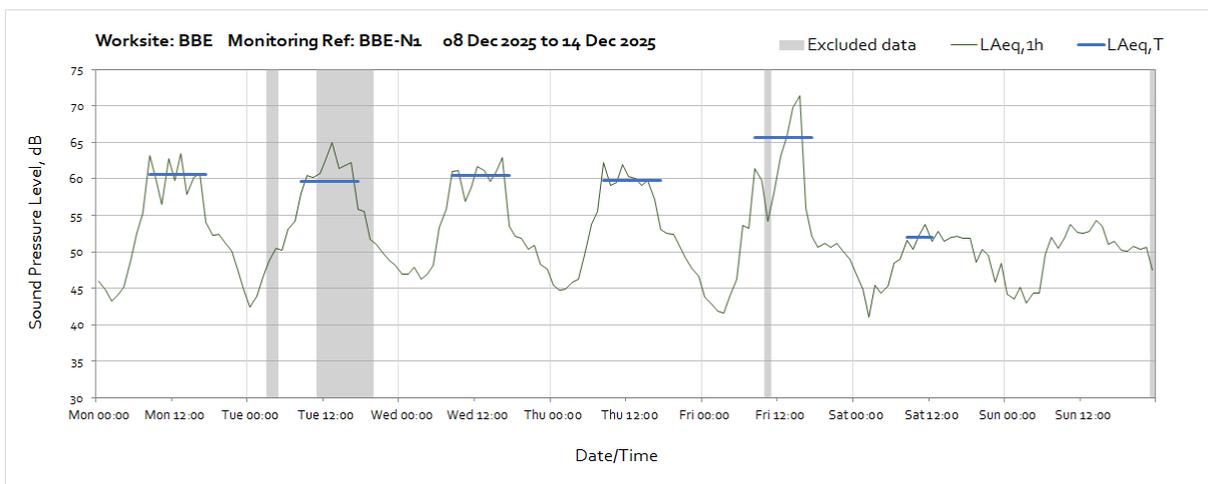
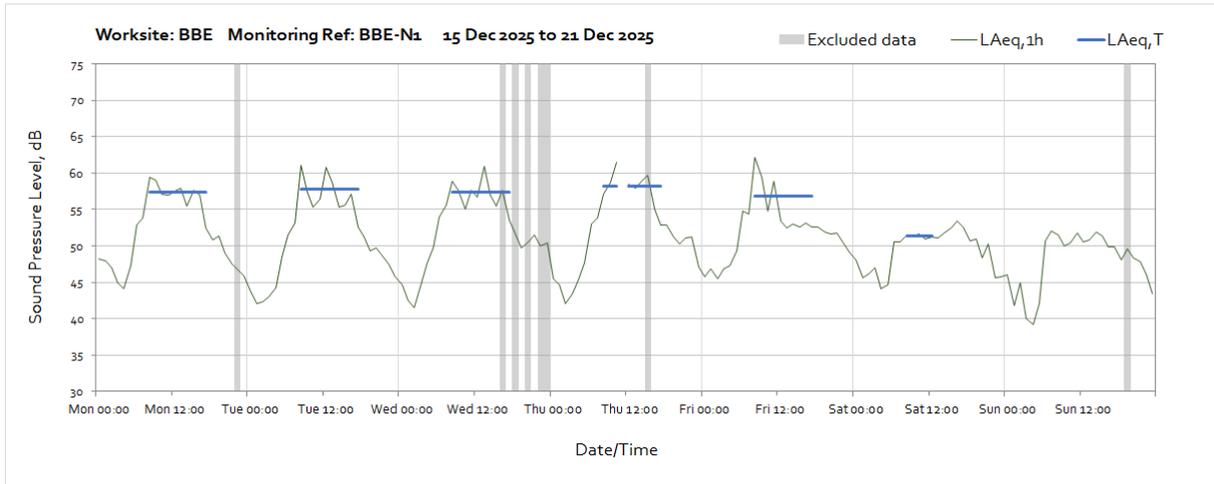
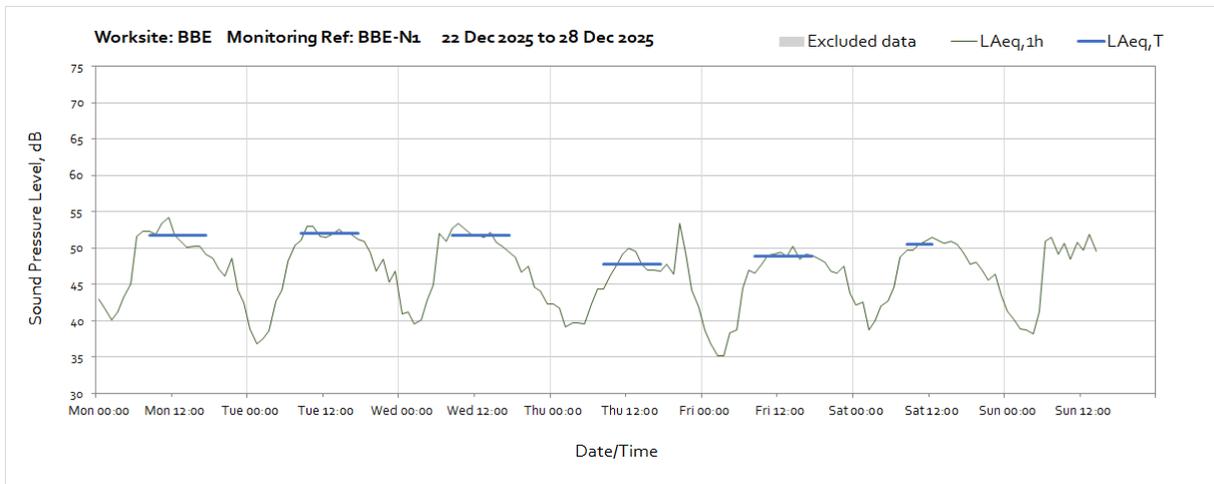
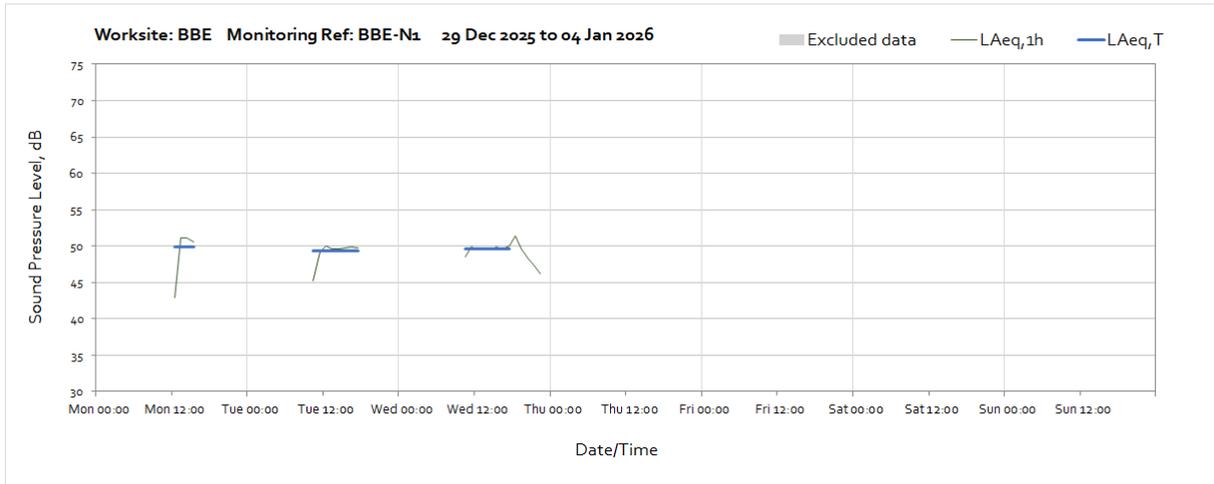
Worksite: BBE – Monitoring Ref: BBE-1

Note: Missing data throughout the month was due to a loss of power to the monitoring station caused by poor weather conditions preventing sufficient light reaching the solar panel

Note: Missing data throughout the month was due to a loss of power to the monitoring station caused by poor weather conditions preventing sufficient light reaching the solar panel.

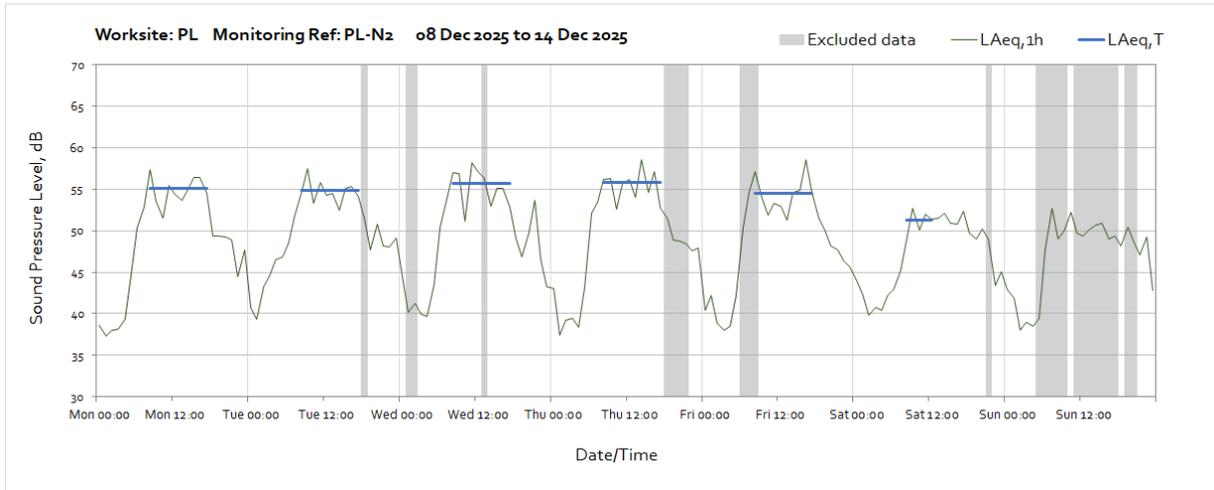
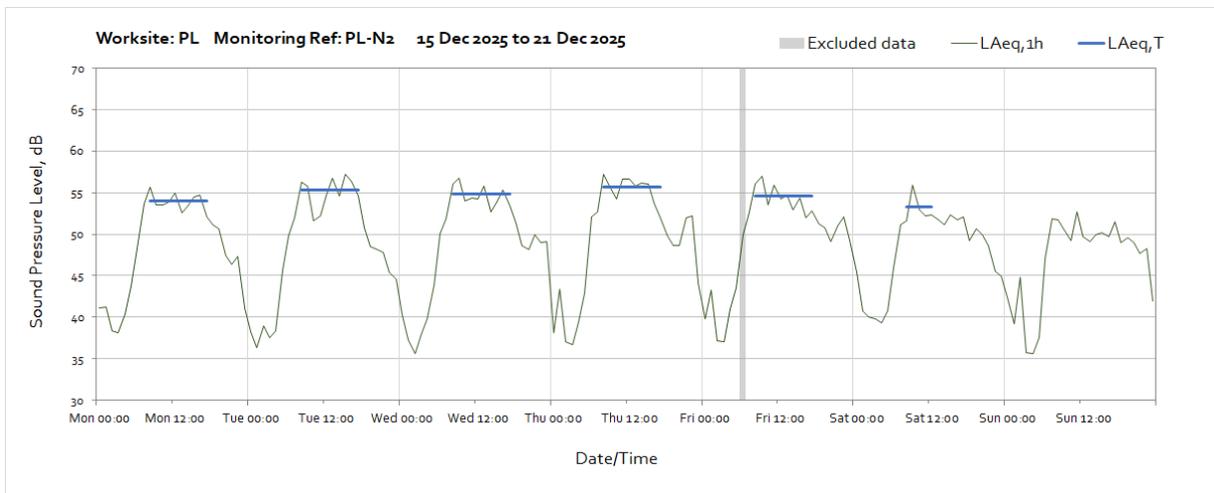
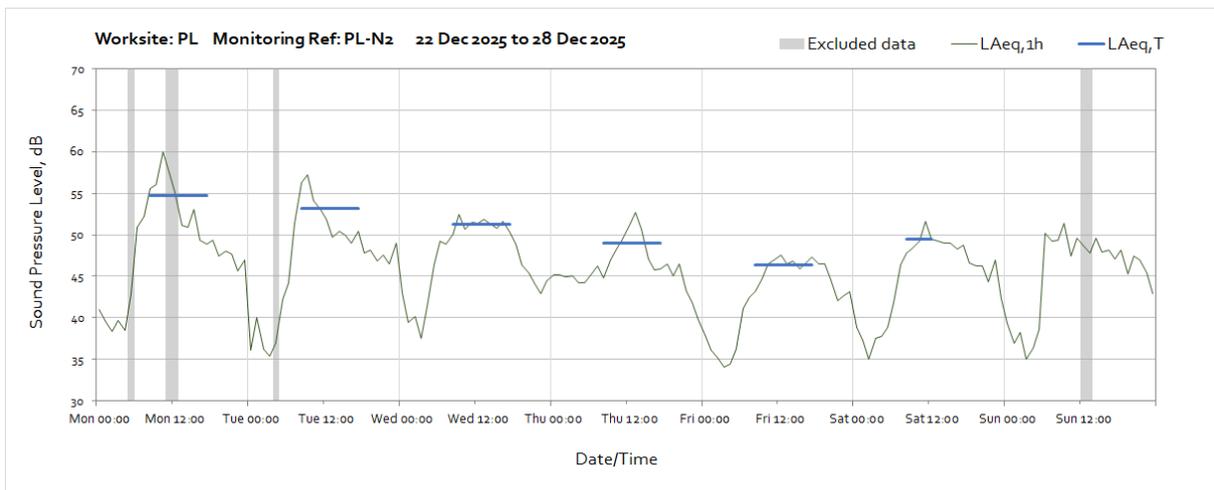
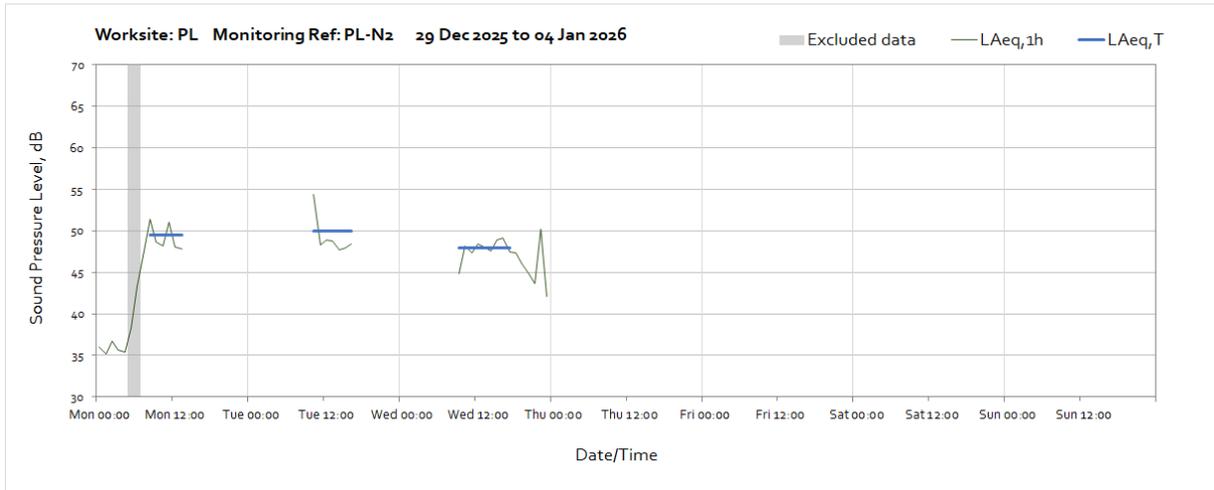
Worksite: PL - Monitoring Ref: PL-2

Note: Missing data between 14:00 on Monday 29th and 10:00 on Tuesday 30th December and between 17:00 on Tuesday 30th and 09:00 on Wednesday 31st December was due to a system error at the monitoring station.

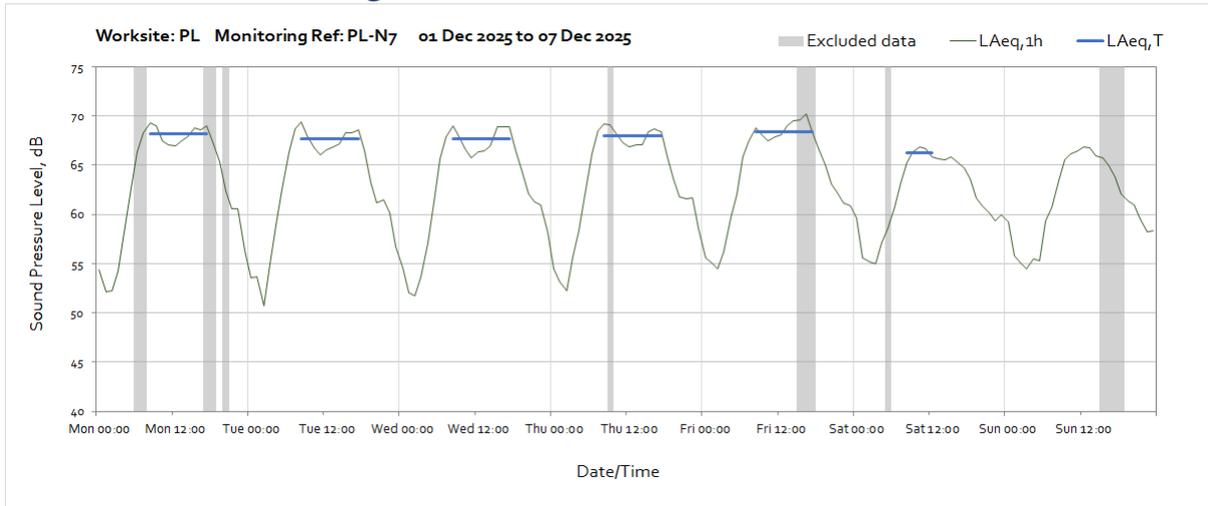
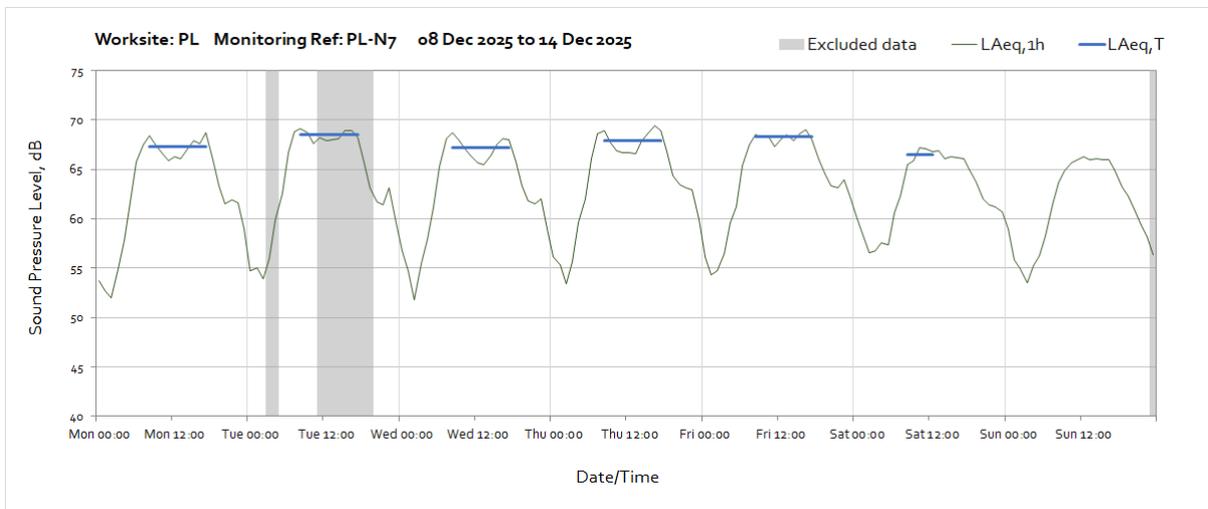
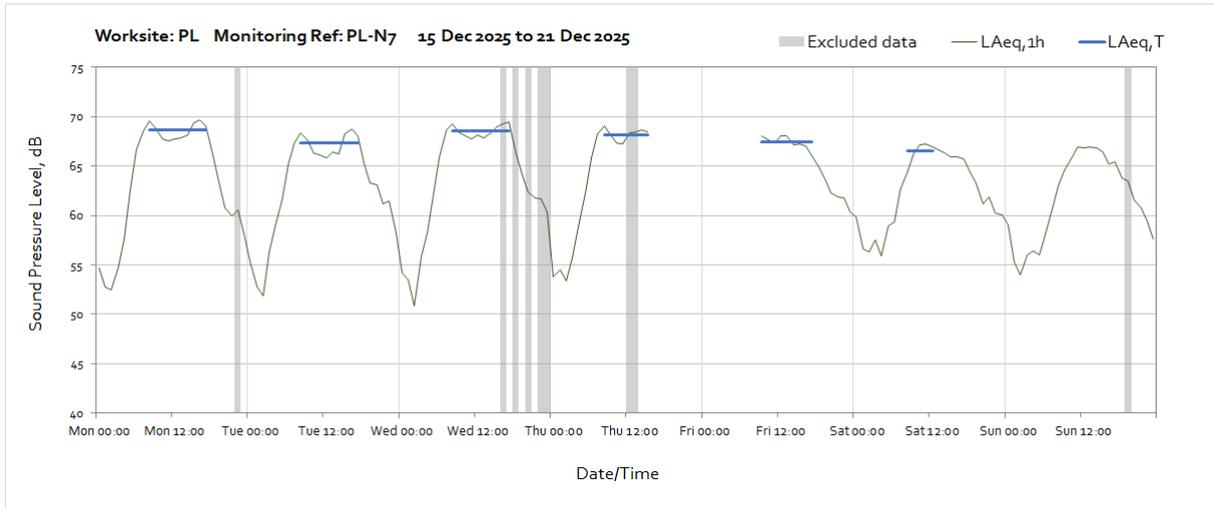
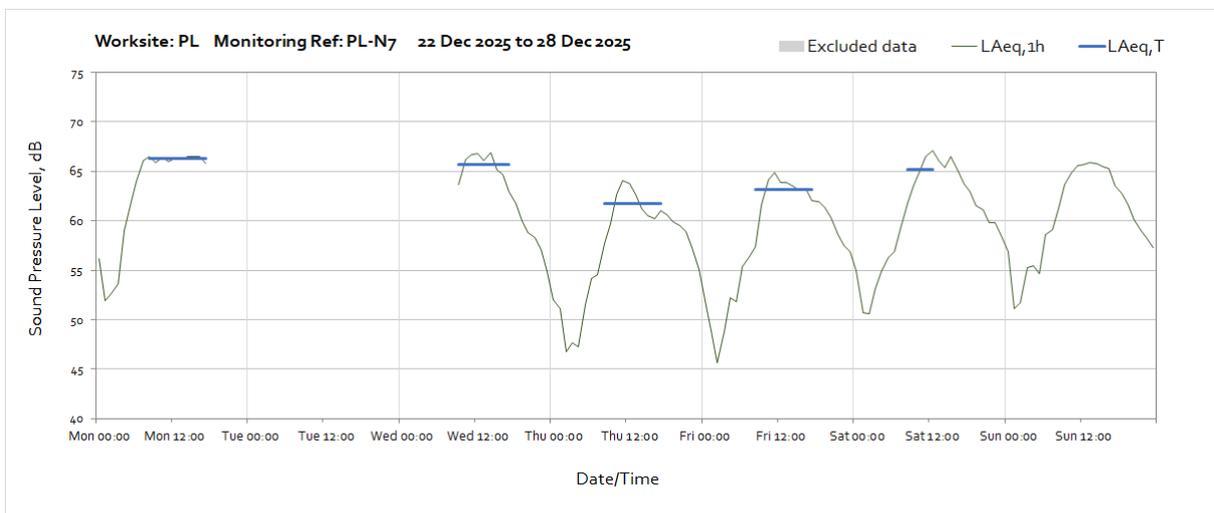
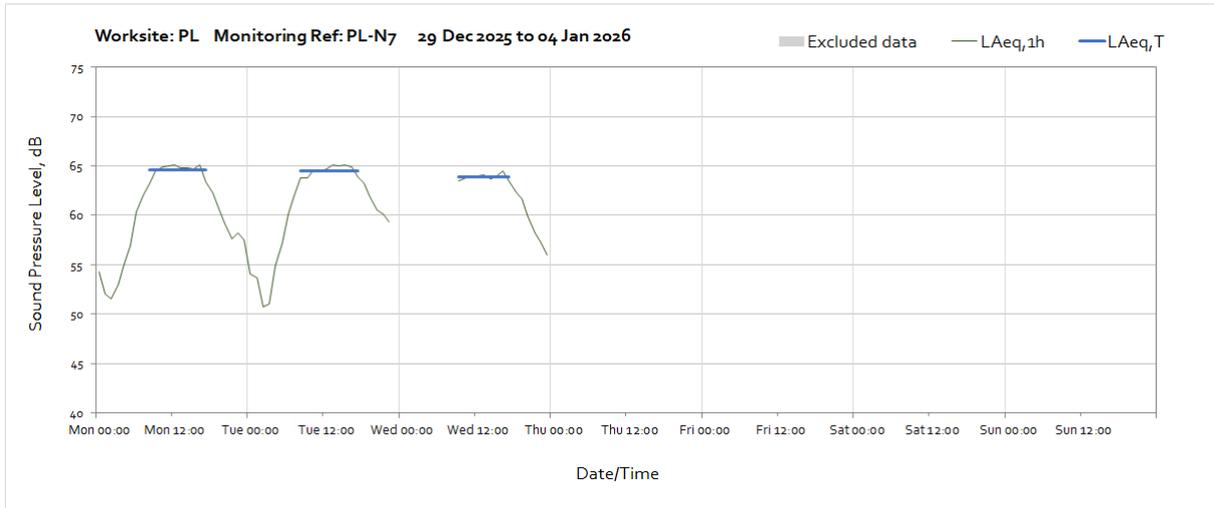
Worksite: PL - Monitoring Ref: PL-7

Note: Missing data throughout the month was due to a loss of power to the monitoring station caused by poor weather conditions preventing sufficient light reaching the solar panel.

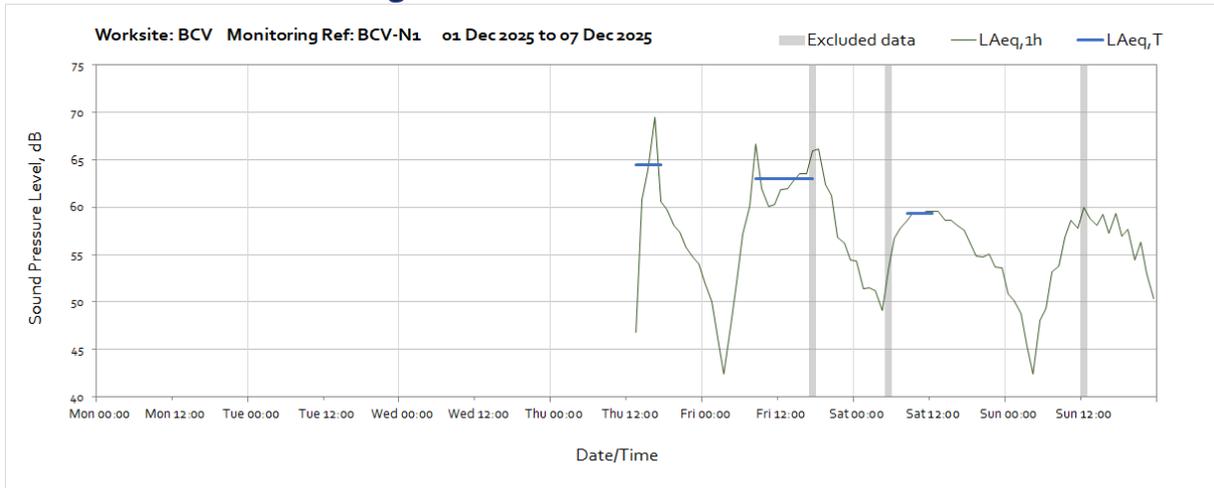
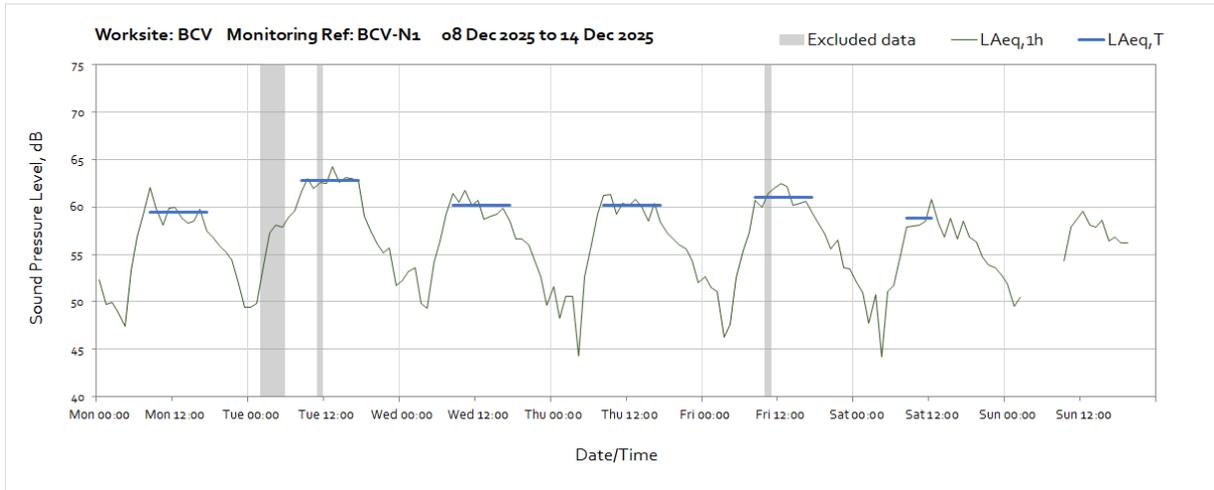
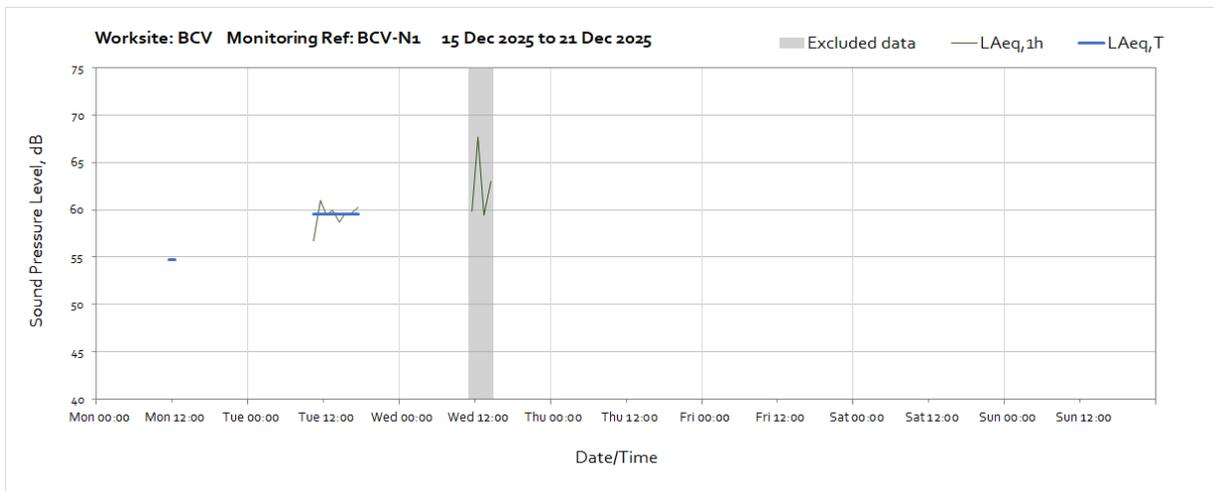
Worksite: BCV – Monitoring Ref: BCV-1

Note: Missing data throughout the month was due to a loss of power to the monitoring station caused by poor weather conditions preventing sufficient light reaching the solar panel.

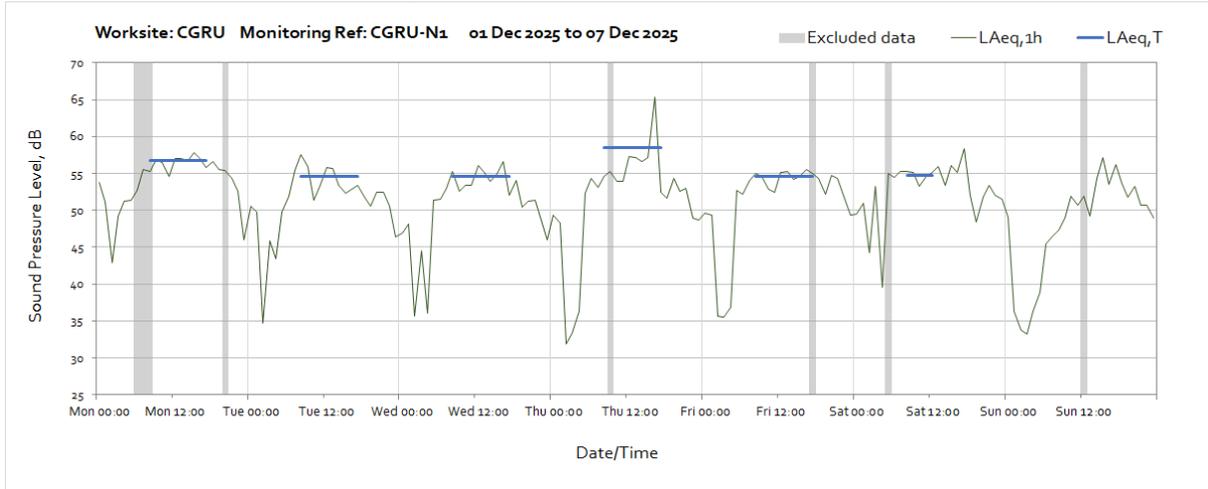
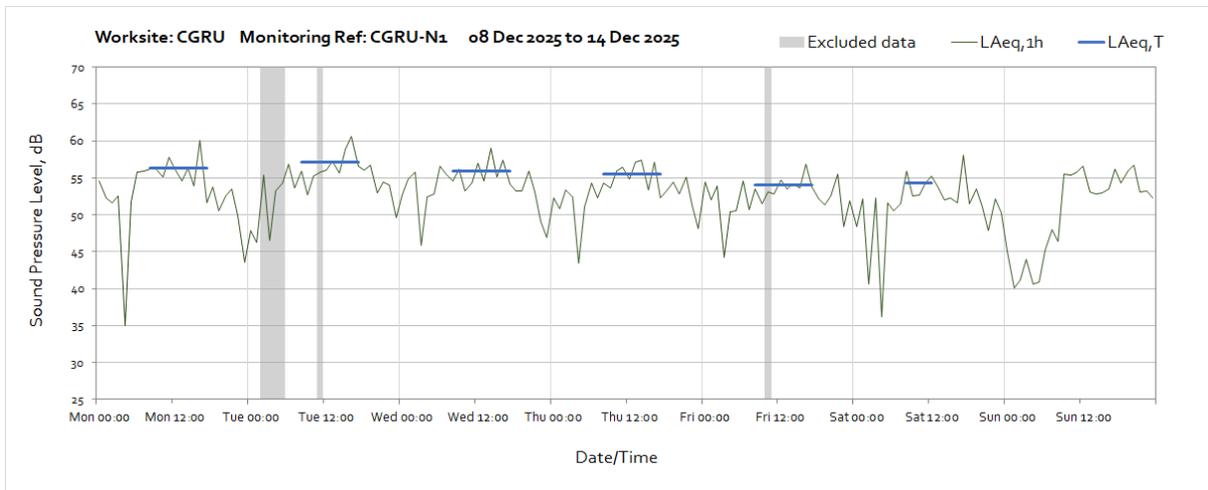
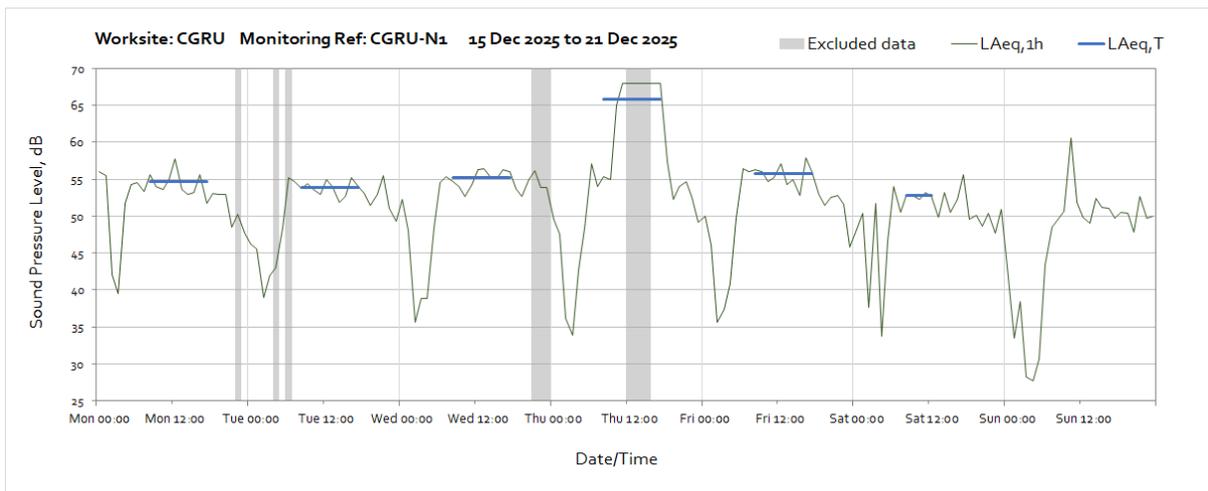
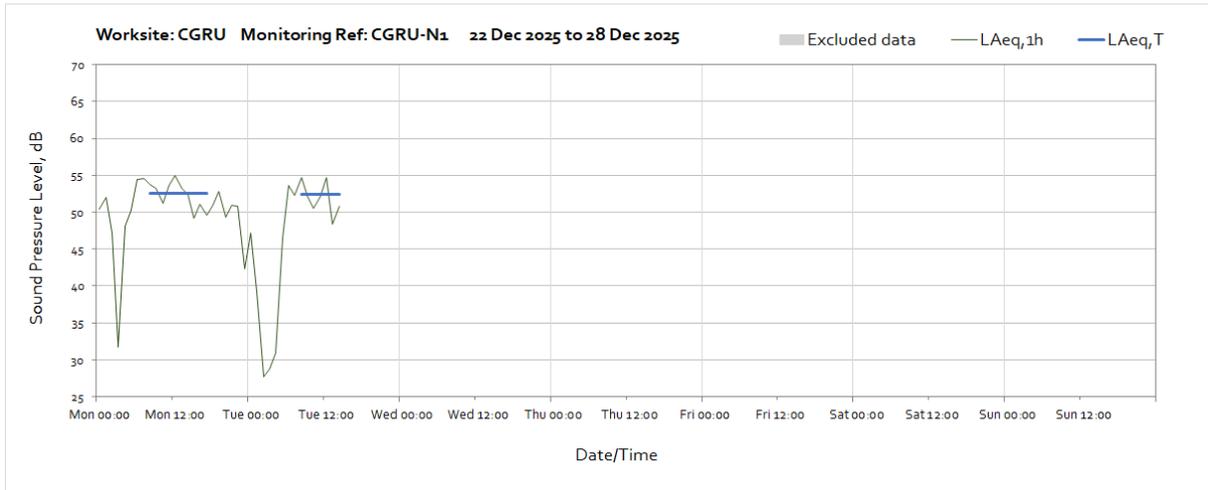
Worksite: CGRU- Monitoring Ref: CGRU-1

Note: Missing data from 15:00 on Tuesday 23rd December until the end of the month was due to a loss of power to the monitoring station caused by poor weather conditions preventing sufficient light reaching the solar panel.
