Construction Noise and Vibration Monthly Report – December 2025

Solihull Metropolitan Borough Council

Non-Technical Summary

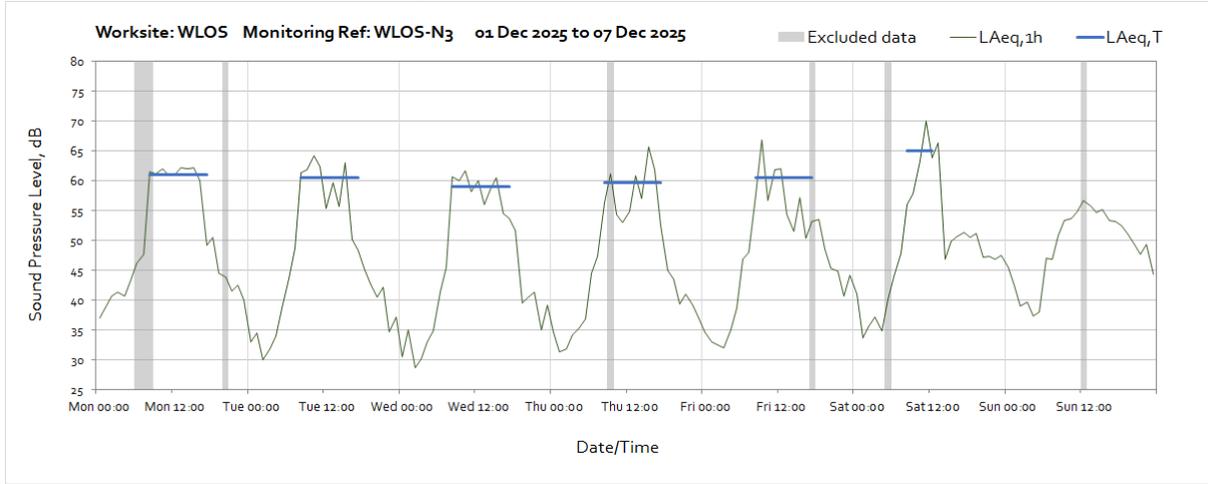
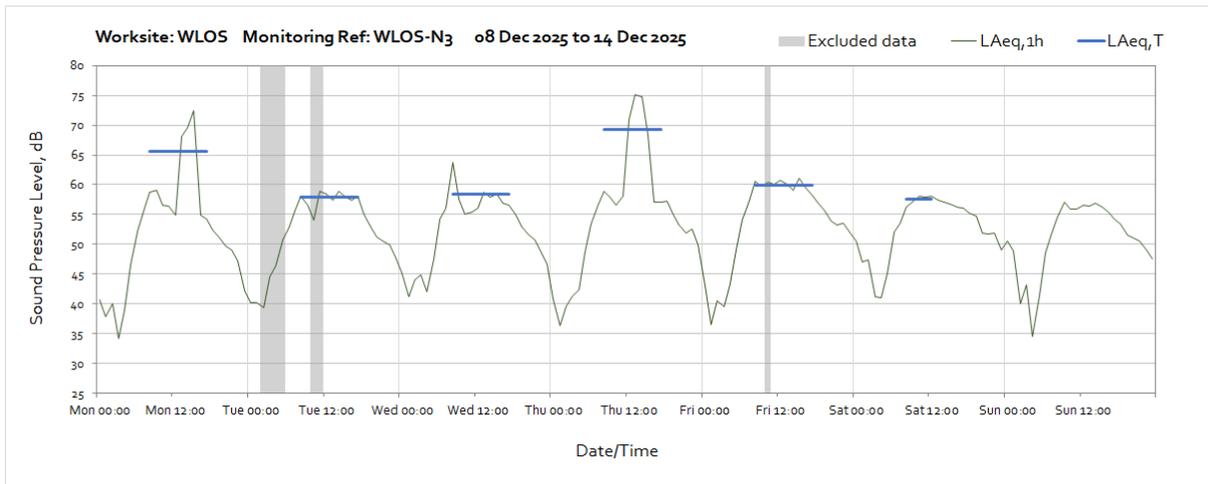
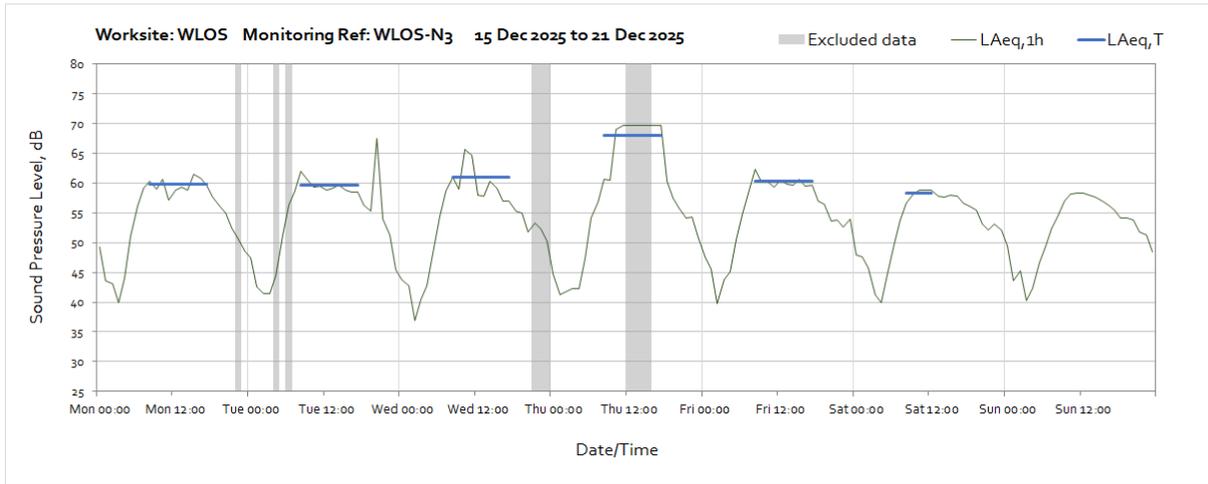
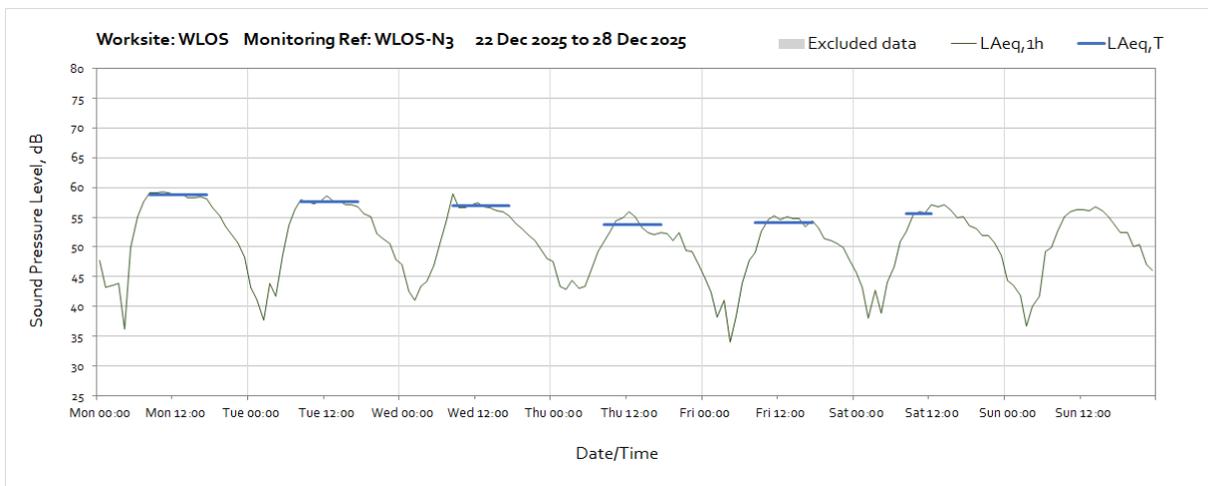
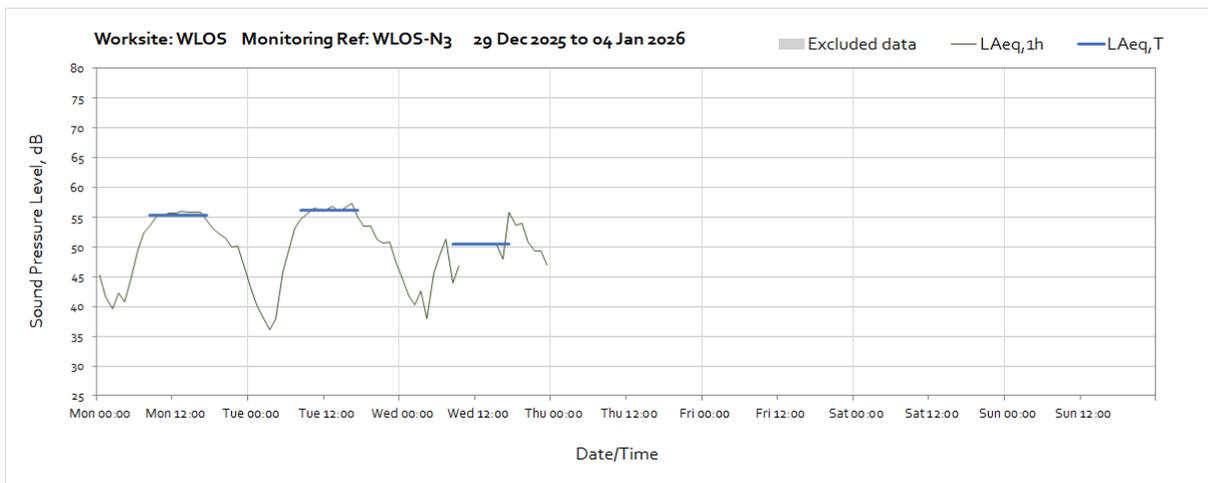
Worksite: WLOS - Monitoring Ref: WLOS-3

Note: Missing data between 10:00 and 13:00 and between 14:00 and 15:00 on wednesday December was due to a system error at the monitoring station.

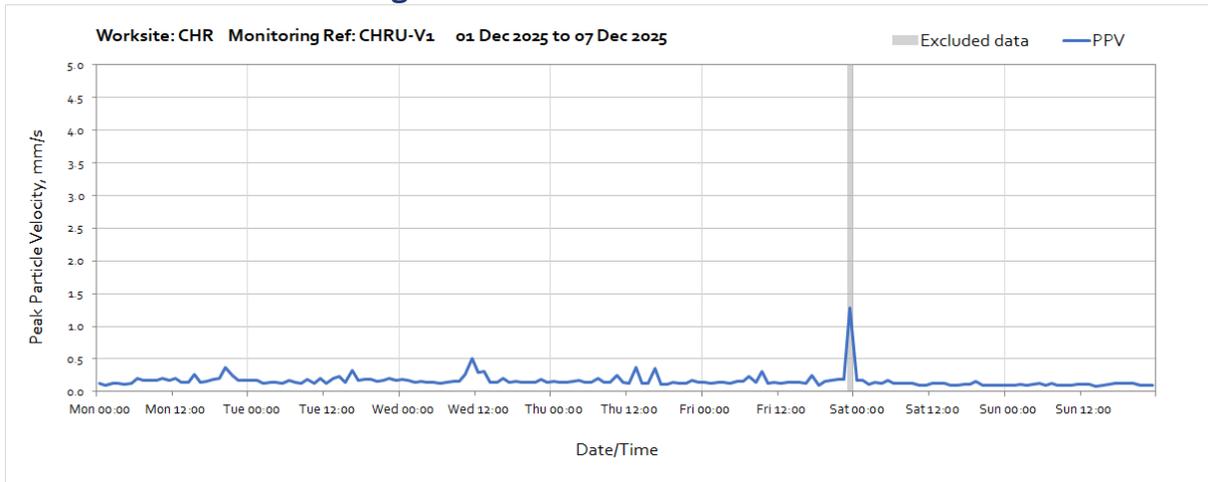
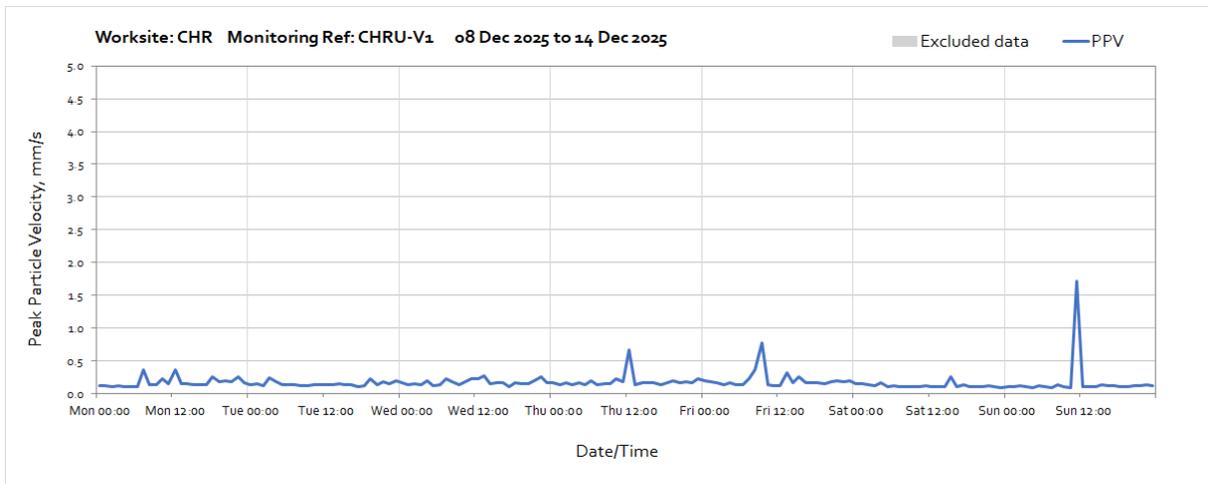
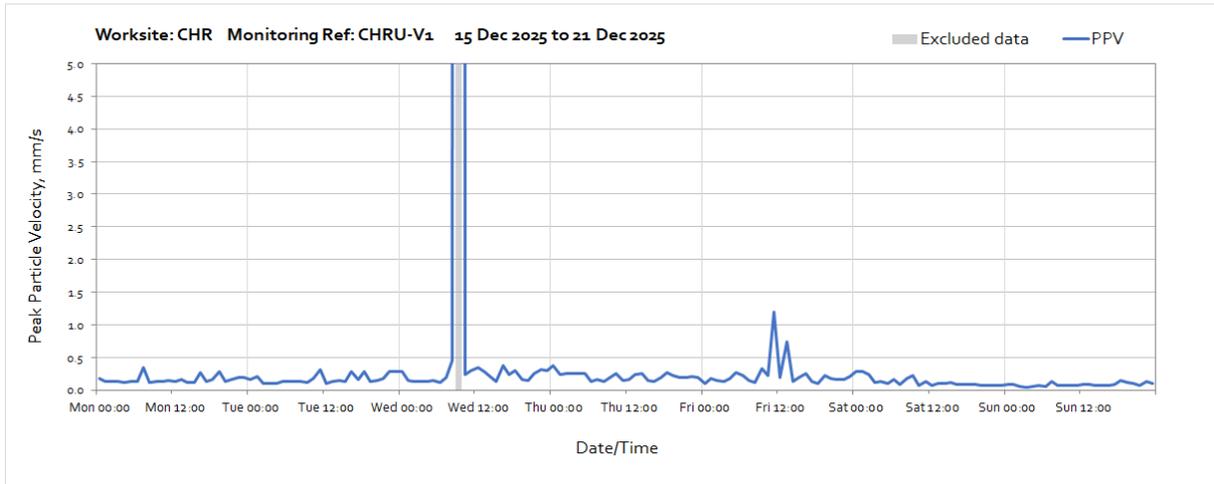
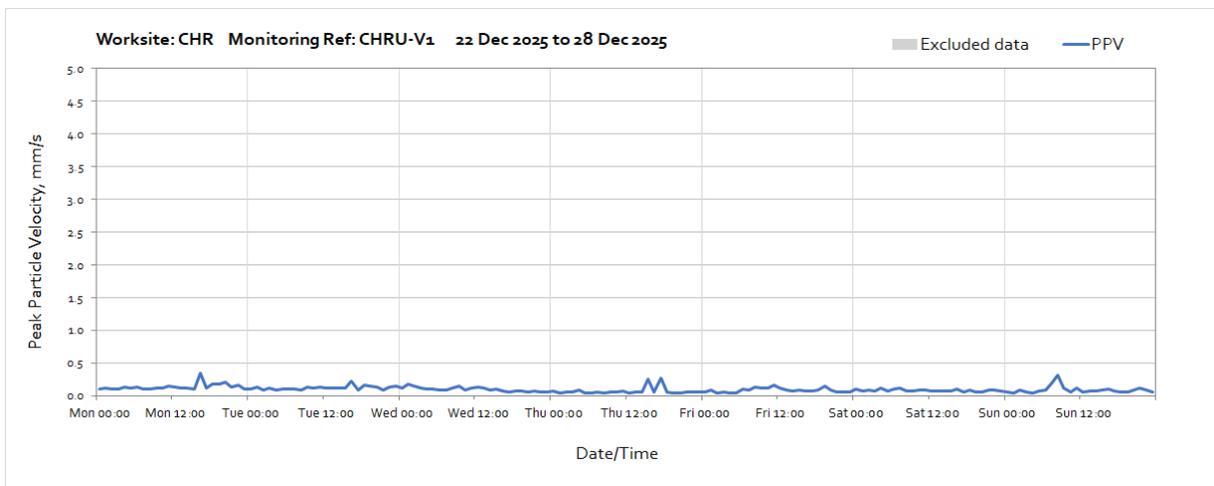
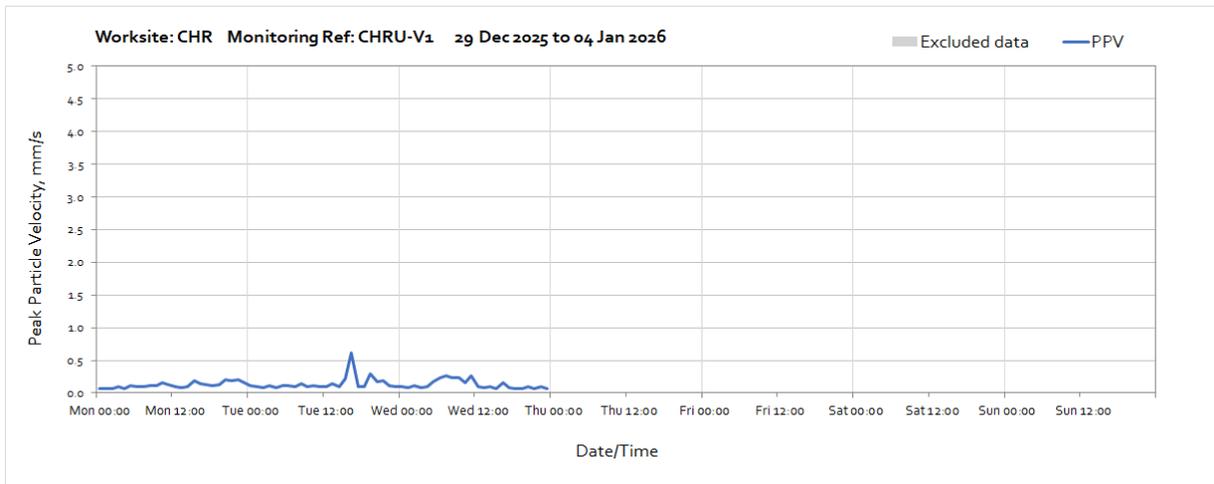
Worksite: CHR – Monitoring Ref: CHRU-V1

The following graphs show the hourly measured peak particle velocity PPV recorded during the monitoring period. The graphs show the highest PPV of the three orthogonal axes x, y and z. Periods where PPV values have been affected by local interference with the vibration monitor or only measured for part of the period, which are not representative of HS2 construction works, have been greyed out and excluded when calculating values in of the main report.

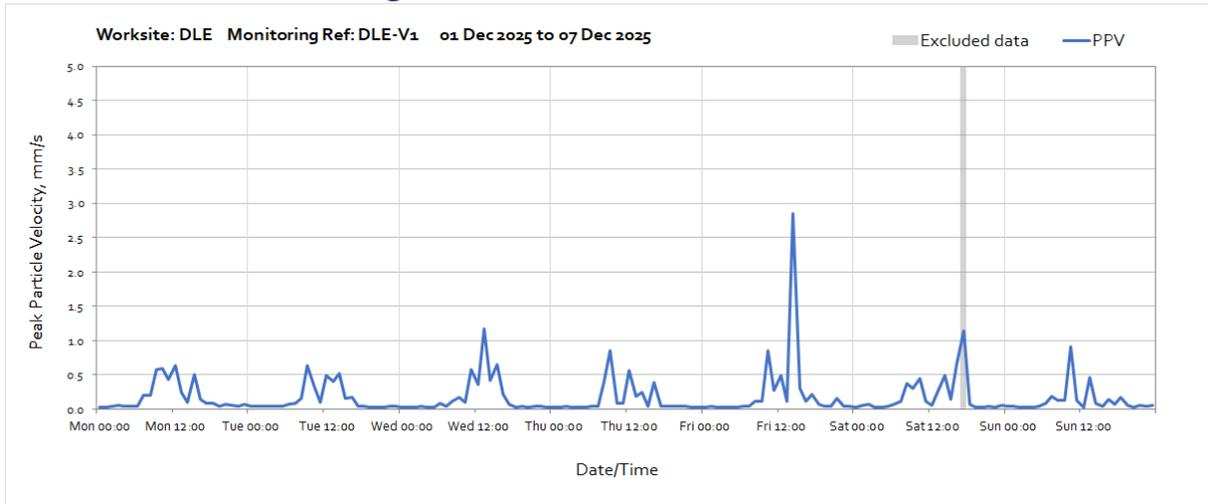
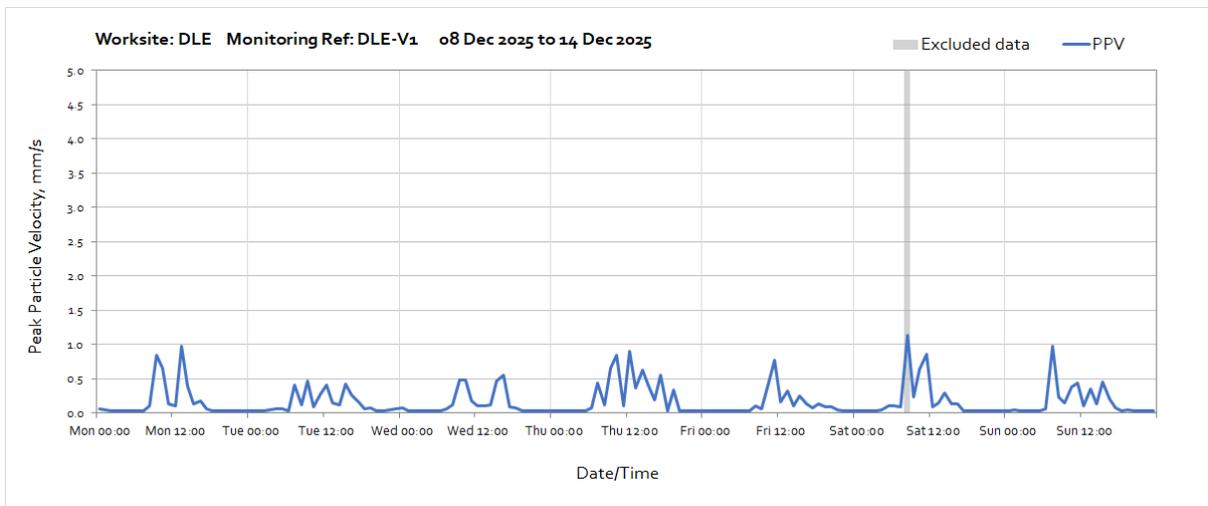
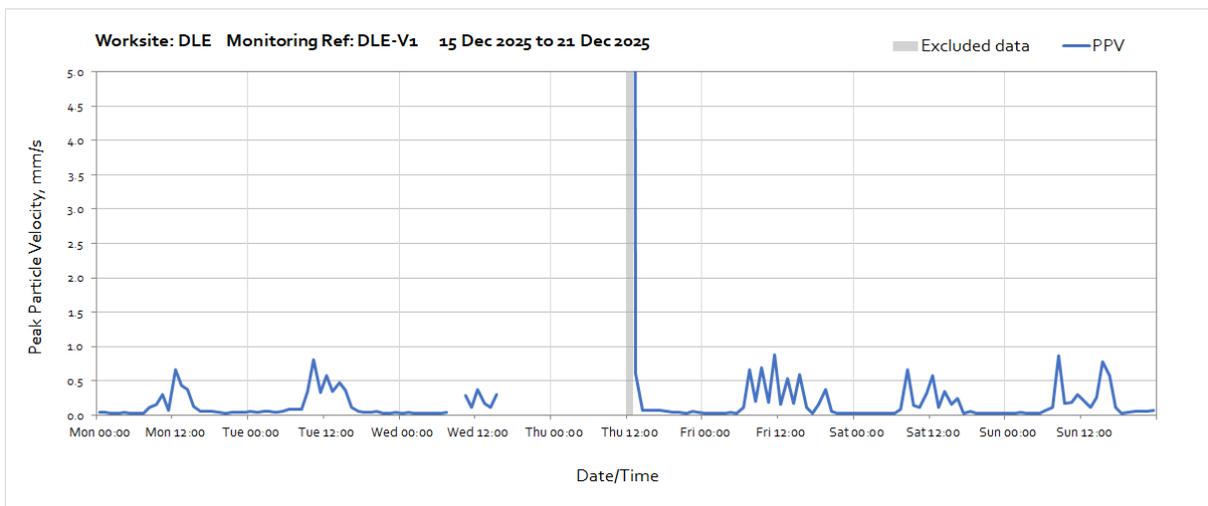
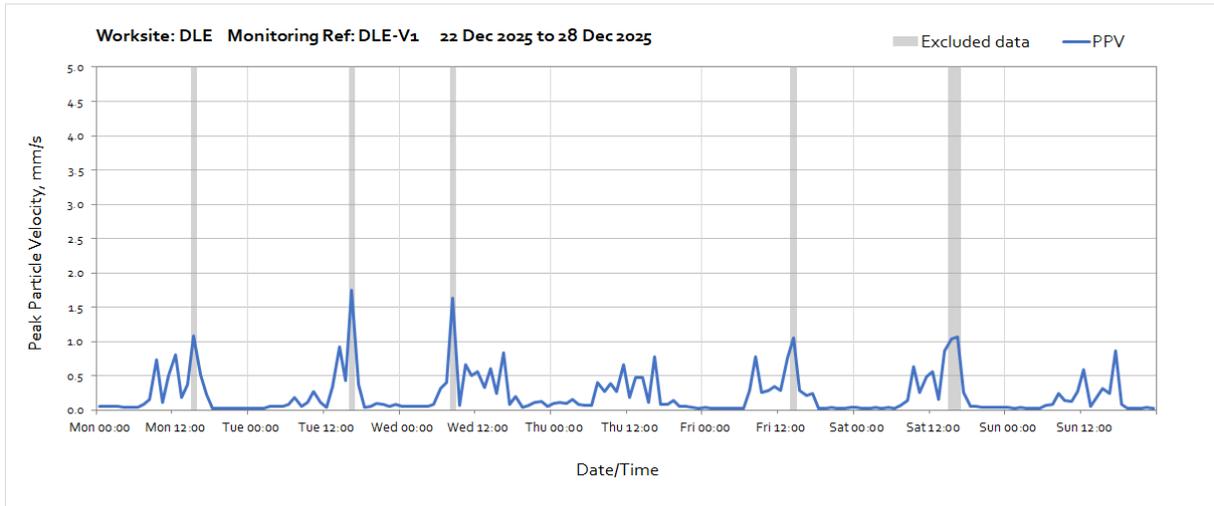
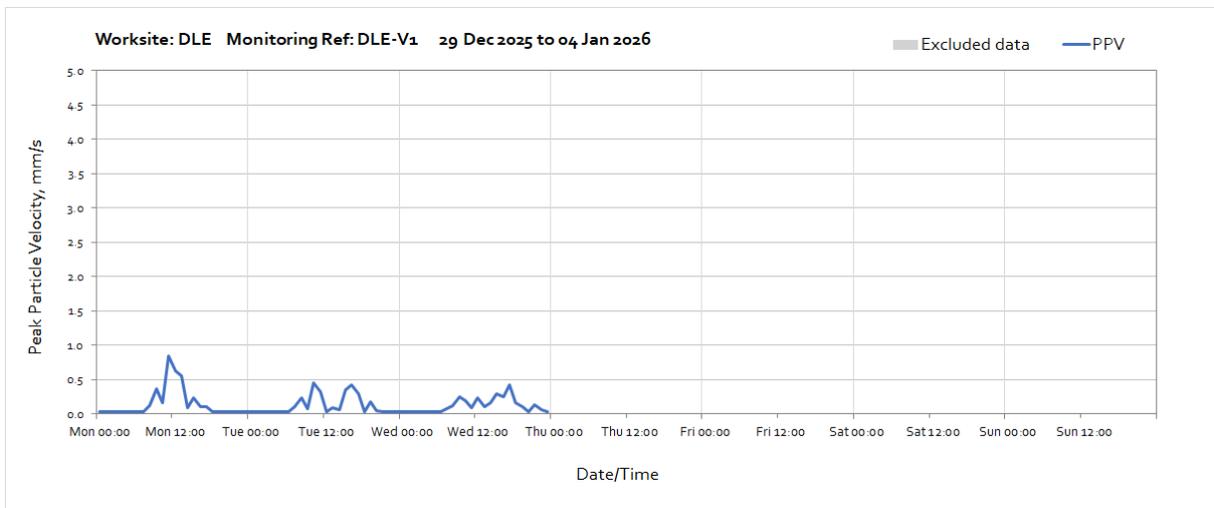
Worksite: DLE – Monitoring Ref: DLE-V1

Note: Missing data throughout the week was due to loss of power at the monitoring station.

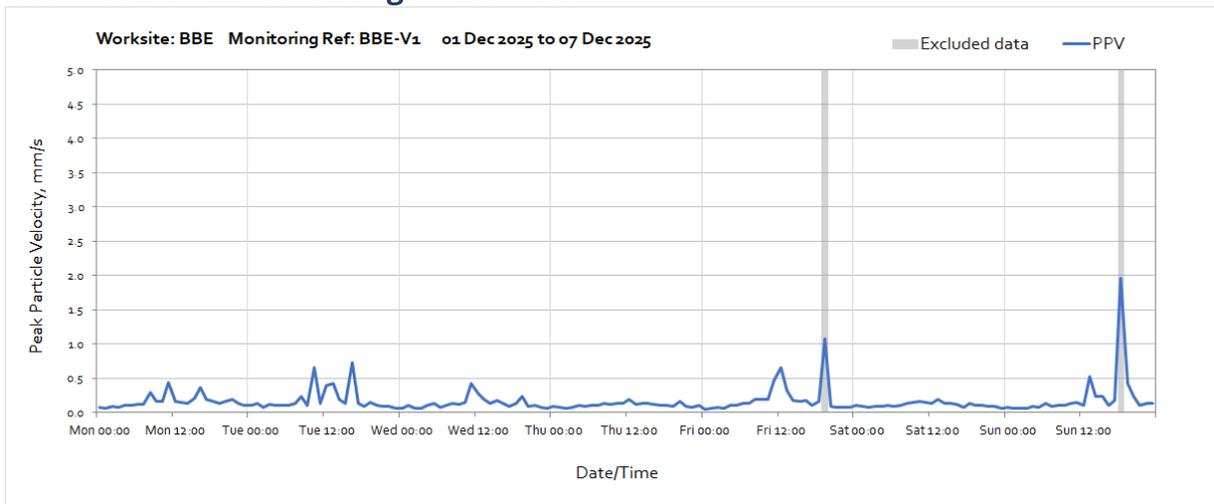
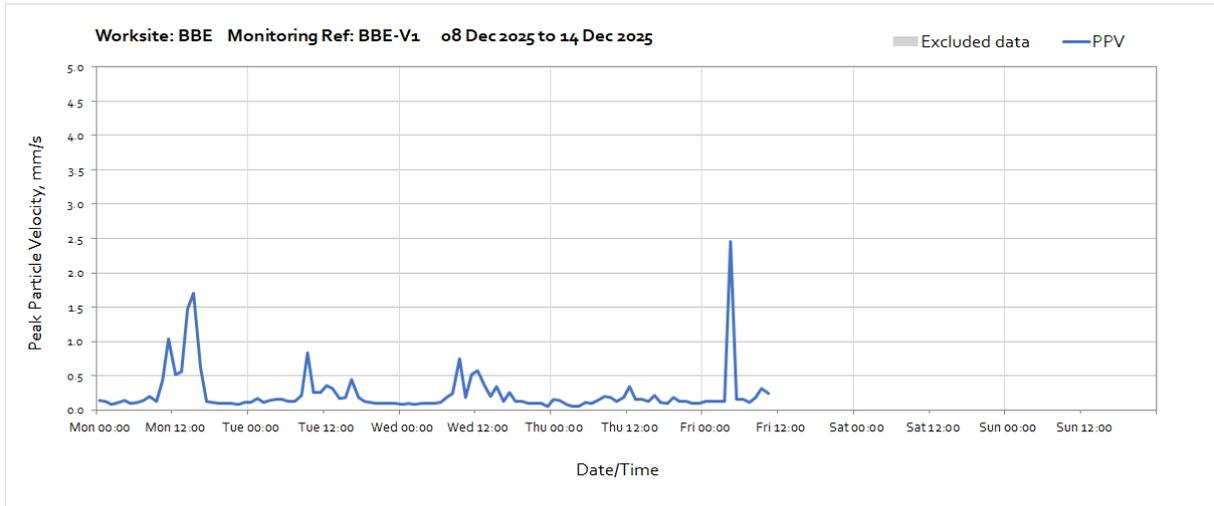
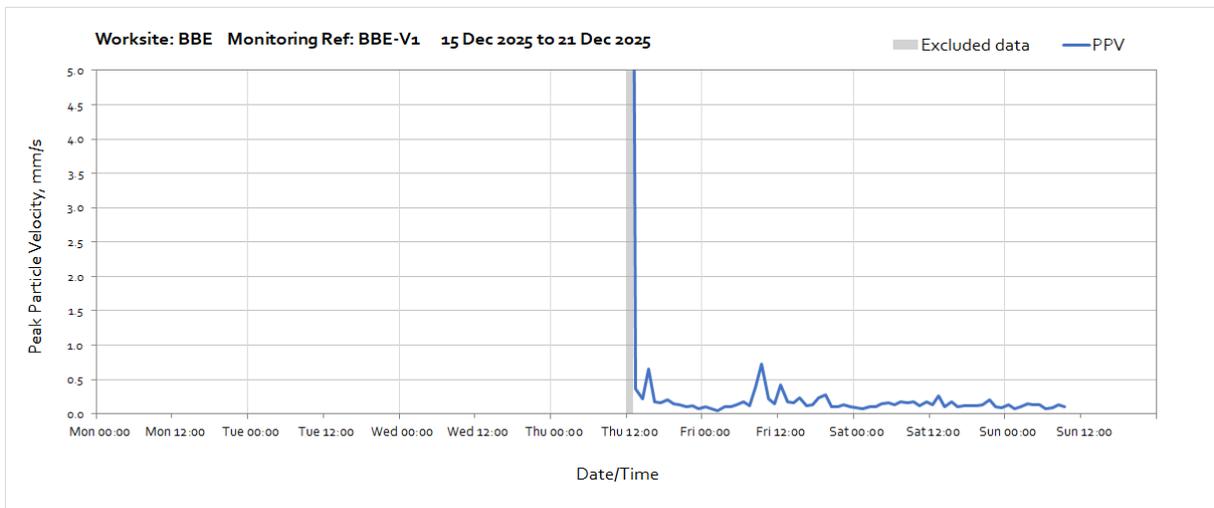
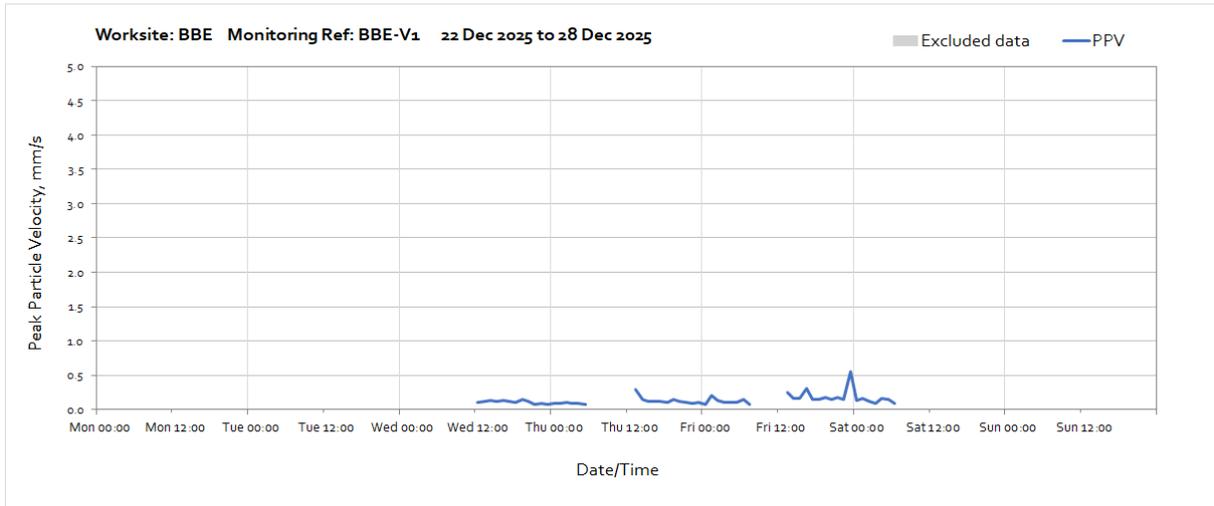
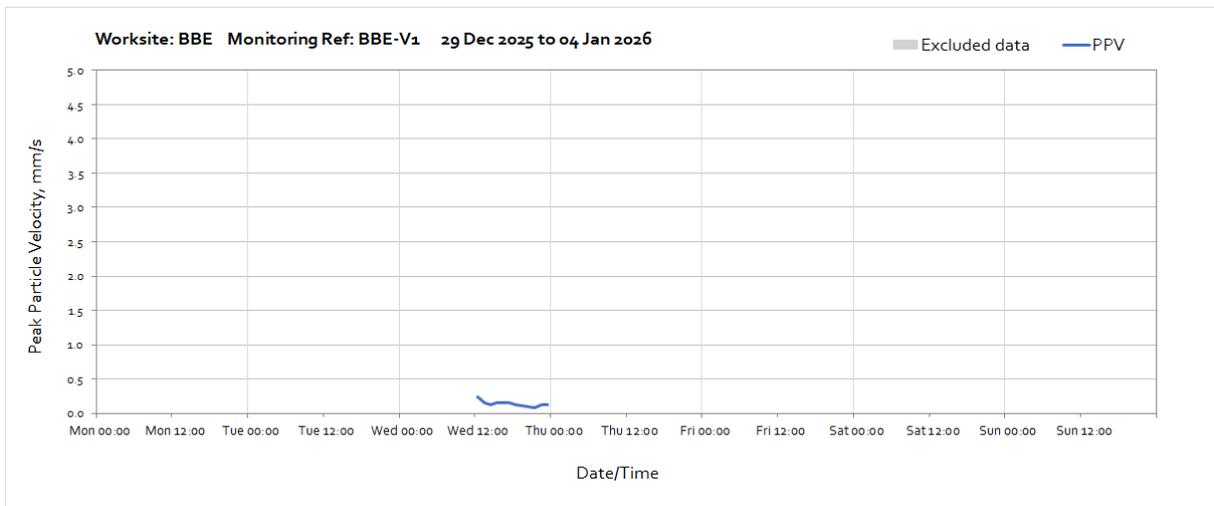
Worksite: BBE - Monitoring Ref: BBE-V1

Note: Missing data throughout the month was due to a loss of power to the monitoring station caused by poor weather conditions preventing sufficient light reaching the solar panel.

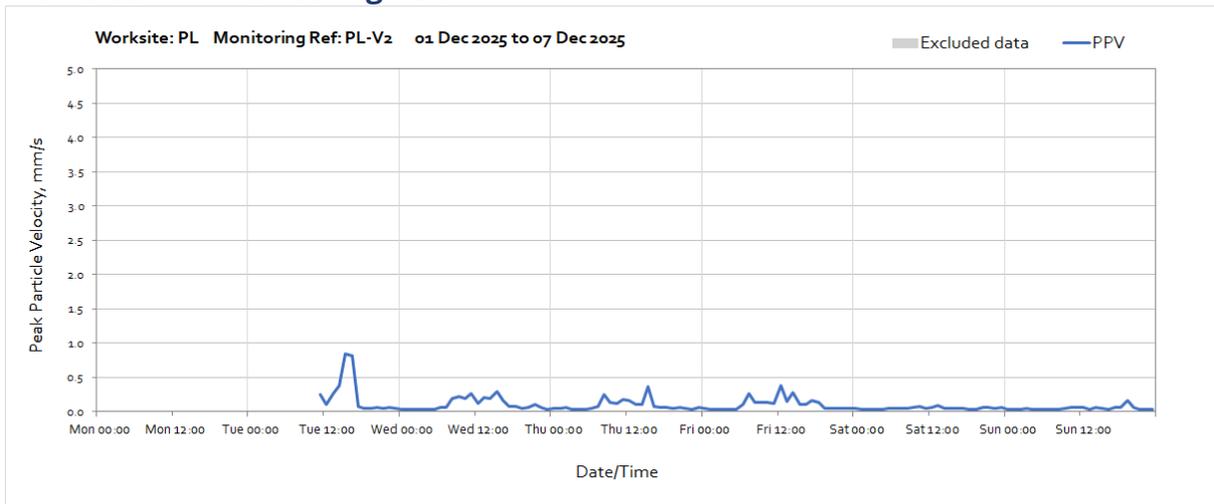
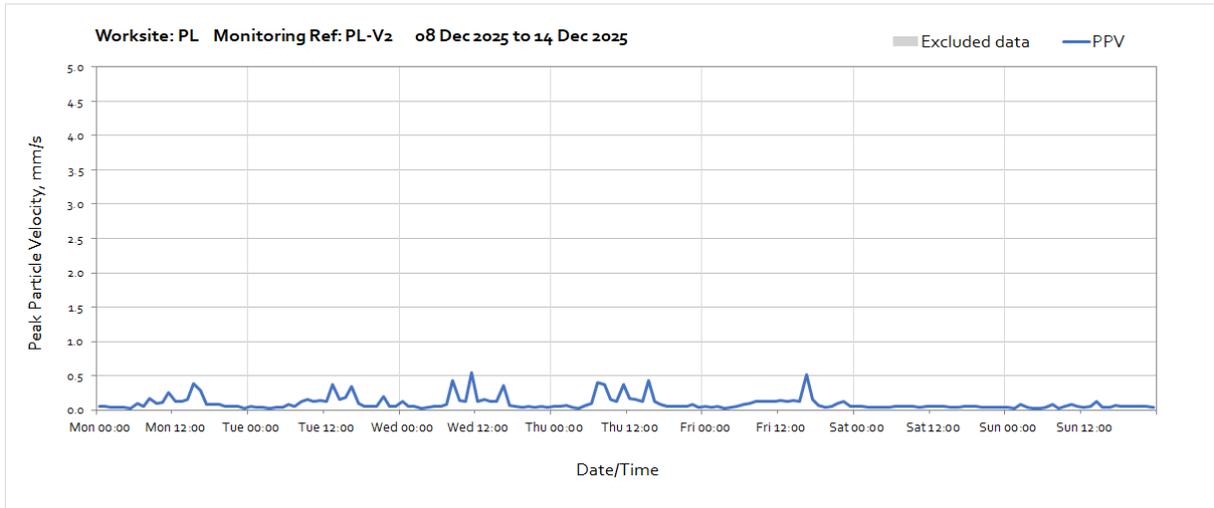
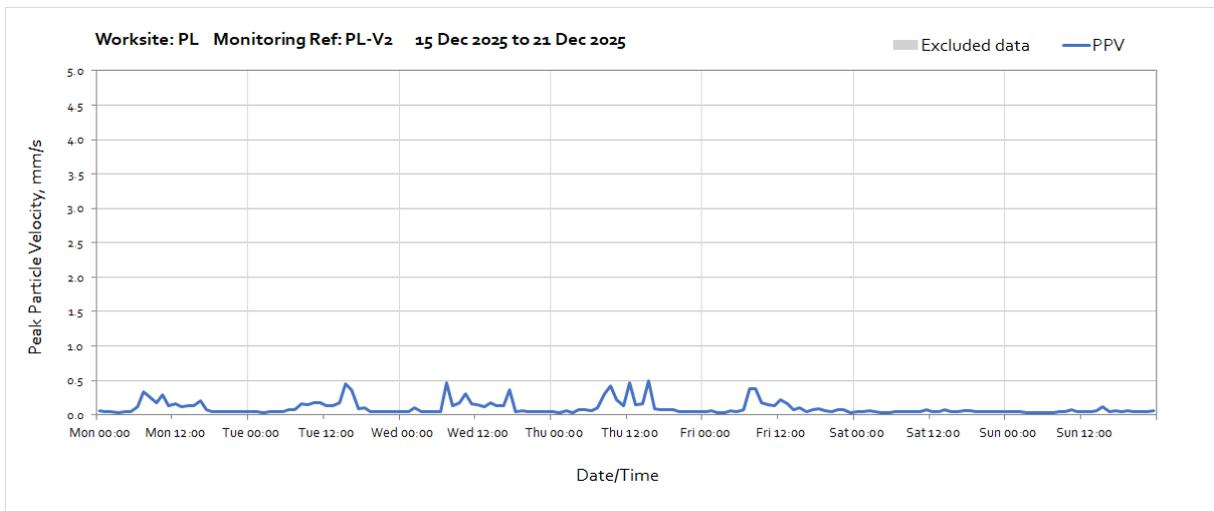
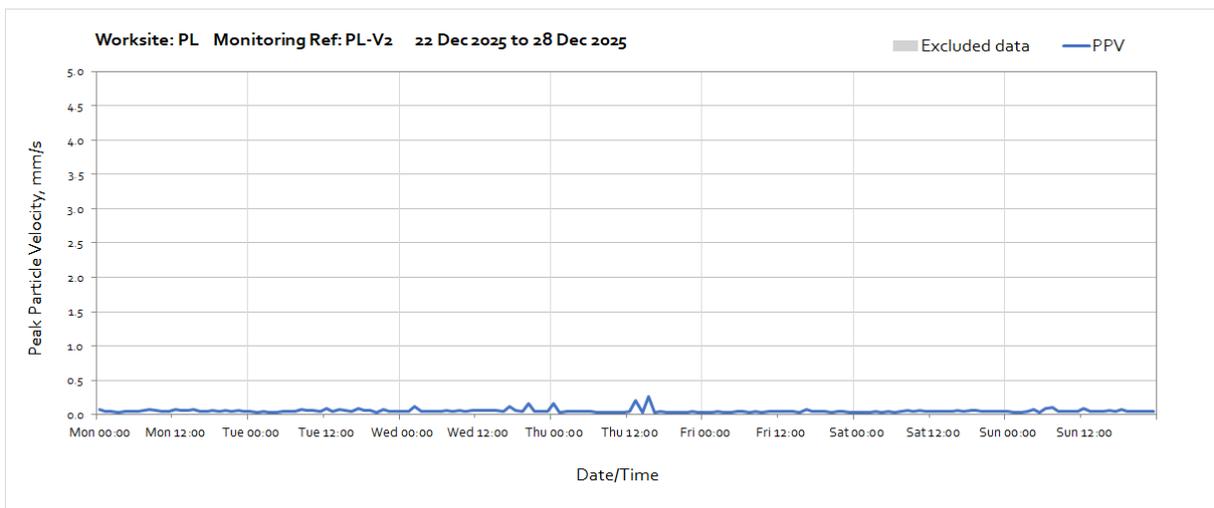
Worksite: PL – Monitoring Ref: PL-V2

Note: Missing data from the beginning of the month until 11:00 on Tuesday 2nd December was due to a signalling error at the monitoring station.

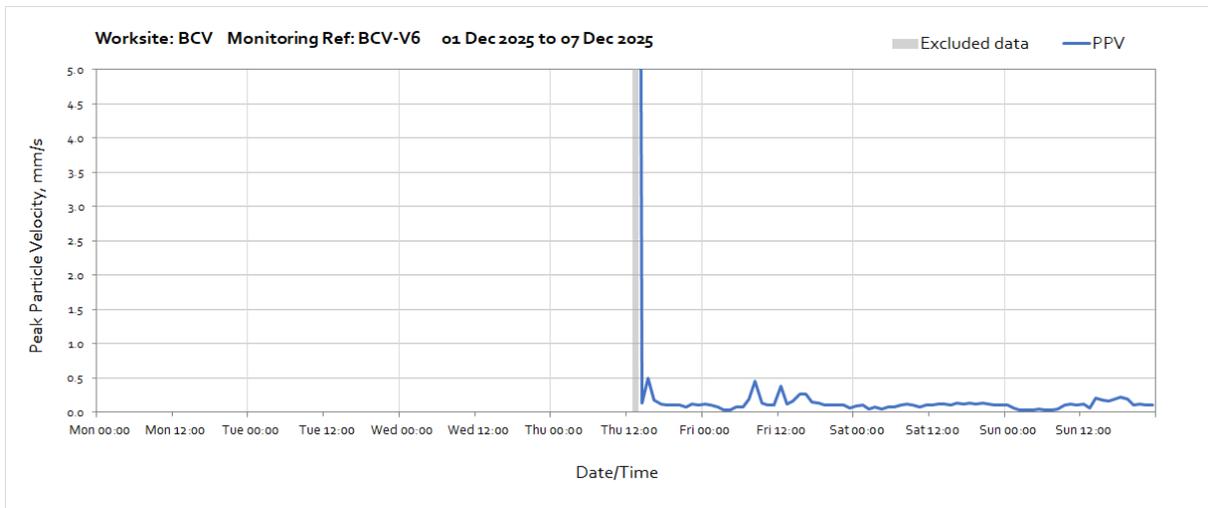
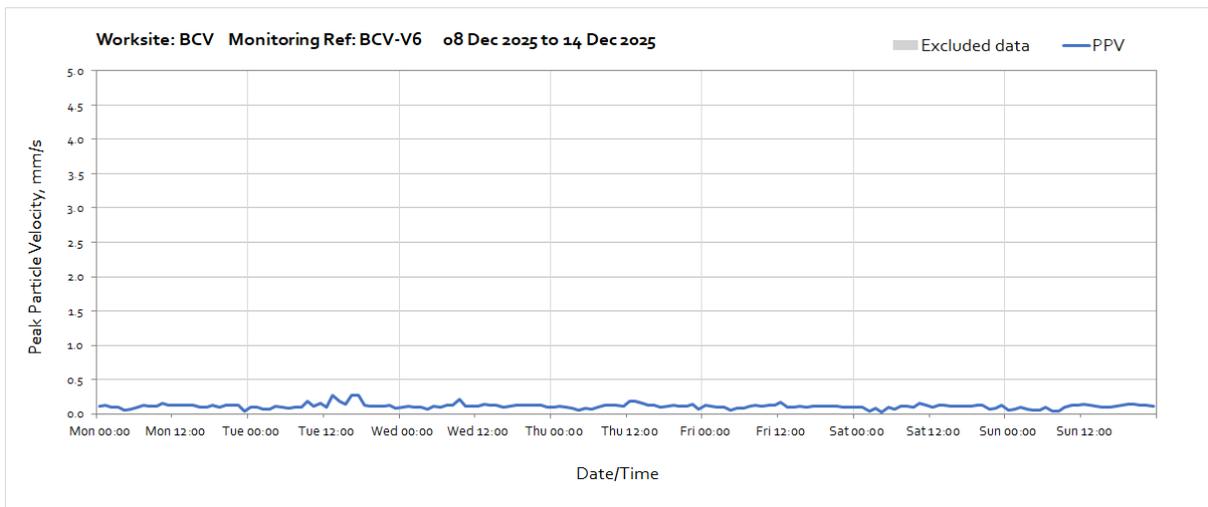
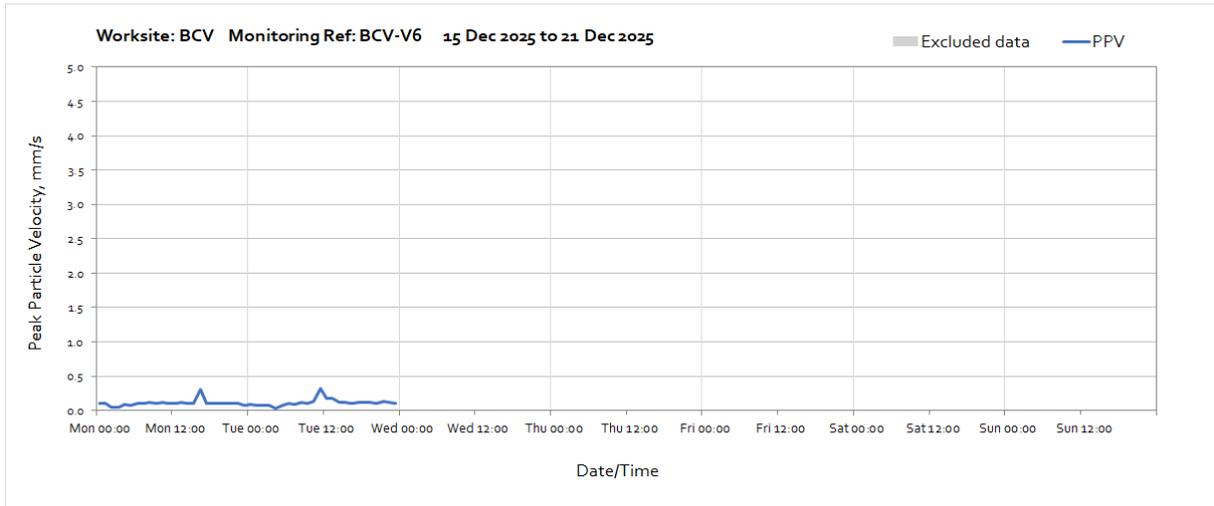
Worksite: BCV – Monitoring Ref: BCV-V6

Note: Missing data from the beginning of the month until 13:00 on Thursday 4th of December was due to a loss of power to the monitoring station caused by poor weather conditions preventing sufficient light reaching the solar panel.

Note: Missing data from 00:00 on Wednesday 16th of December until the end of the month was due to a loss of power to the monitoring station caused by poor weather conditions preventing sufficient light reaching the solar panel.

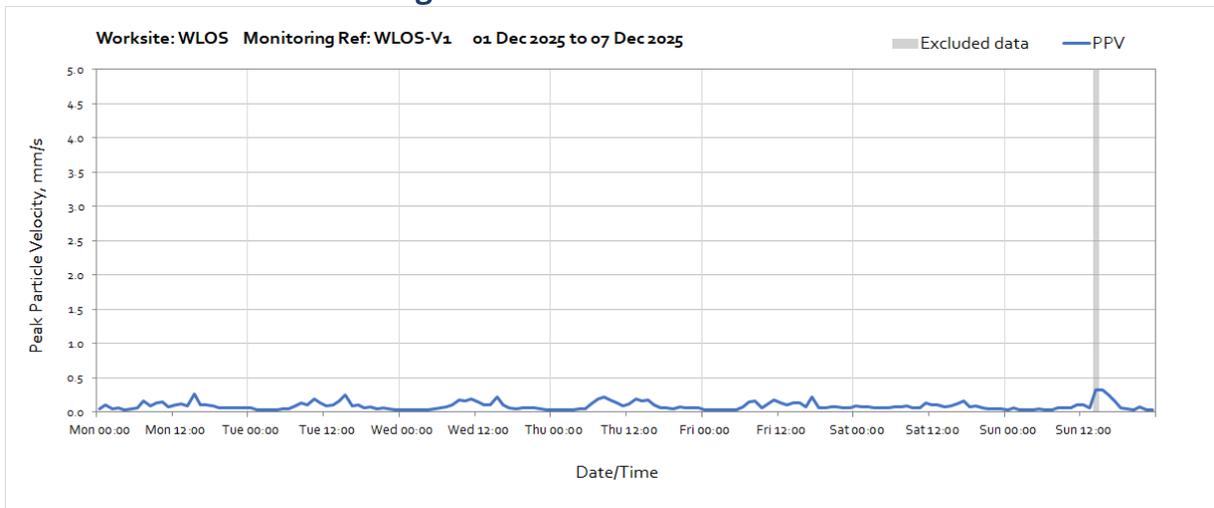
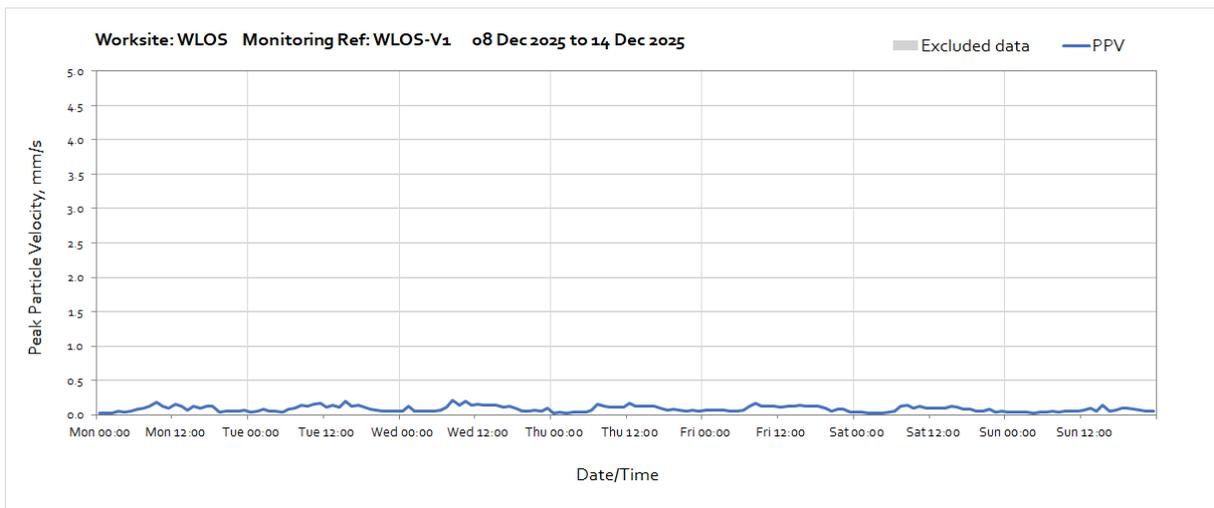
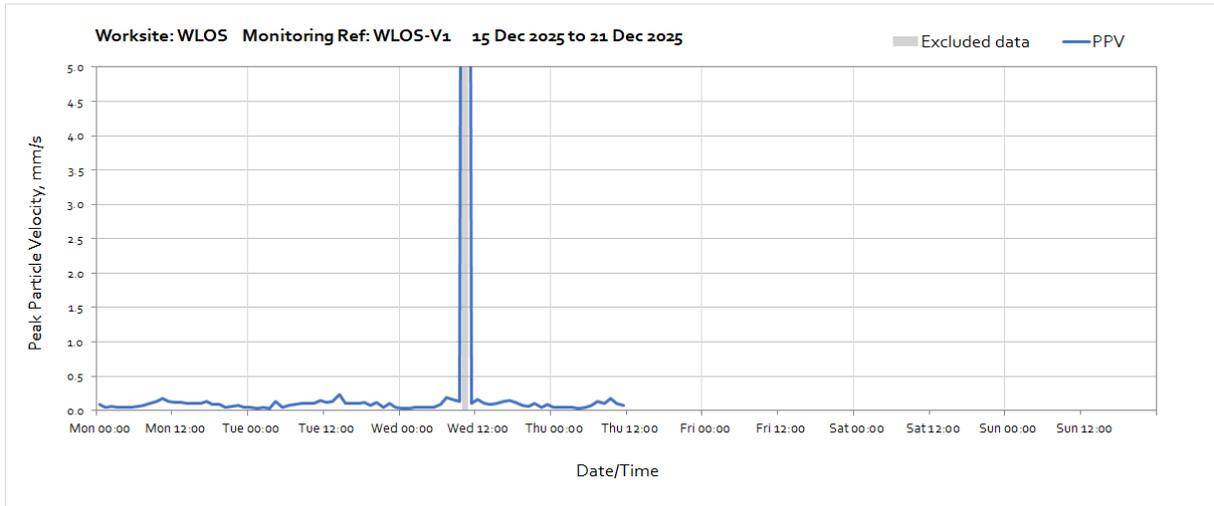
Worksite: WLOS - Monitoring Ref: WLOS-V1

Note: Missing data from 11:00 on Thursday 18th of December until the end of the month was due to a loss of power to the monitoring station caused by poor weather conditions preventing sufficient light reaching the solar panel.

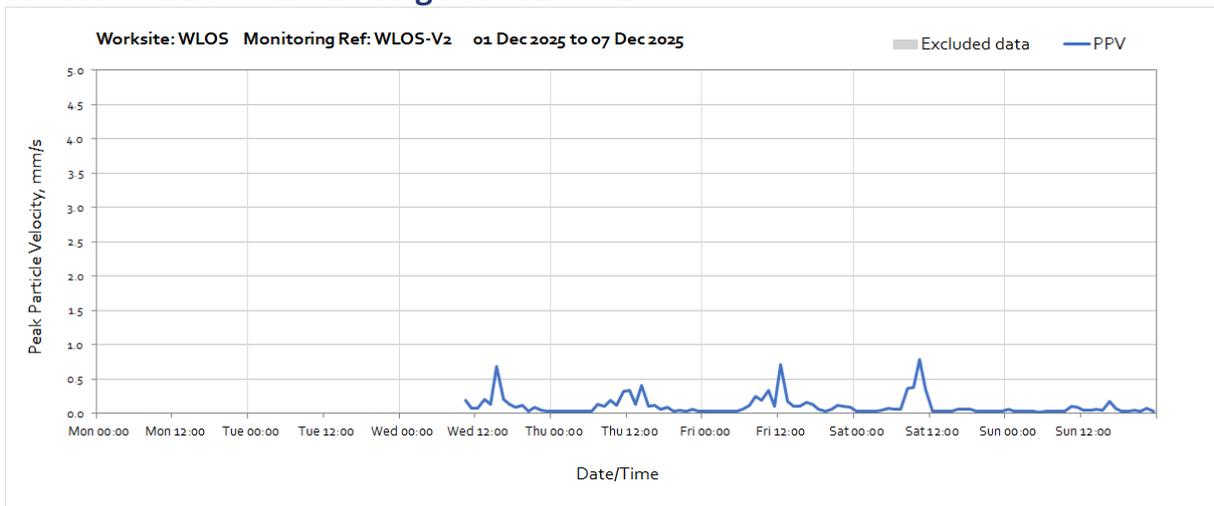
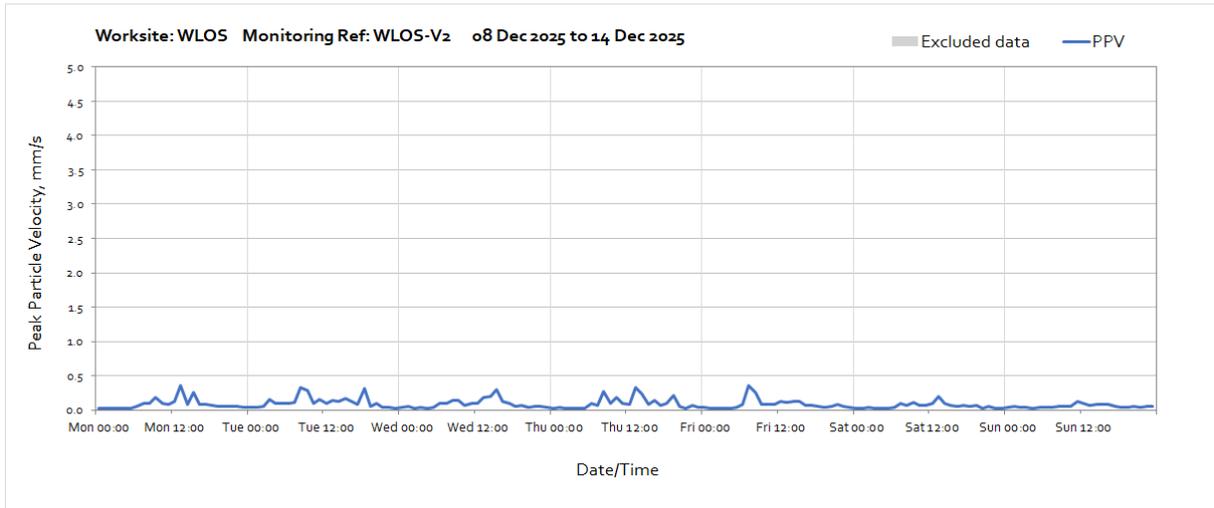
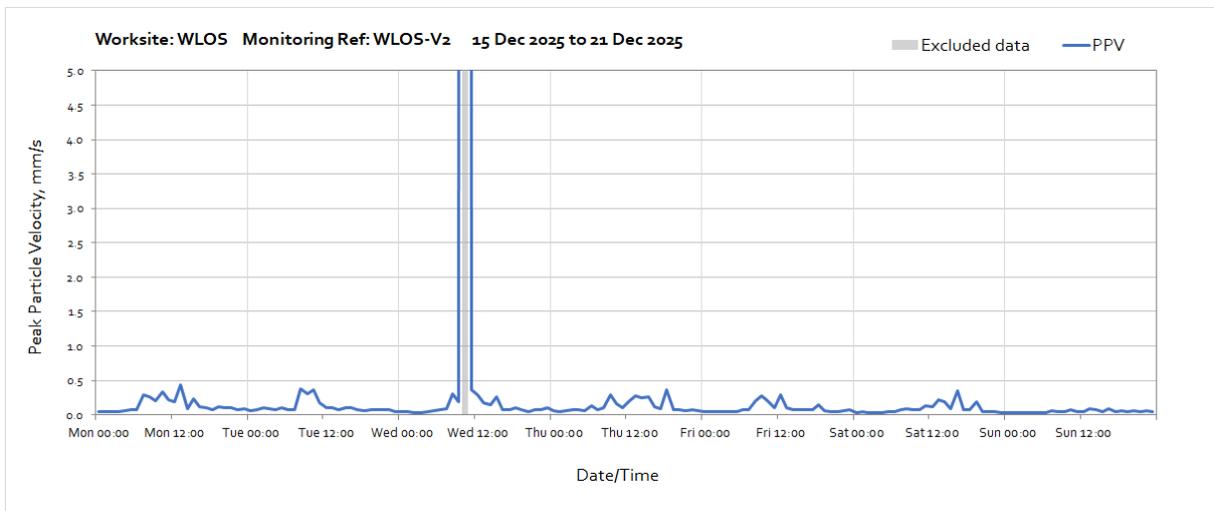
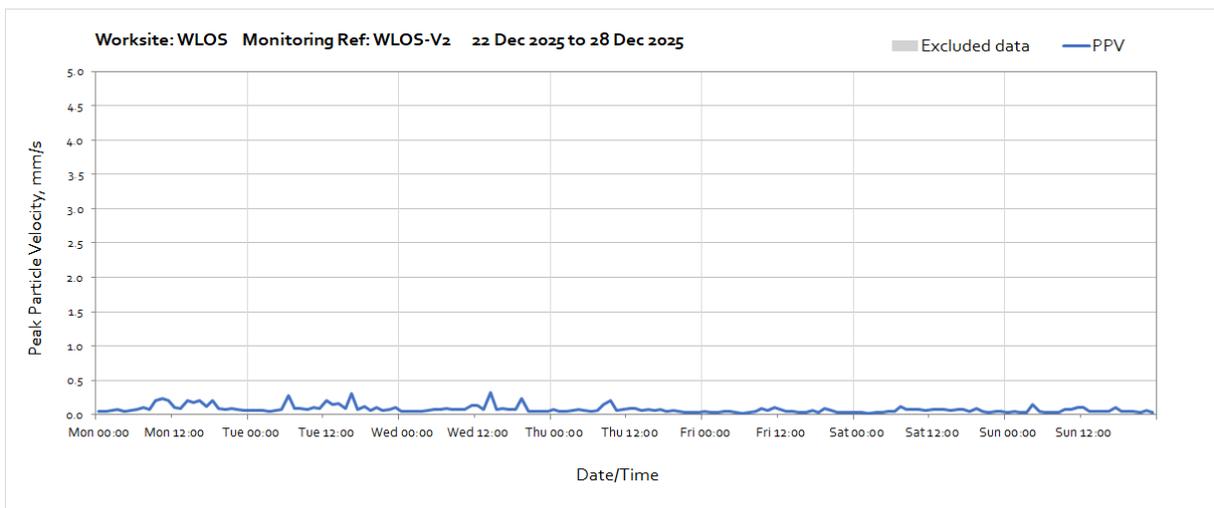
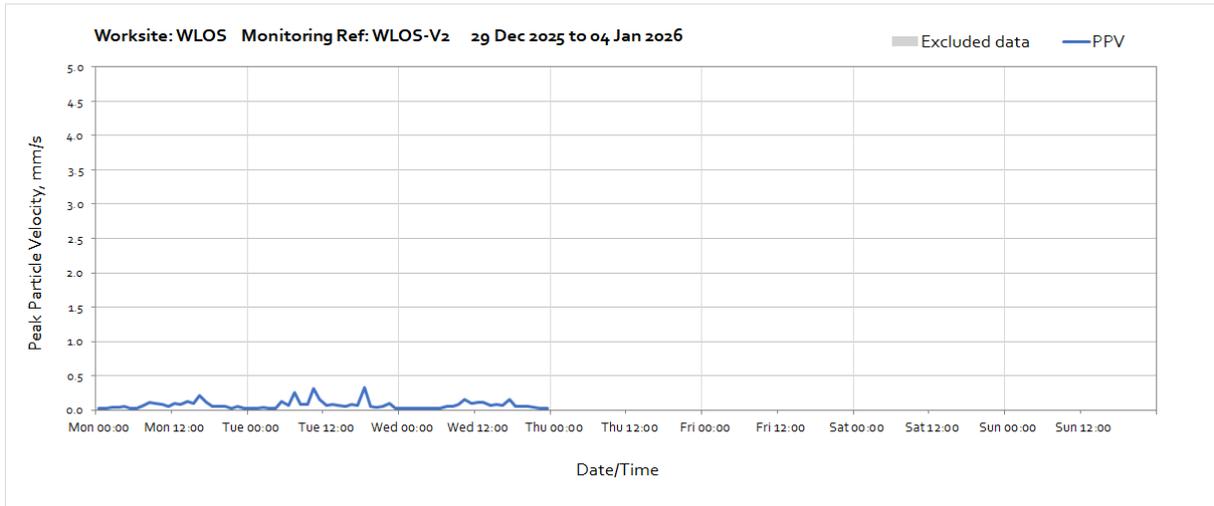
Worksite: WLOS – Monitoring Ref: WLOS-V2

Note: Missing data from the beginning of the month until 10:00 on Wednesday 3rd December was due to monitoring station power supply issues.
