Construction Noise and Vibration Monthly Report – January 2026

Stratford-on-Avon District Council

This Noise and Vibration Monitoring Report fulfils HS2 Limited's commitment detailed in the Environmental Minimum Requirements (EMRs), Annex 1, Code of Construction Practice, to present the results of noise and vibration monitoring carried out within Stratford-on-Avon District Council (SADC) during the month of January 2026.

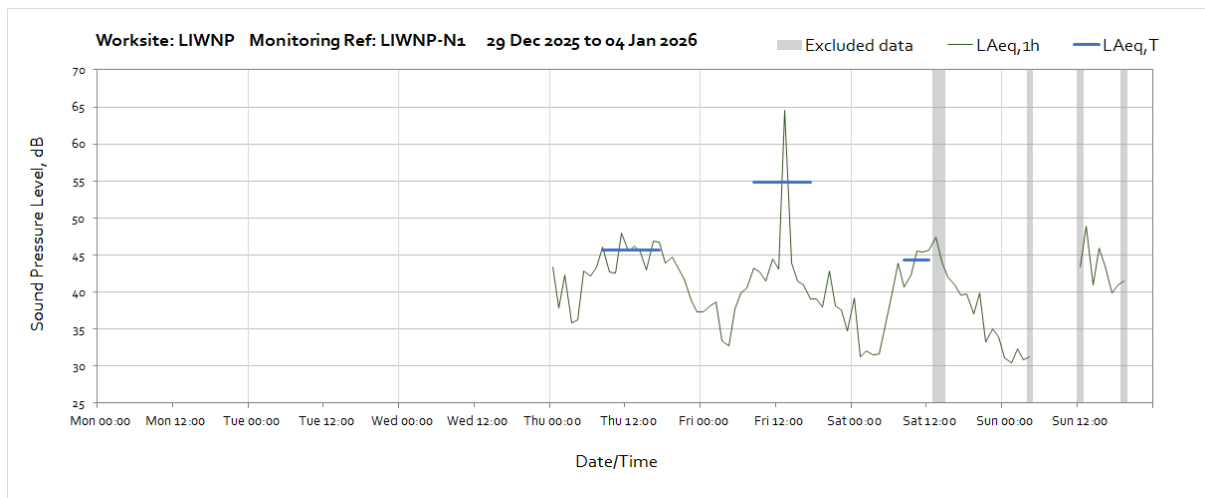
Worksite: LIWNP Monitoring Ref: LIWNP-N1

Note: Missing data between 04:00 and 12:00 on Sunday 4th January was due to loss of power to the monitoring station caused by poor weather conditions preventing sufficient light to reach the solar panel.

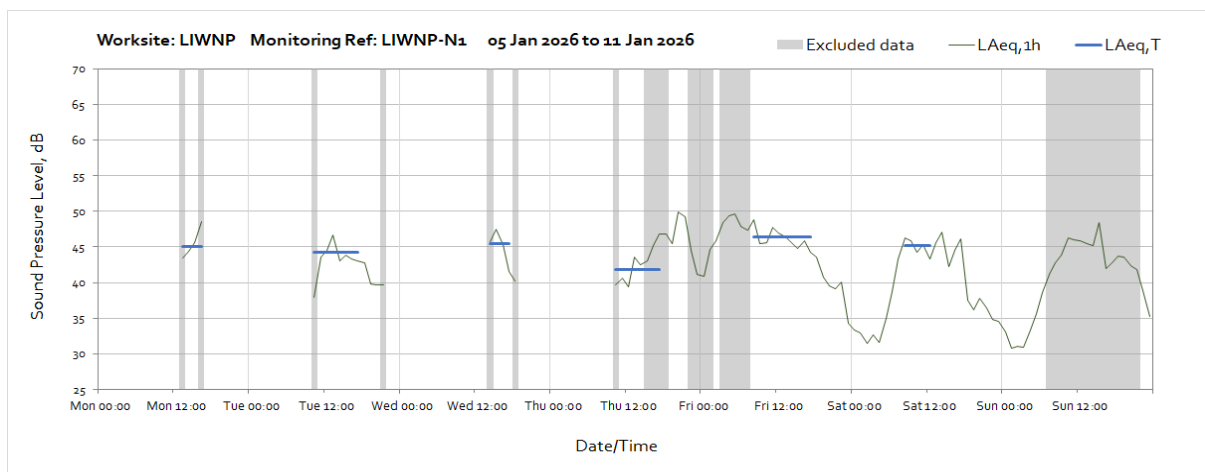
Note: Missing data throughout the week was due to loss of power to the monitoring station caused by poor weather conditions preventing sufficient light to reach the solar panel.

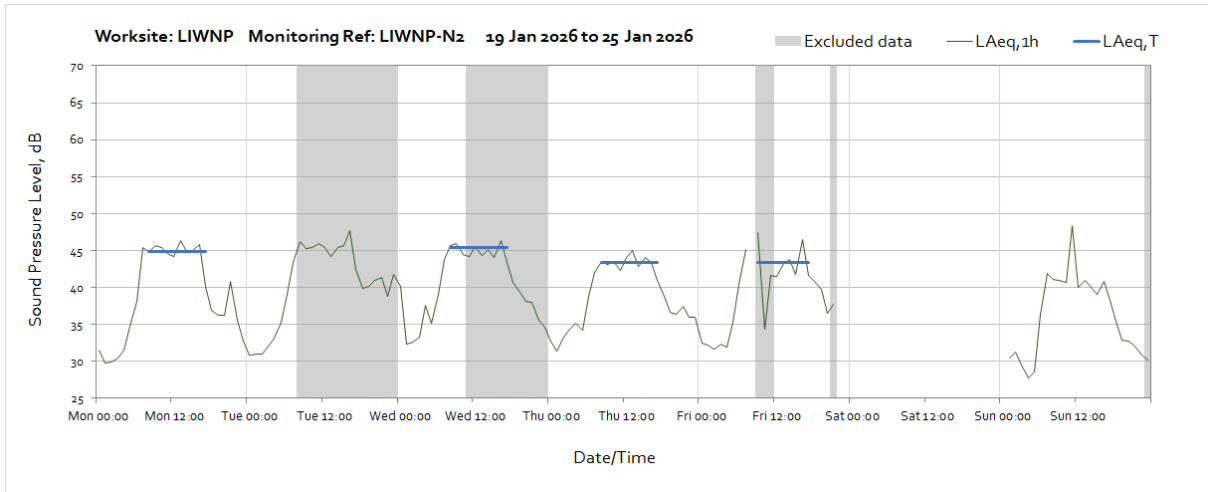
Note: Missing data throughout the week was due to loss of power to the monitoring station caused by poor weather conditions preventing sufficient light to reach the solar panel.

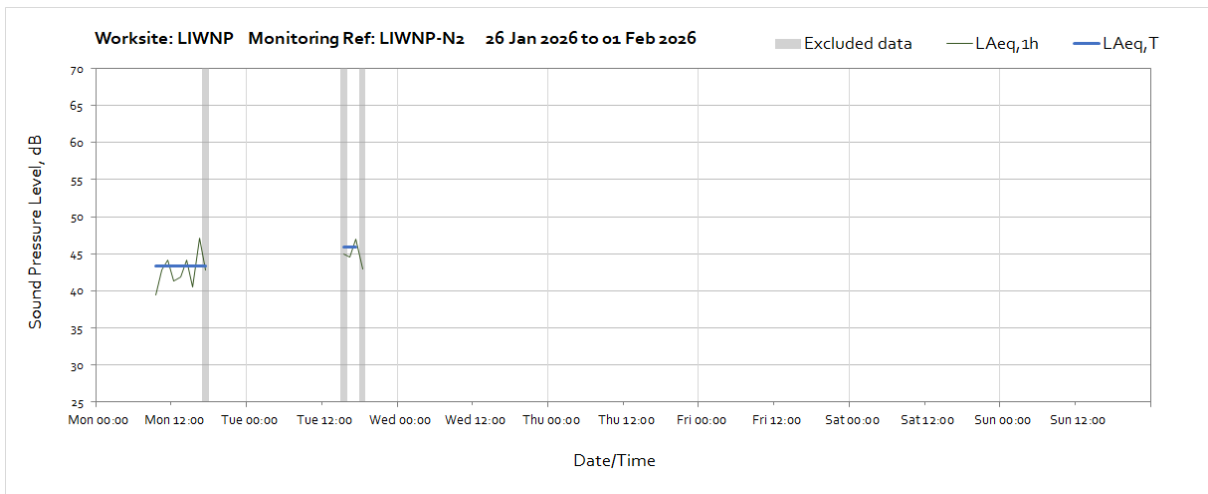
Note: Missing data throughout the week and till the end of the month was due to loss of power to the monitoring station caused by poor weather conditions preventing sufficient light to reach the solar panel.

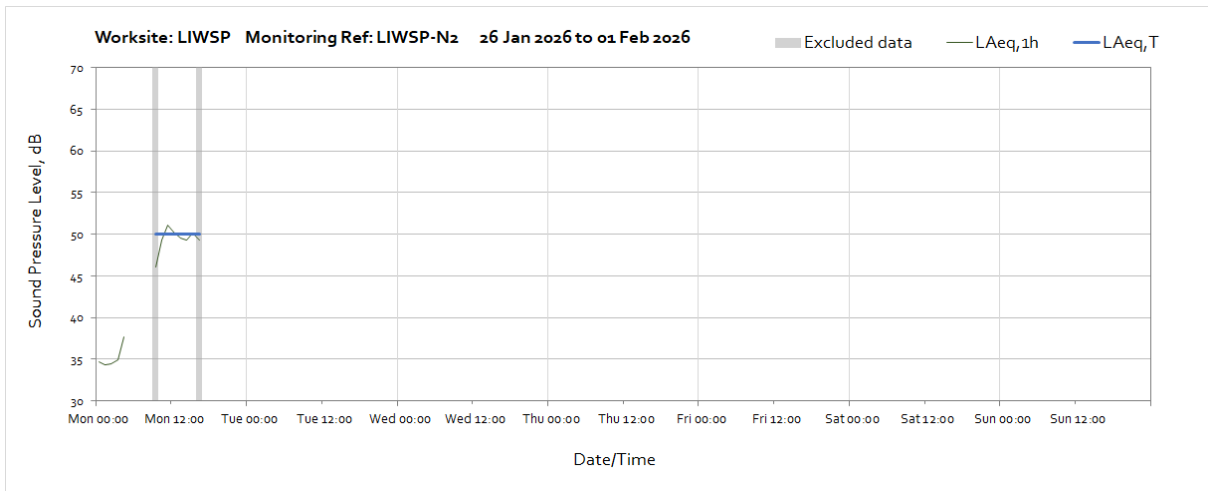
Note: Missing data throughout the week and till the end of the month was due to loss of power to the monitoring station.
