HS2

February 2026

**Construction Noise and Vibration
Monthly Report – February 2026**
London Borough of Camden

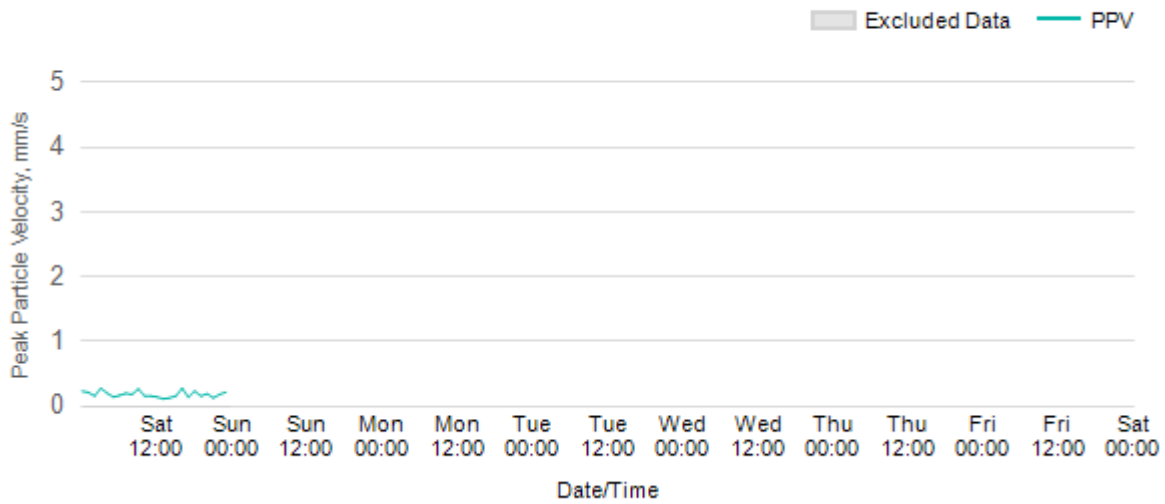
Worksite: Euston Approaches Monitoring Ref: PVS-V001 29 February 2026 to 7 March 2026

The following graphs show the hourly measured peak particle velocity PPV recorded during the monitoring period. The graphs show the resultant PPV due to vibration components on three orthogonal axis x, y and z. Where high values of PPV were caused by local interference with the vibration monitor, which are not representative of HS2 construction works, these values have been greyed out in the following charts and have been excluded to calculate values in Table 4 of the main report.
