Housing Health and Safety Rating System (HHSRS)

Case Studies

Hazard A2
Falling on
Stairs etc.

Example A2.5
Post-1979
Semi-detached House
(non-HMO)

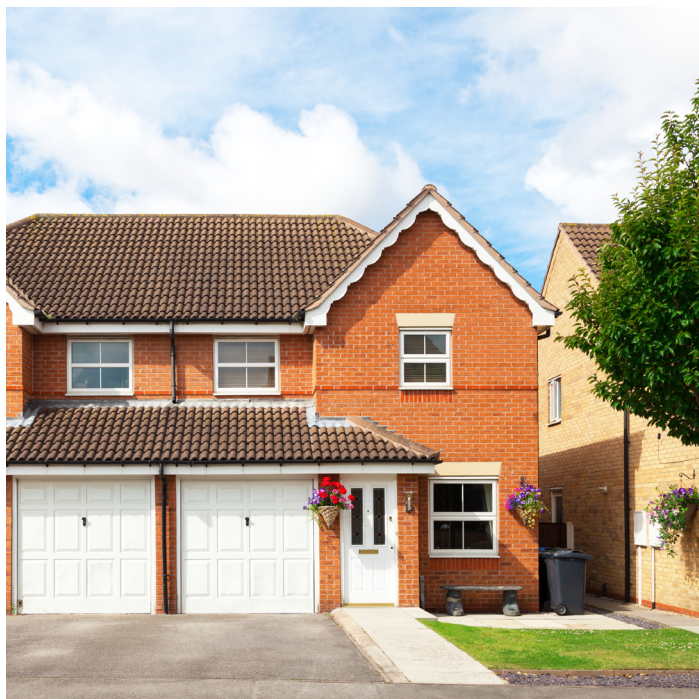
The open-plan grassed area surrounding the four houses slopes gently and there are no obvious hazards. The approach to the front door is down three concrete flagstone steps from the car parking area. There is no handrail, but there is a PIR-operated light in the porch. The risers for these three steps are even, there are no nosings to trip over, and the treads are 450mm.

1
Front exterior view of house
