Housing Health and Safety Rating System (HHSRS)

Hazard A6
Collisions, Entrapment
and Ergonomics

Example A6.3
1920–1945
Third-floor Flat
(Non-HMO)

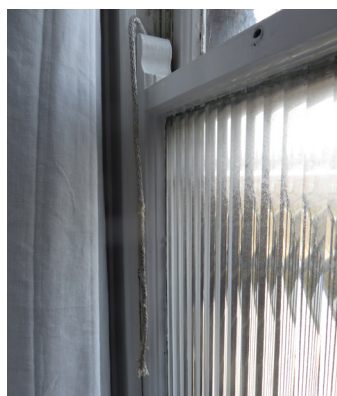
3
Close up of single glazed
sash window in living room

Living room windows: In each window, the two large sliding sashes comprise a thin frame, each carrying two large panes of single glazing. All the sash cords are threadbare, and in one window the cord holding one side of the lower opening light has snapped. This window can still be opened and will remain open due to the one remaining counterweight and the friction resulting from the consequent tilting of the frame. In summer, both windows are regularly left open as the living room faces due south and is prone to overheating. The glass is not safety glass, and there is no form of restrictor to the window.

National average for likelihood and spread of harms following works to comply with baseline indicators. Compliance with baseline indicators should leave the sash windows in good working order with a restrictor to prevent the sash window being opened more than 100mm without positive action to disengage the restrictor.
