Housing Health and Safety
Rating System (HHSRS)

Hazard B13
Indoor
Air Pollutants

Example B13.2
1920-45
Single-storey
House
(Non-HMO)

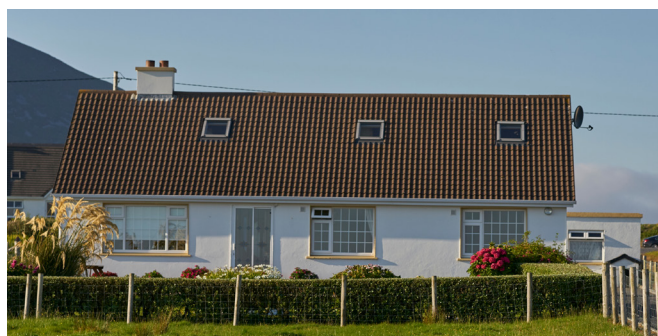
1

Front exterior

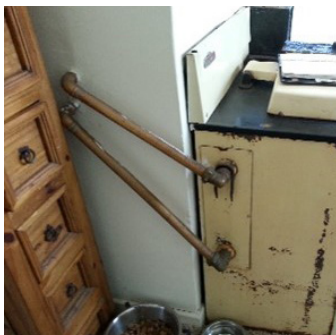
Heating provision for the property is via a solid-fuel stove in the kitchen-diner. The stove has a vertical flue and no cowl, and heats radiators in the bedroom, living room and bathroom. The fire clay around the base of the flue is badly cracked and loose. The flue itself vents into the chimney stack but is in a poor condition, as are the seals around the oven and fire-box doors. There are no instructions for the use of the stove, and the tenant is under the impression it can burn any wood, coal or coke available. There are no airbricks or trickle vents in the windows and no mechanical extract ventilation.

No carbon monoxide alarm had been provided at the time of the inspection. The stove is used continually, apart from in the summer, as the main heating source as free fuel is available to the tenant. There are no service records for the stove.

2
Solid fuel stove in kitchen

The requirements set out in BIs 15.4 and 15.6 should be implemented, ensuring the solid-fuel appliance is compliant with relevant standards and is properly maintained, and includes the provision of sufficient air flow to the room hosting the appliance and extract ventilation in both kitchen and bathroom. Trickle vents would also be installed in the windows for background ventilation. The occupiers will be alerted to any carbon monoxide emissions by the presence of a detector, as required by BI 19.5. These measures will reduce the likelihood of a harmful occurrence significantly and return to the class of harm outcomes to the national averages for the dwelling type and age. The score will not however return to the average as the lack of instruction leaves the occupant vulnerable to sub-optimal use, which has the potential to increase the levels of combustion products and reduce the efficiency of ventilation. There is a lack of lobby between the garage and the living accommodation.

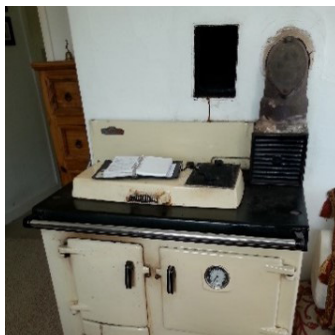
3
Close up of stove front

There are no instructions for the use of the stove, nor are there any details of the correct material to burn on it, and it doesn't have any servicing records. The use of inappropriate fuels may be less efficient in terms of combustion, leading to increased levels of by-products.

The current occupiers should be provided with an instruction manual for the solid-fuel appliance and general advice should be given regarding optimum use of the appliance. This information should be provided to each new tenant.

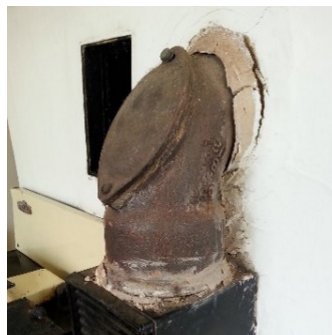
4
Cracked clay around base
of flue

The solid-fuel stove, being the heating source for the dwelling, is in constant use for the majority of the year. Unfortunately, this stove has not been maintained sufficiently and is in a state of disrepair. The fire clay around the base of the flue is badly cracked and loose. The flue itself is in poor condition, as are the seals around the oven and fire-box doors. The lack of a cowl to prevent backflow due to weather conditions and the disrepair to the flue means that there is an increased likelihood that combustion by-products will be released into the indoor environment.
