Housing Health and Safety
Rating System (HHSRS)

Hazard B15
Asbestos and
Manufactured
Mineral Fibres

Example B15.2
1946-79
Pre-fabricated
Bungalow

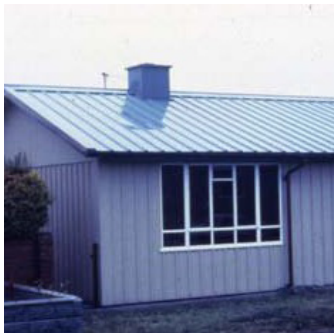
1
Front exterior

This is a 1950s prefabricated semi-detached bungalow. The bungalow has a new lightweight roof and fully insulated loft. Internally, the property has been improved over the years, with modern electrics and a gas-fired central heating system added. It is rented by an elderly couple.

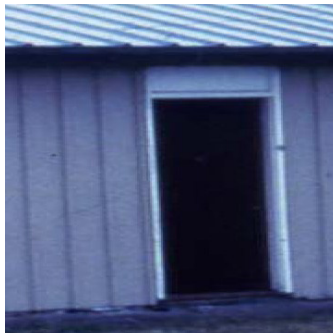
2
Close up of property front
door

The external asbestos sheet wall panels have been damaged in several places, causing pieces to fall off and break down. Where the base of the wall panels has broken or is missing, fibrous material has accumulated on the ground. This has occurred in several places on the ground and paths around the bungalow, including near the front door.

Although the loose material is located externally, it is in several places including close to the front door. As a consequence there is an increased risk of inhaling asbestos fibres from damaged wall panels and the base plate when entering and leaving the property as well as while gardening or undertaking external home maintenance tasks. There is also an increased risk of inhalation when sweeping up fibres that have accumulated on paths around the perimeter of the property, although fibres will disperse in the external air. There is a risk of disturbed fibres entering the property through open windows and doors, including being walked into the property on footwear or asbestos-containing materials carried in, thereby increasing exposure. Whilst the risk of contracting lung disease within 12 months is low, exposure to asbestos fibres throughout the year could cause disease to occur later in life as there is no safe level of exposure.

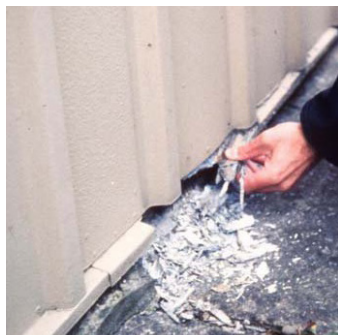
3
Damaged wall panel and
asbestos fibres

There is exposed, unlabelled and damaged asbestos in several locations which is likely to continue to deteriorate if left. The damage to the asbestos panels is such that there is loose and friable asbestos material, which significantly increases the likelihood of an event resulting in harm.

The baseline indicators require that all asbestos-containing material shall be maintained, non-friable and free from any defects such as holes, cracks, tears and/or looseness that may allow the release of fibres into the environment. This would therefore require the arrangement of a competent person to sample the external wall panels and base pates, confirm the type of asbestos and prepare and undertake a suitable remedial action plan, which should require works to the damaged wall panels via appropriate sealing of existing panels (if possible) and removal of all fibres and contaminated material around the dwelling. Any remaining asbestos would be labelled and an asbestos register provided to the building owner. If work is completed to address the baseline indicators, this will significantly reduce the likelihood of an event that will result in harm.

Total removal of the ACMs from the building and replacement with another building material would reduce the property to the national average.

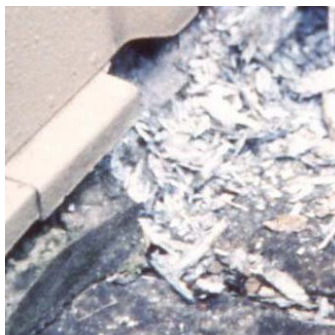
4
Close up of damaged wall
panel and asbestos fibres
