## Housing Health and Safety Rating System (HHSRS)

Hazard D21  
Lighting

Example D21.1  
Pre-1920  
Flat

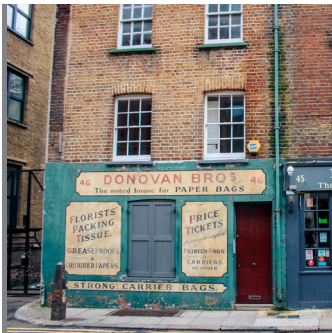
1  
Front exterior

This is a pre-1919, one-bedroomed basement flat in a Georgian building that has commercial use on the ground floor and flats on the three floors above the ground floor. It is located in a city centre, close to the night-time economy.

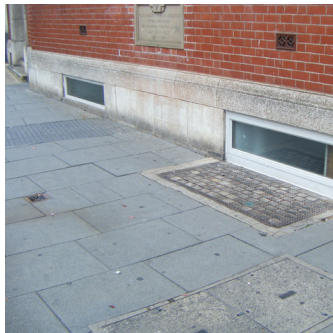
2  
Rear exterior wall

The basement flat has no windows direct to the outside and no natural ventilation. The only natural light is via two sets of opaque glass blocks in the public pavement on the rear elevation of the building. These provide borrowed light via lightwells into the living room and bedroom only. There is no natural light at all in the kitchen or bathroom.

Where dwellings are below ground level, remedial works to improve daylight penetration (such as modern light-enhancing wells) may not be reasonably practicable or within the landlord's control. Also, the ability to provide a view of the surroundings may be impracticable or even impossible.

In such instances, the Inspection and Assessment Manual confirms that alternative uses of the dwelling may need to be considered. In this case, the obligatory works to provide natural light and a view of the surroundings are not achievable. It may be necessary to consider prohibiting use of the basement flat for living and sleeping purposes.

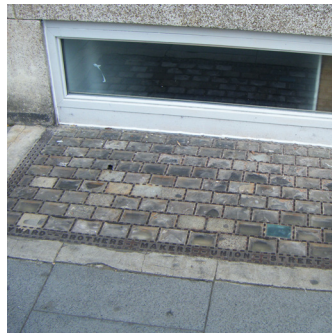
3  
Close up of glass blocks

This flat is positioned below ground level and has no windows direct to the outside. The only natural light is via two sets of opaque glass blocks in the public pavement on the west elevation of the building, which provide borrowed light via lightwells into the living room and bedroom only. These will get dirty and could be obstructed by litter, refuse bins or even illegal parking, and anyone walking over them will cast shadows.

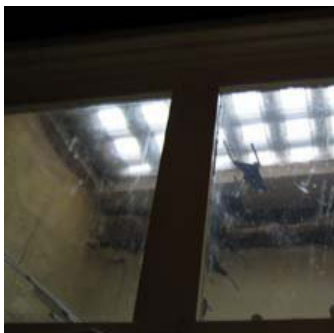
4  
View from bedroom  
window

The flat is dark, and whilst there are no defects to the artificial lights, they are required at all times for normal household tasks and activities. It is not possible to see the outside environment at all from within the flat.

The limited daylight afforded by the two lightwells means that the dwelling is naturally dark, and artificial light is required at all times for normal household tasks and activities. During a power cut, there would be minimal light to the flat, possibly total darkness. Additionally, there is no outlook, as it is not possible to see the outside environment at all from within the flat.

Compliance with the baseline indicators would reduce the likelihood of harm. However, installing windows to provide much-needed natural light, ventilation and an unobstructed view of outside is not practicable. As such, the dwelling cannot comply with the lighting (and probably ventilation) BIs. There are no other improvements required to comply with other BIs that would mitigate the hazard.
