| <b>3M Peltor Comtac VIII Headset</b> | |
| <b>PSD Number</b> | 2607-0161 |
| <b>Product Type</b> | Personal protective equipment (PPE) - Hearing Protection - Powered |

## Product Recall

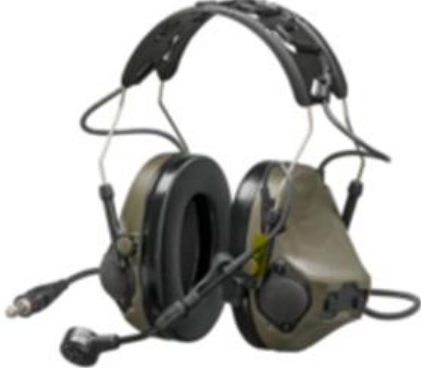
| <b>3M Peltor Comtac VIII Headset</b> | |
|---|---|
| <b>Product Description</b> | Over the ear hearing protection and communications headset designed for military and civil defence personnel.<br><br>Recall is applicable to headsets manufactured between November 27, 2025 and February 6, 2026 with the model/type and printed circuit board assembly numbers listed in Annex A. |
| <b>Risk Description</b> | The product presents a serious risk of hearing loss because affected batches may emit feedback noise (measured up to 106 dBA) through the headset speakers. The likelihood of occurrence of this issue can be increased in cold ambient temperatures and with a depleted battery state.<br><br>The product does not meet the requirements of the Regulation (EU) 2016/425 on Personal Protective Equipment and the applicable standards: EN 352-1:2020, EN 352-4:2020, EN 352-6:2020. |

| <b>3M Peltor Comtac VIII Headset</b> | |
|---|---|
| <b>Corrective Measures</b> | The product has been recalled from distributors by 3M United Kingdom PLC. A Stop Use Notification has been issued.<br><br>For more information, or to check whether your product is affected, please contact your distributor. |

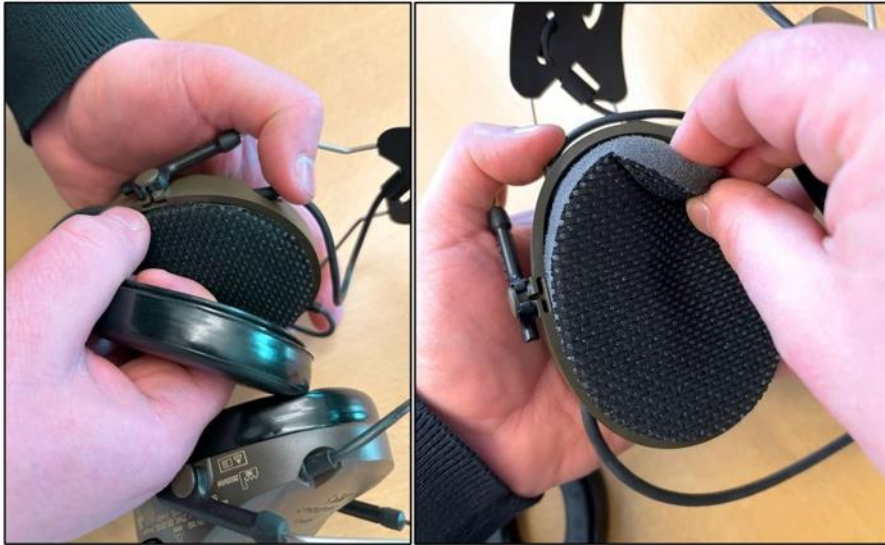
**Step 1:** To remove sealing ring from the left cup (boom mic/keypad side), grab the ring as shown in the picture and pull the ring outwards.

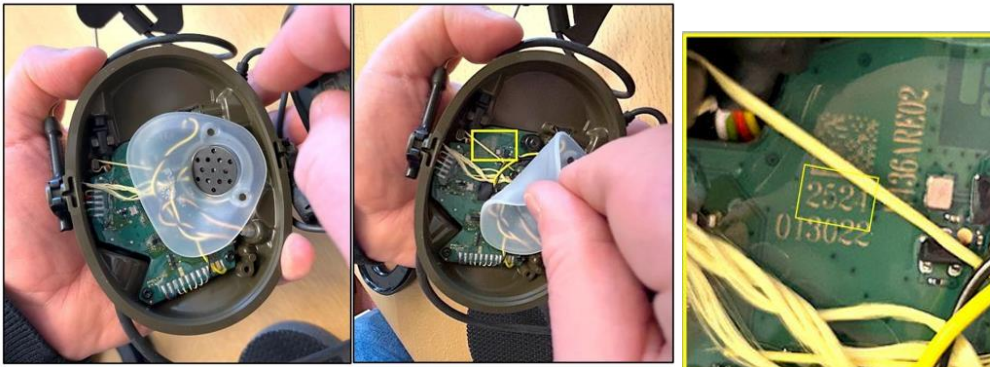
**Step 2:** When the ring is removed from the cup, also remove the foam that is placed inside the cup.

In the example shown to the left, the batch of the PCBA is "2524" representing manufacturing year 2025 and week 24.
