# Abbreviated Dust Monitoring Report

Monitoring Period: 27 July 2026 to 30 August 2026

**Project:** Grenfell Tower

**Document Ref:** EEMC-DMR-201/112 – Grenfell Tower Rev 00

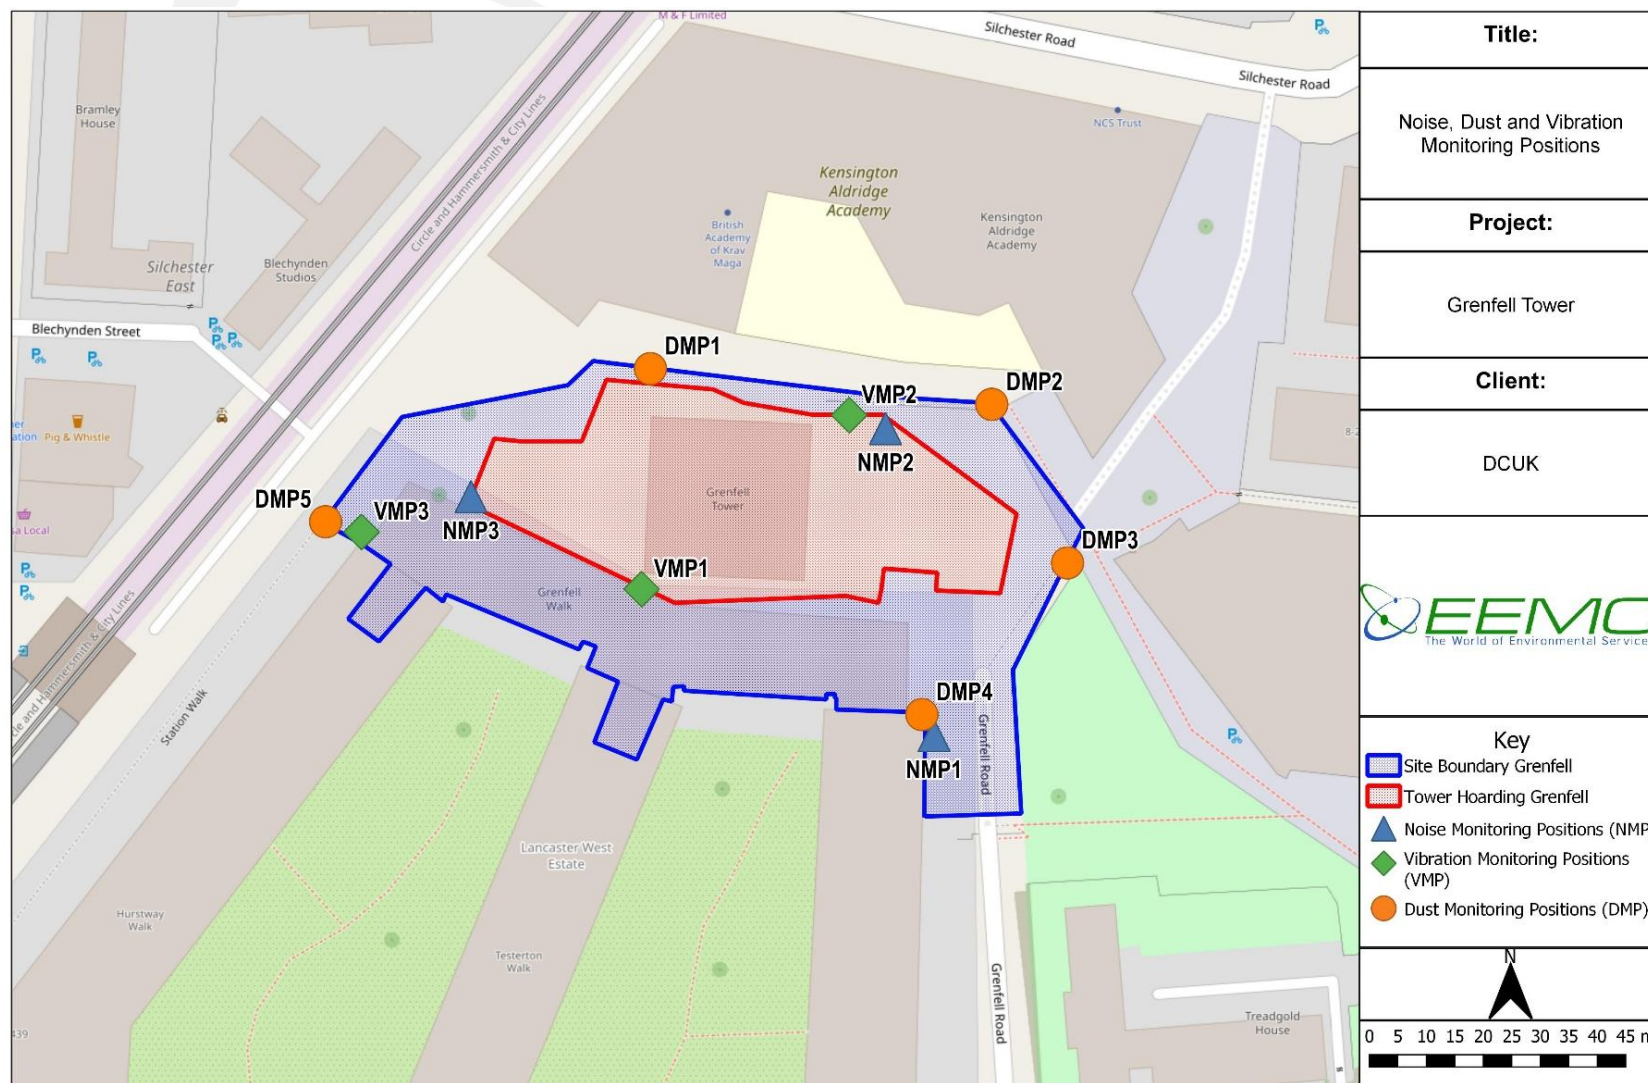
**Figure 1- Map of Noise, Dust & Vibration Monitoring Locations**

The site boundary and hoarding line of this project are shown in Figure 1. The project is located at Grenfell Tower, Grenfell Road, W11 1TQ. The entire site is located within the Royal Borough of Kensington & Chelsea (RBKC) and is bordered by residential blocks to the south, a school and football pitches to the north and a leisure centre to the east. The London Underground viaduct is 70m to the west, and Latimer Road Tube station is 200m from the project.

Five (5) MCerts-approved HIVE-AQ DUSTROID™ monitors are deployed to carry out continuous monitoring on site. A map showing the monitoring locations is shown in Figure 1. Photographs showing the equipment installed at locations DMP1- DMP5 are shown in Images 1-5.

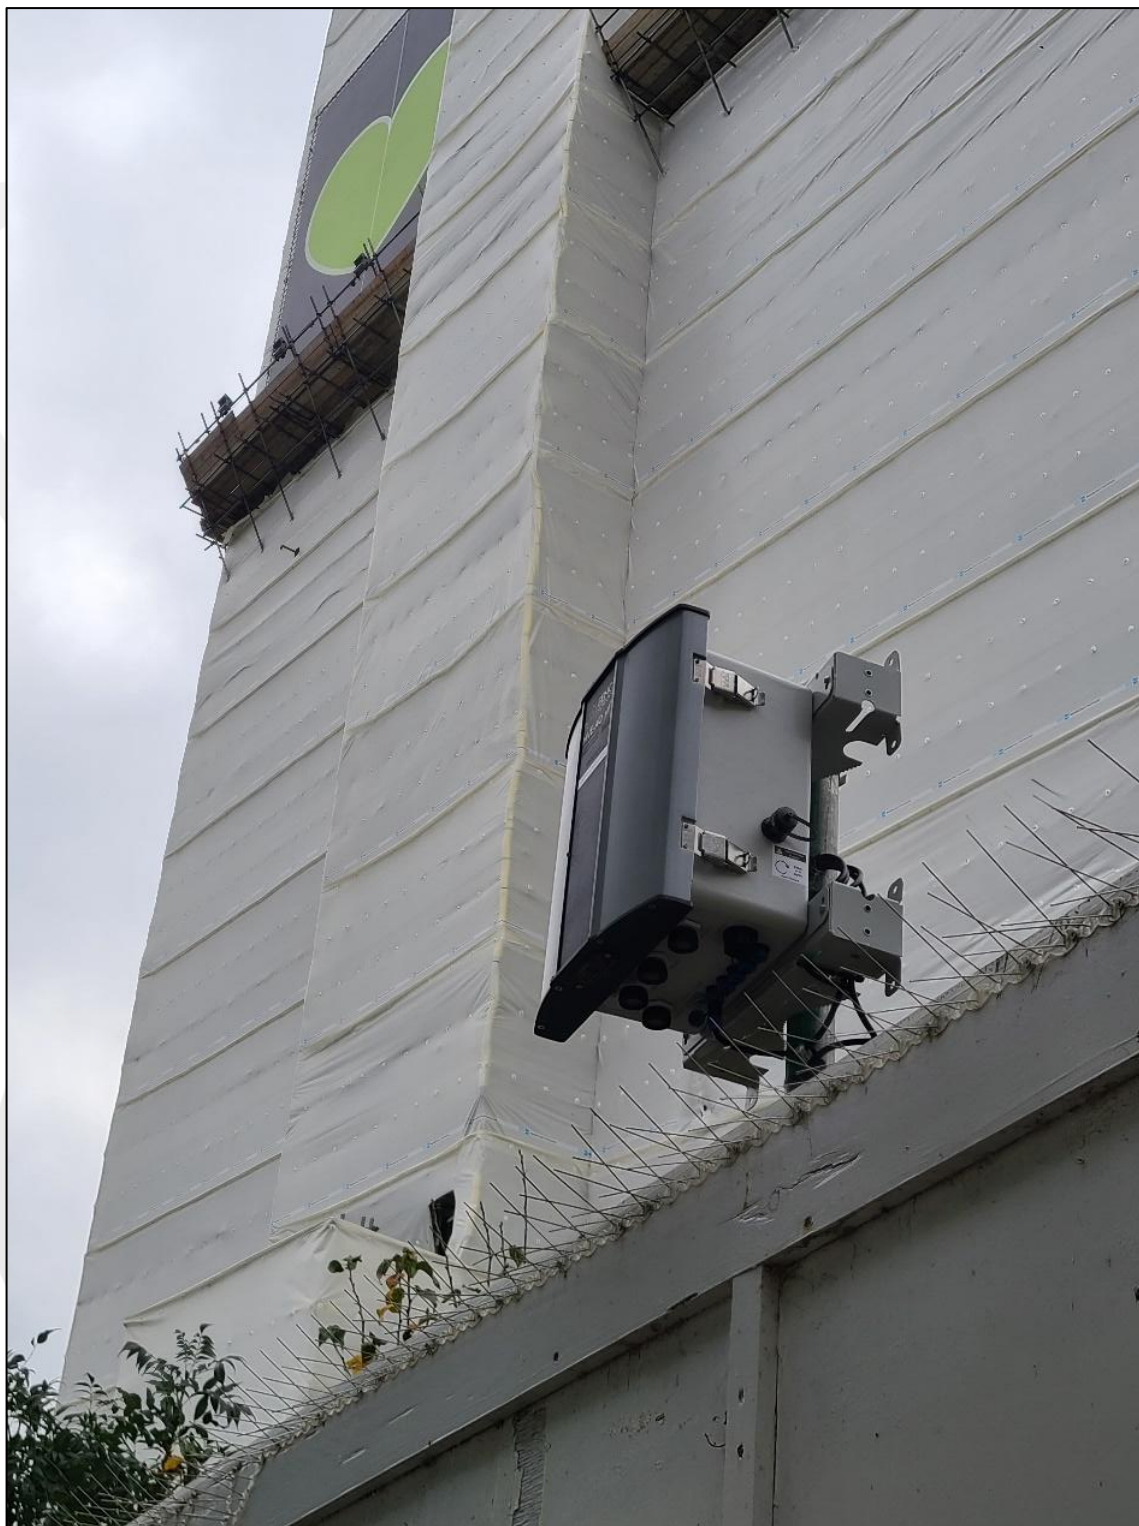
**Image 1 – DMP1 Monitoring Location** (*photo taken on site on 19/5/2025*).

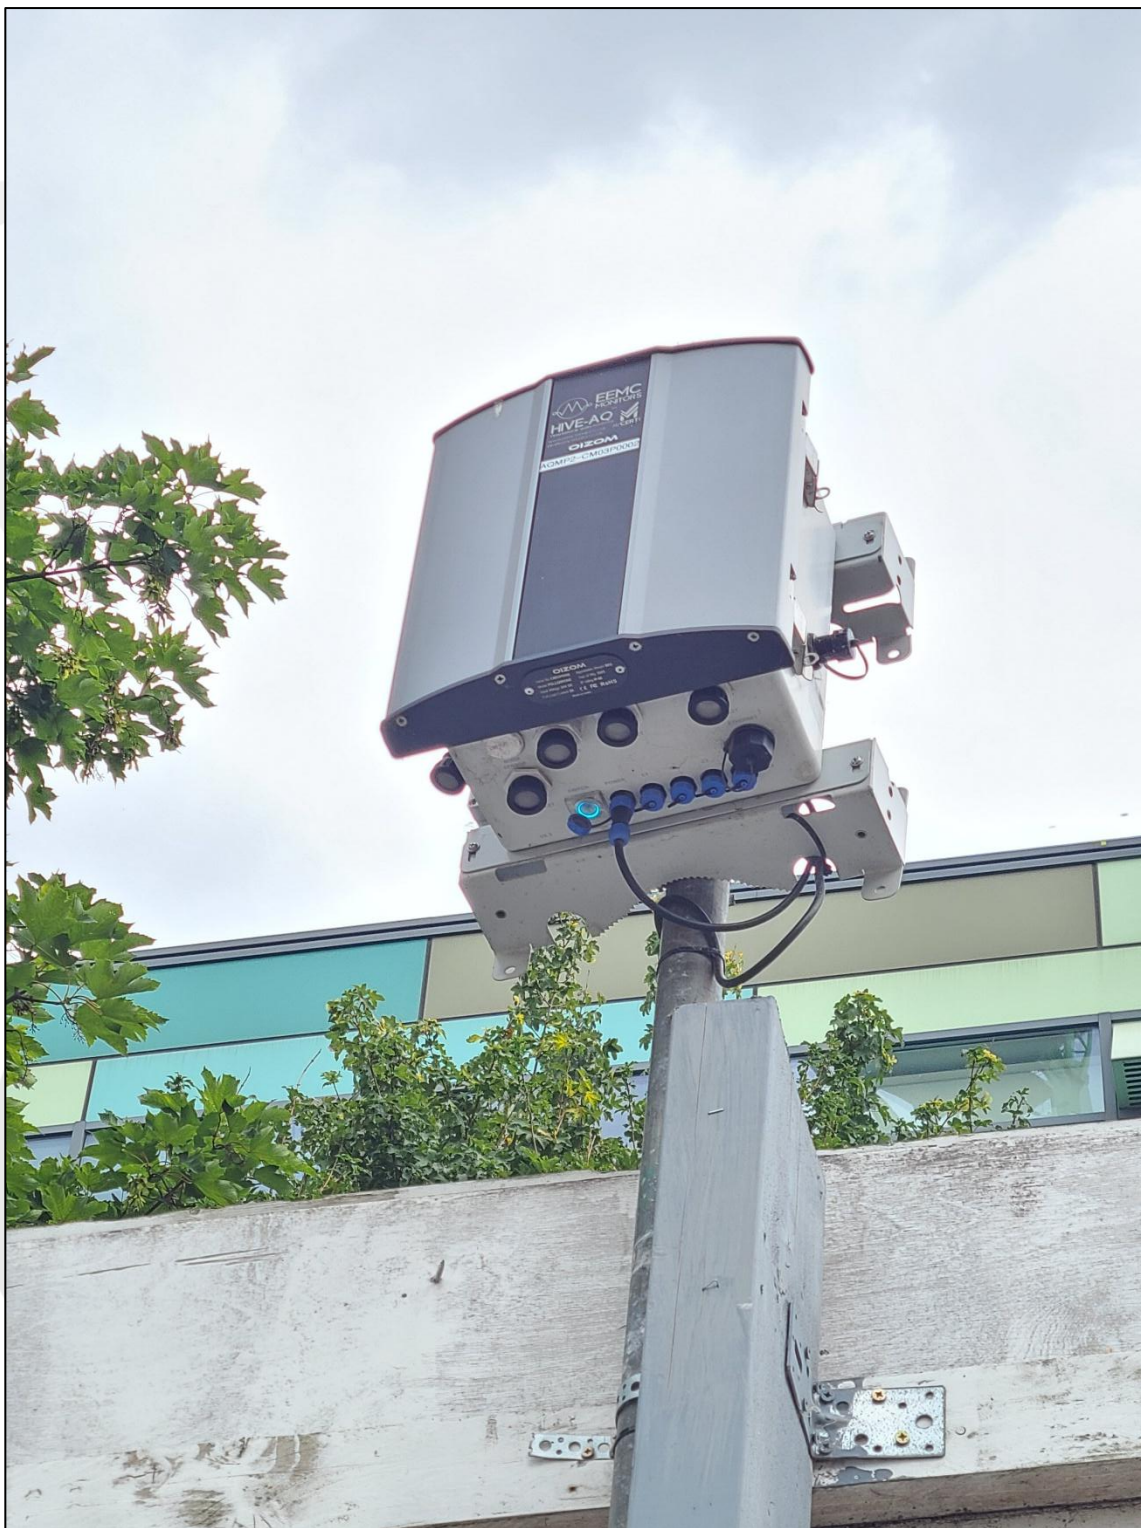
**Image 2 – DMP2 Monitoring Location** (photo taken on site on 24/07/2026).

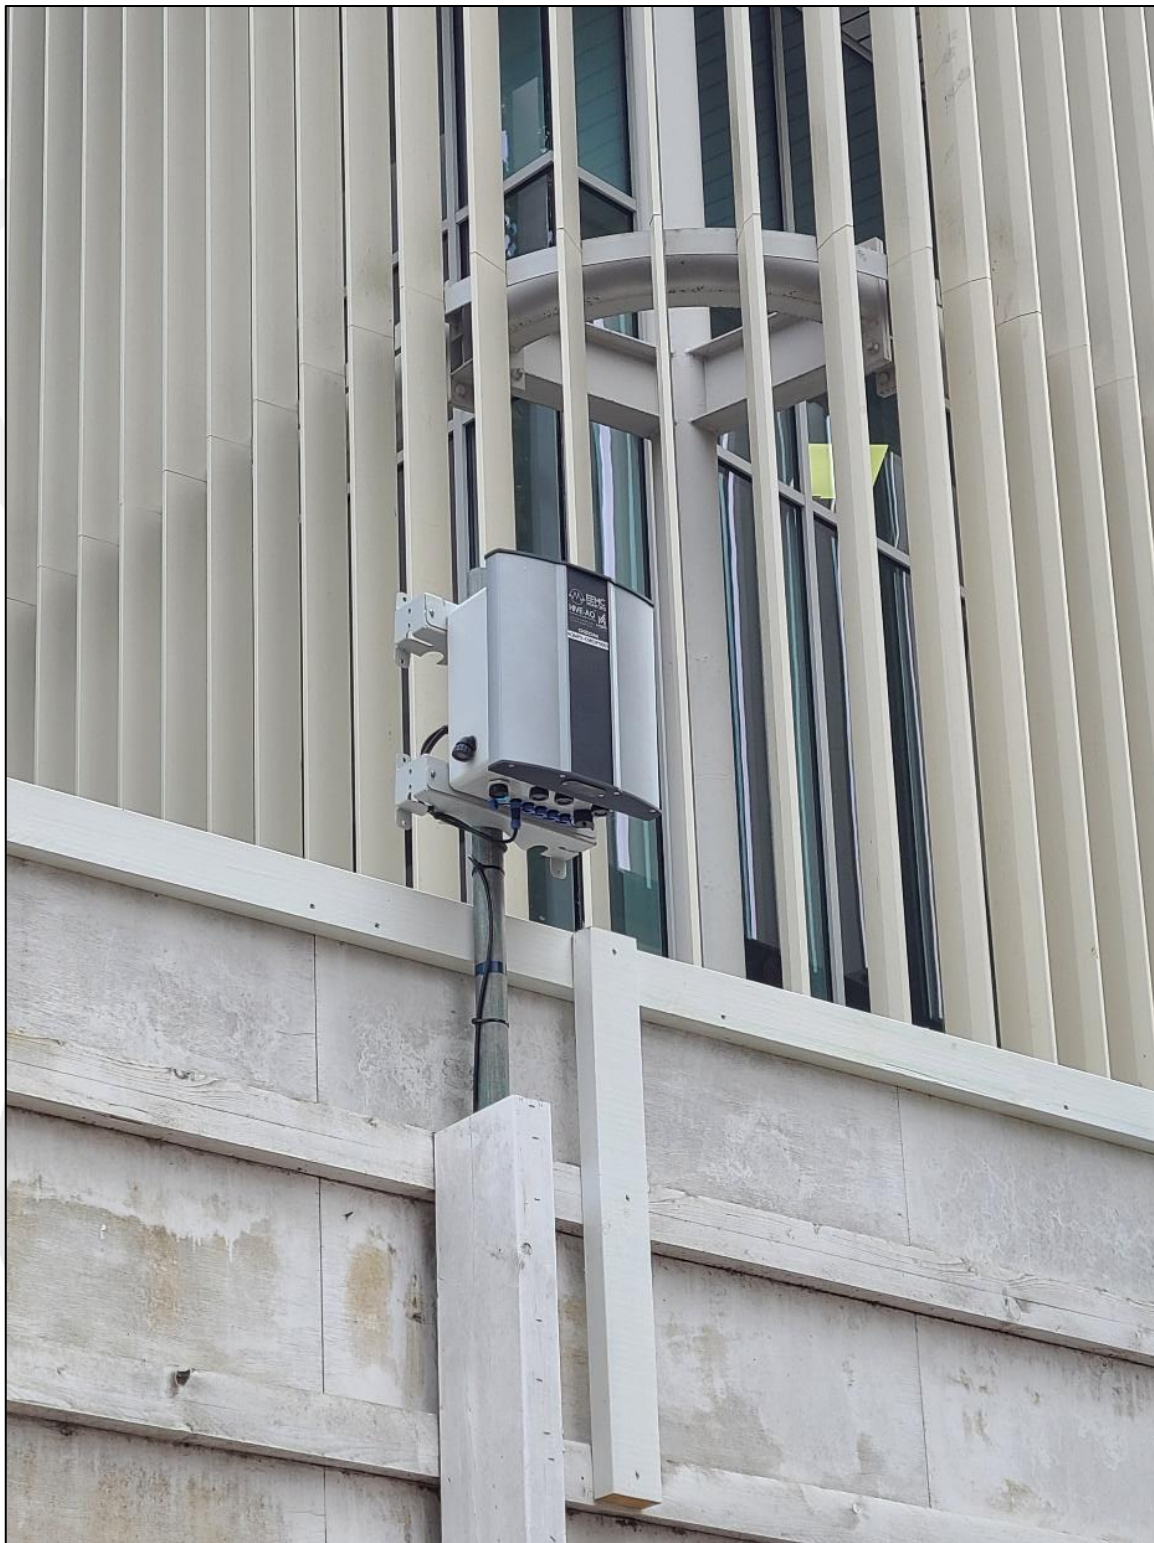
**Image 3 – DMP3 Monitoring Location** *(photo taken on site on 19/5/2025).*

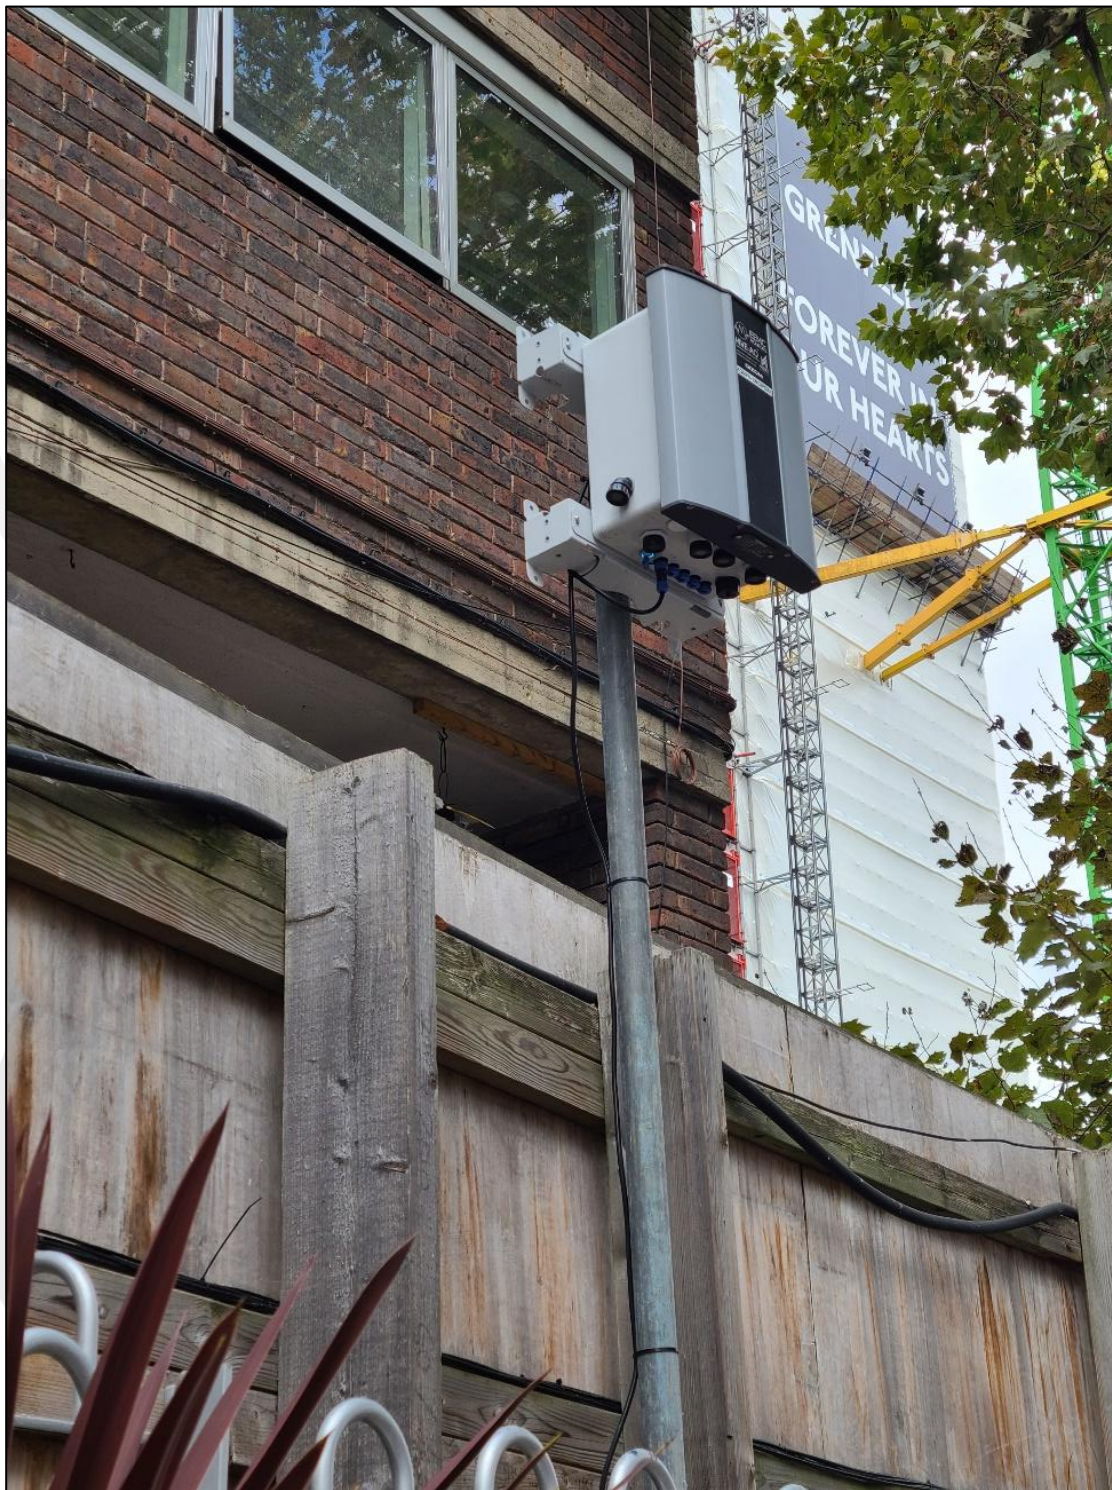
**Image 4- DMP4 Monitoring Location** *(photo taken on site on 19/5/2025)*

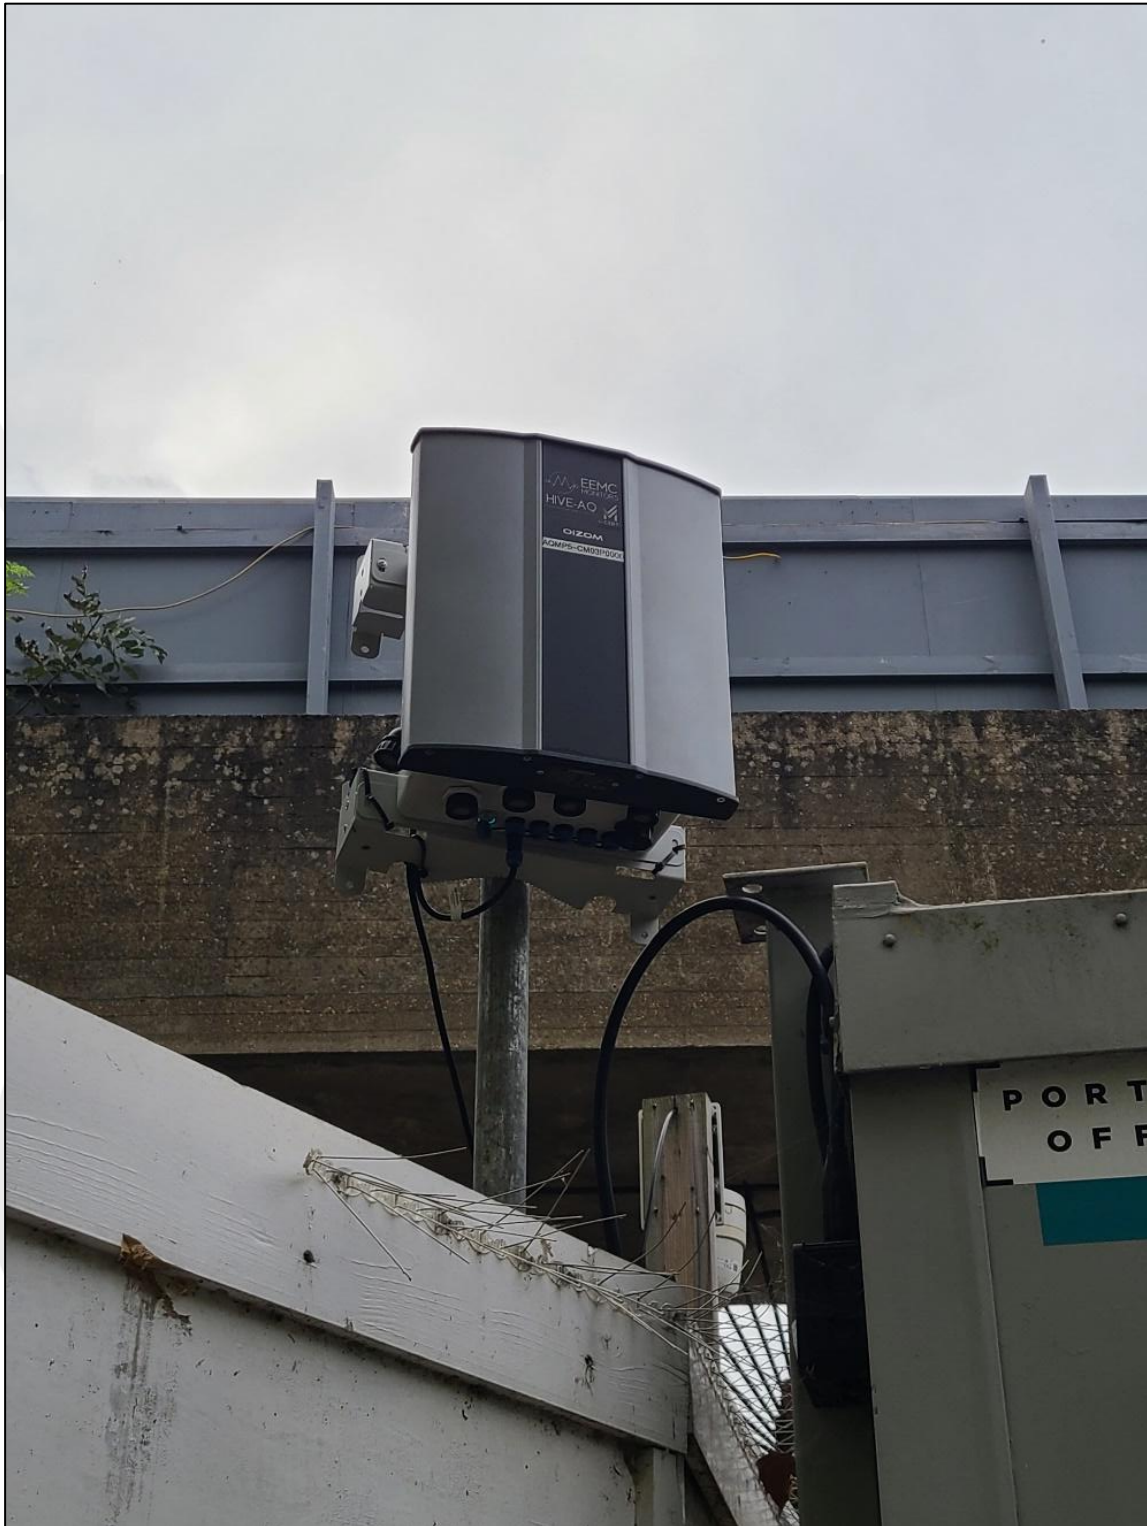
**Images 5- DMP5 Monitoring Location** *(photo taken on site on 19/5/2025)*

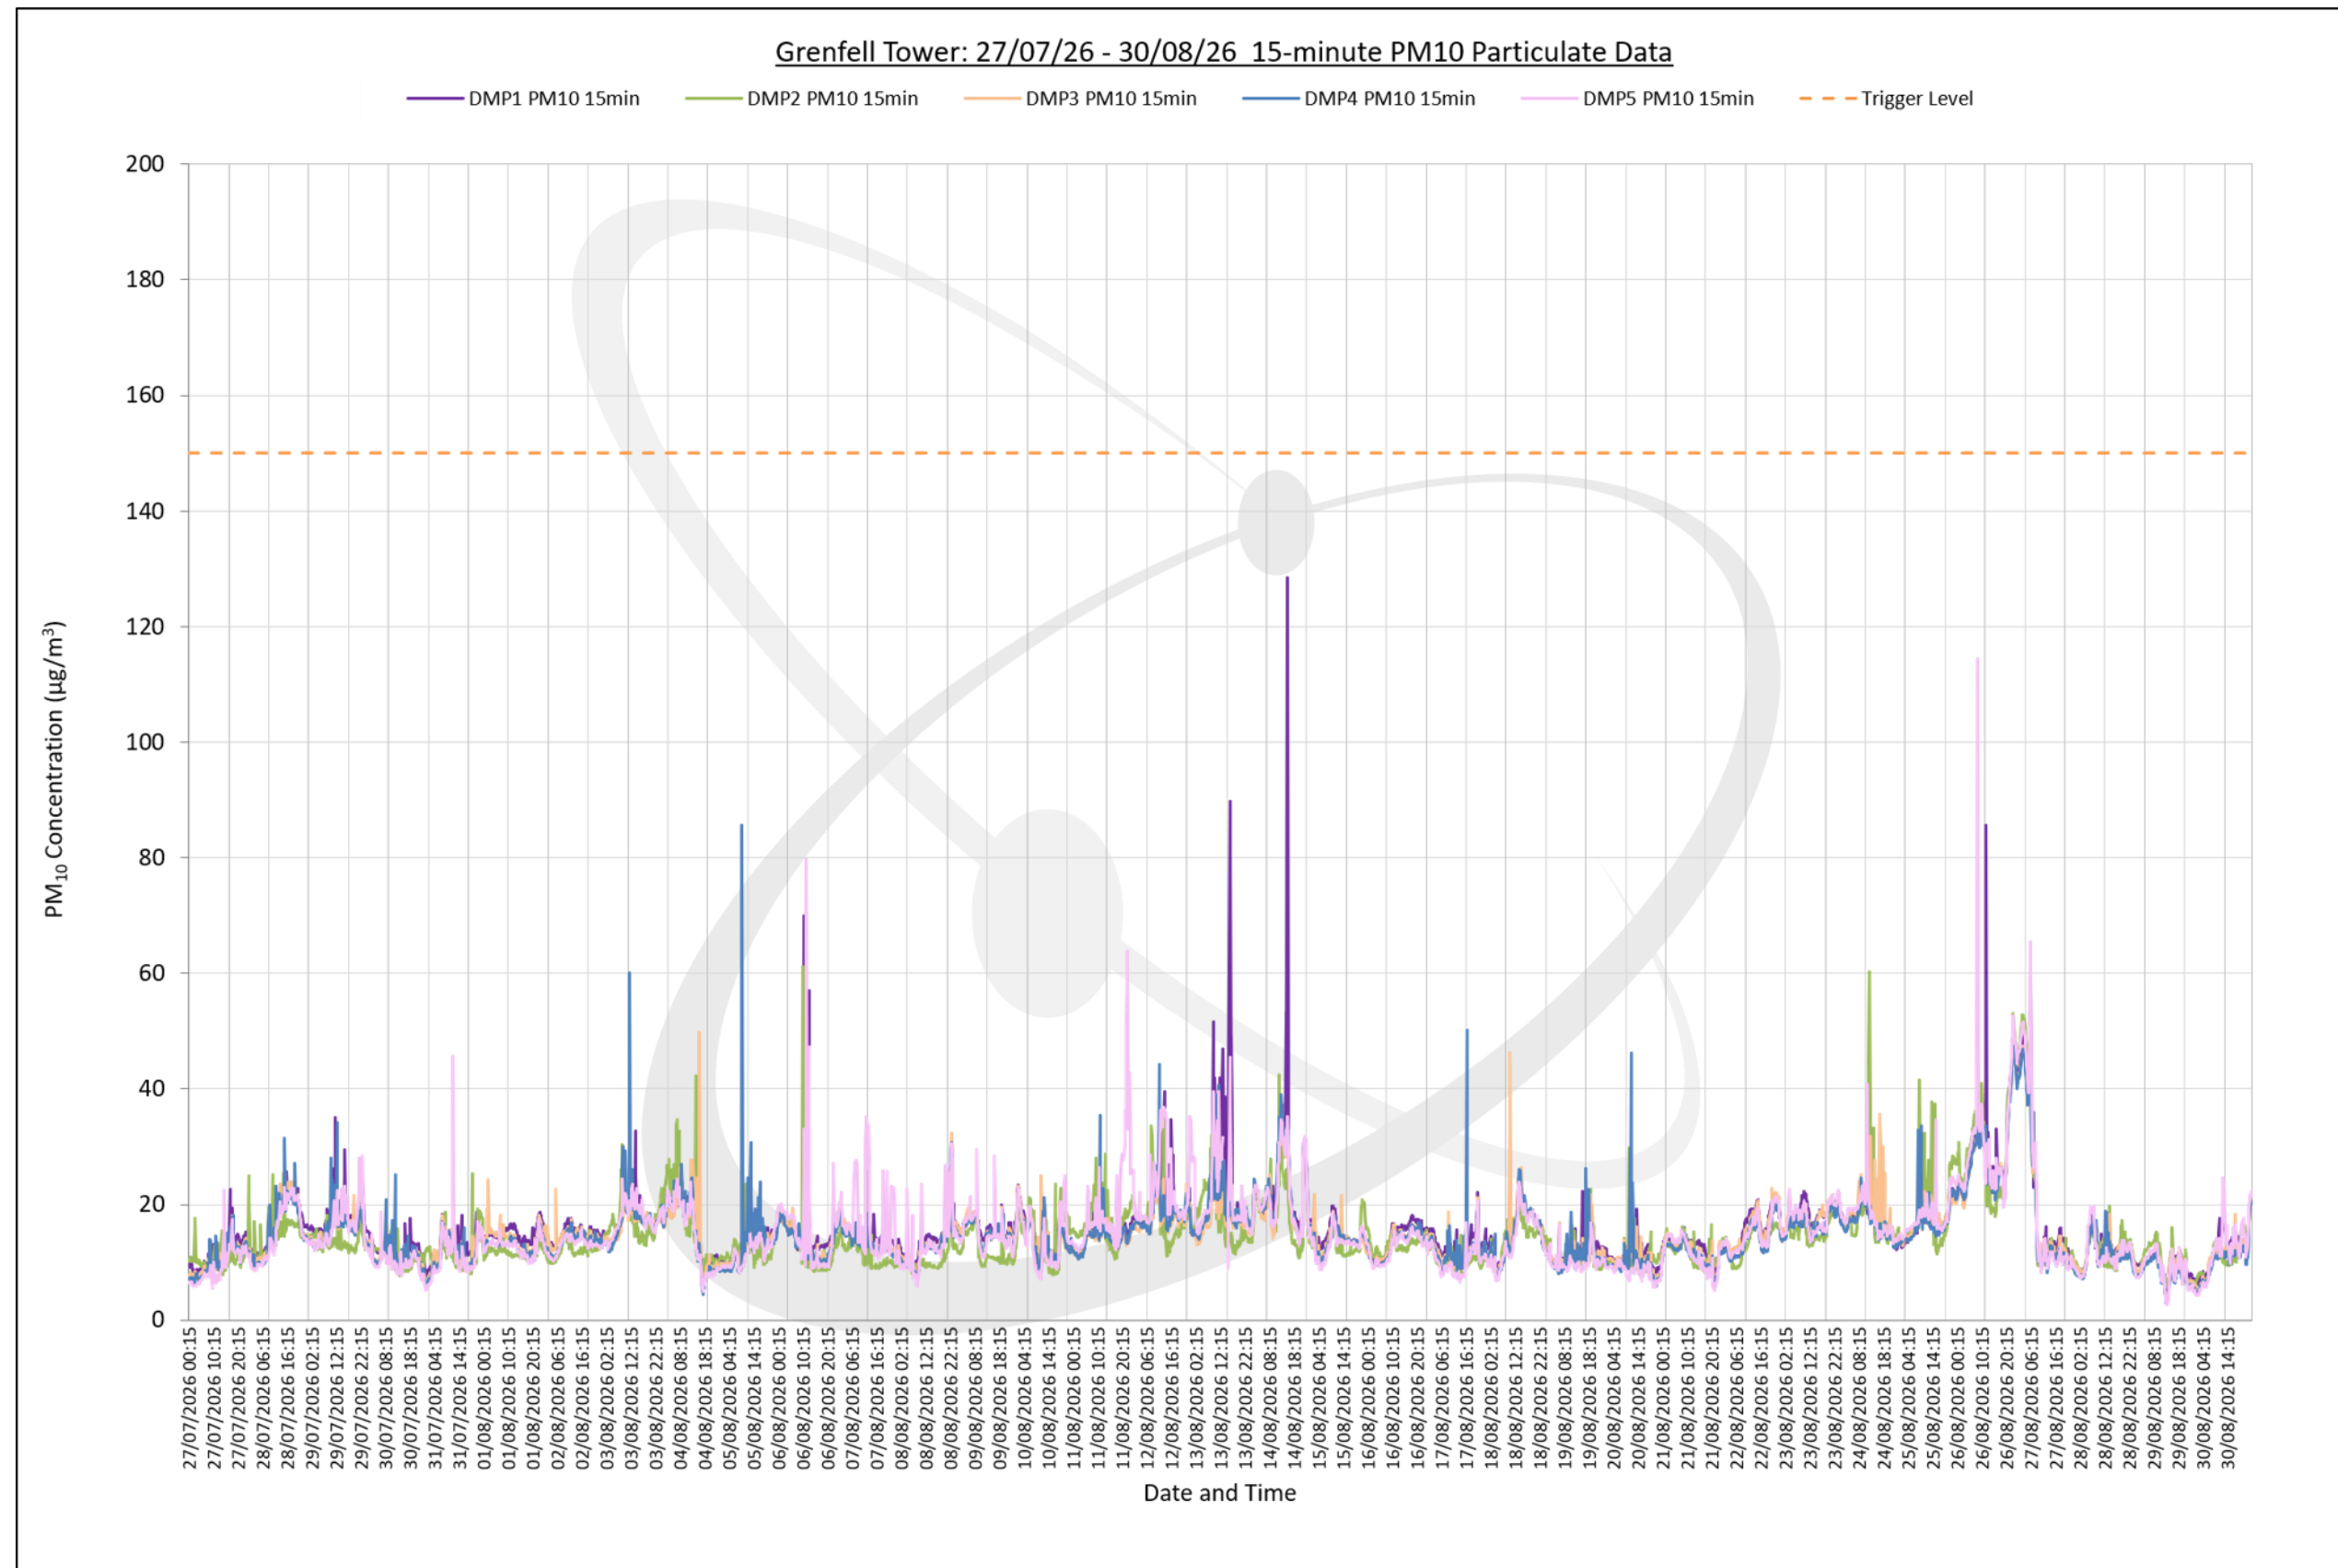
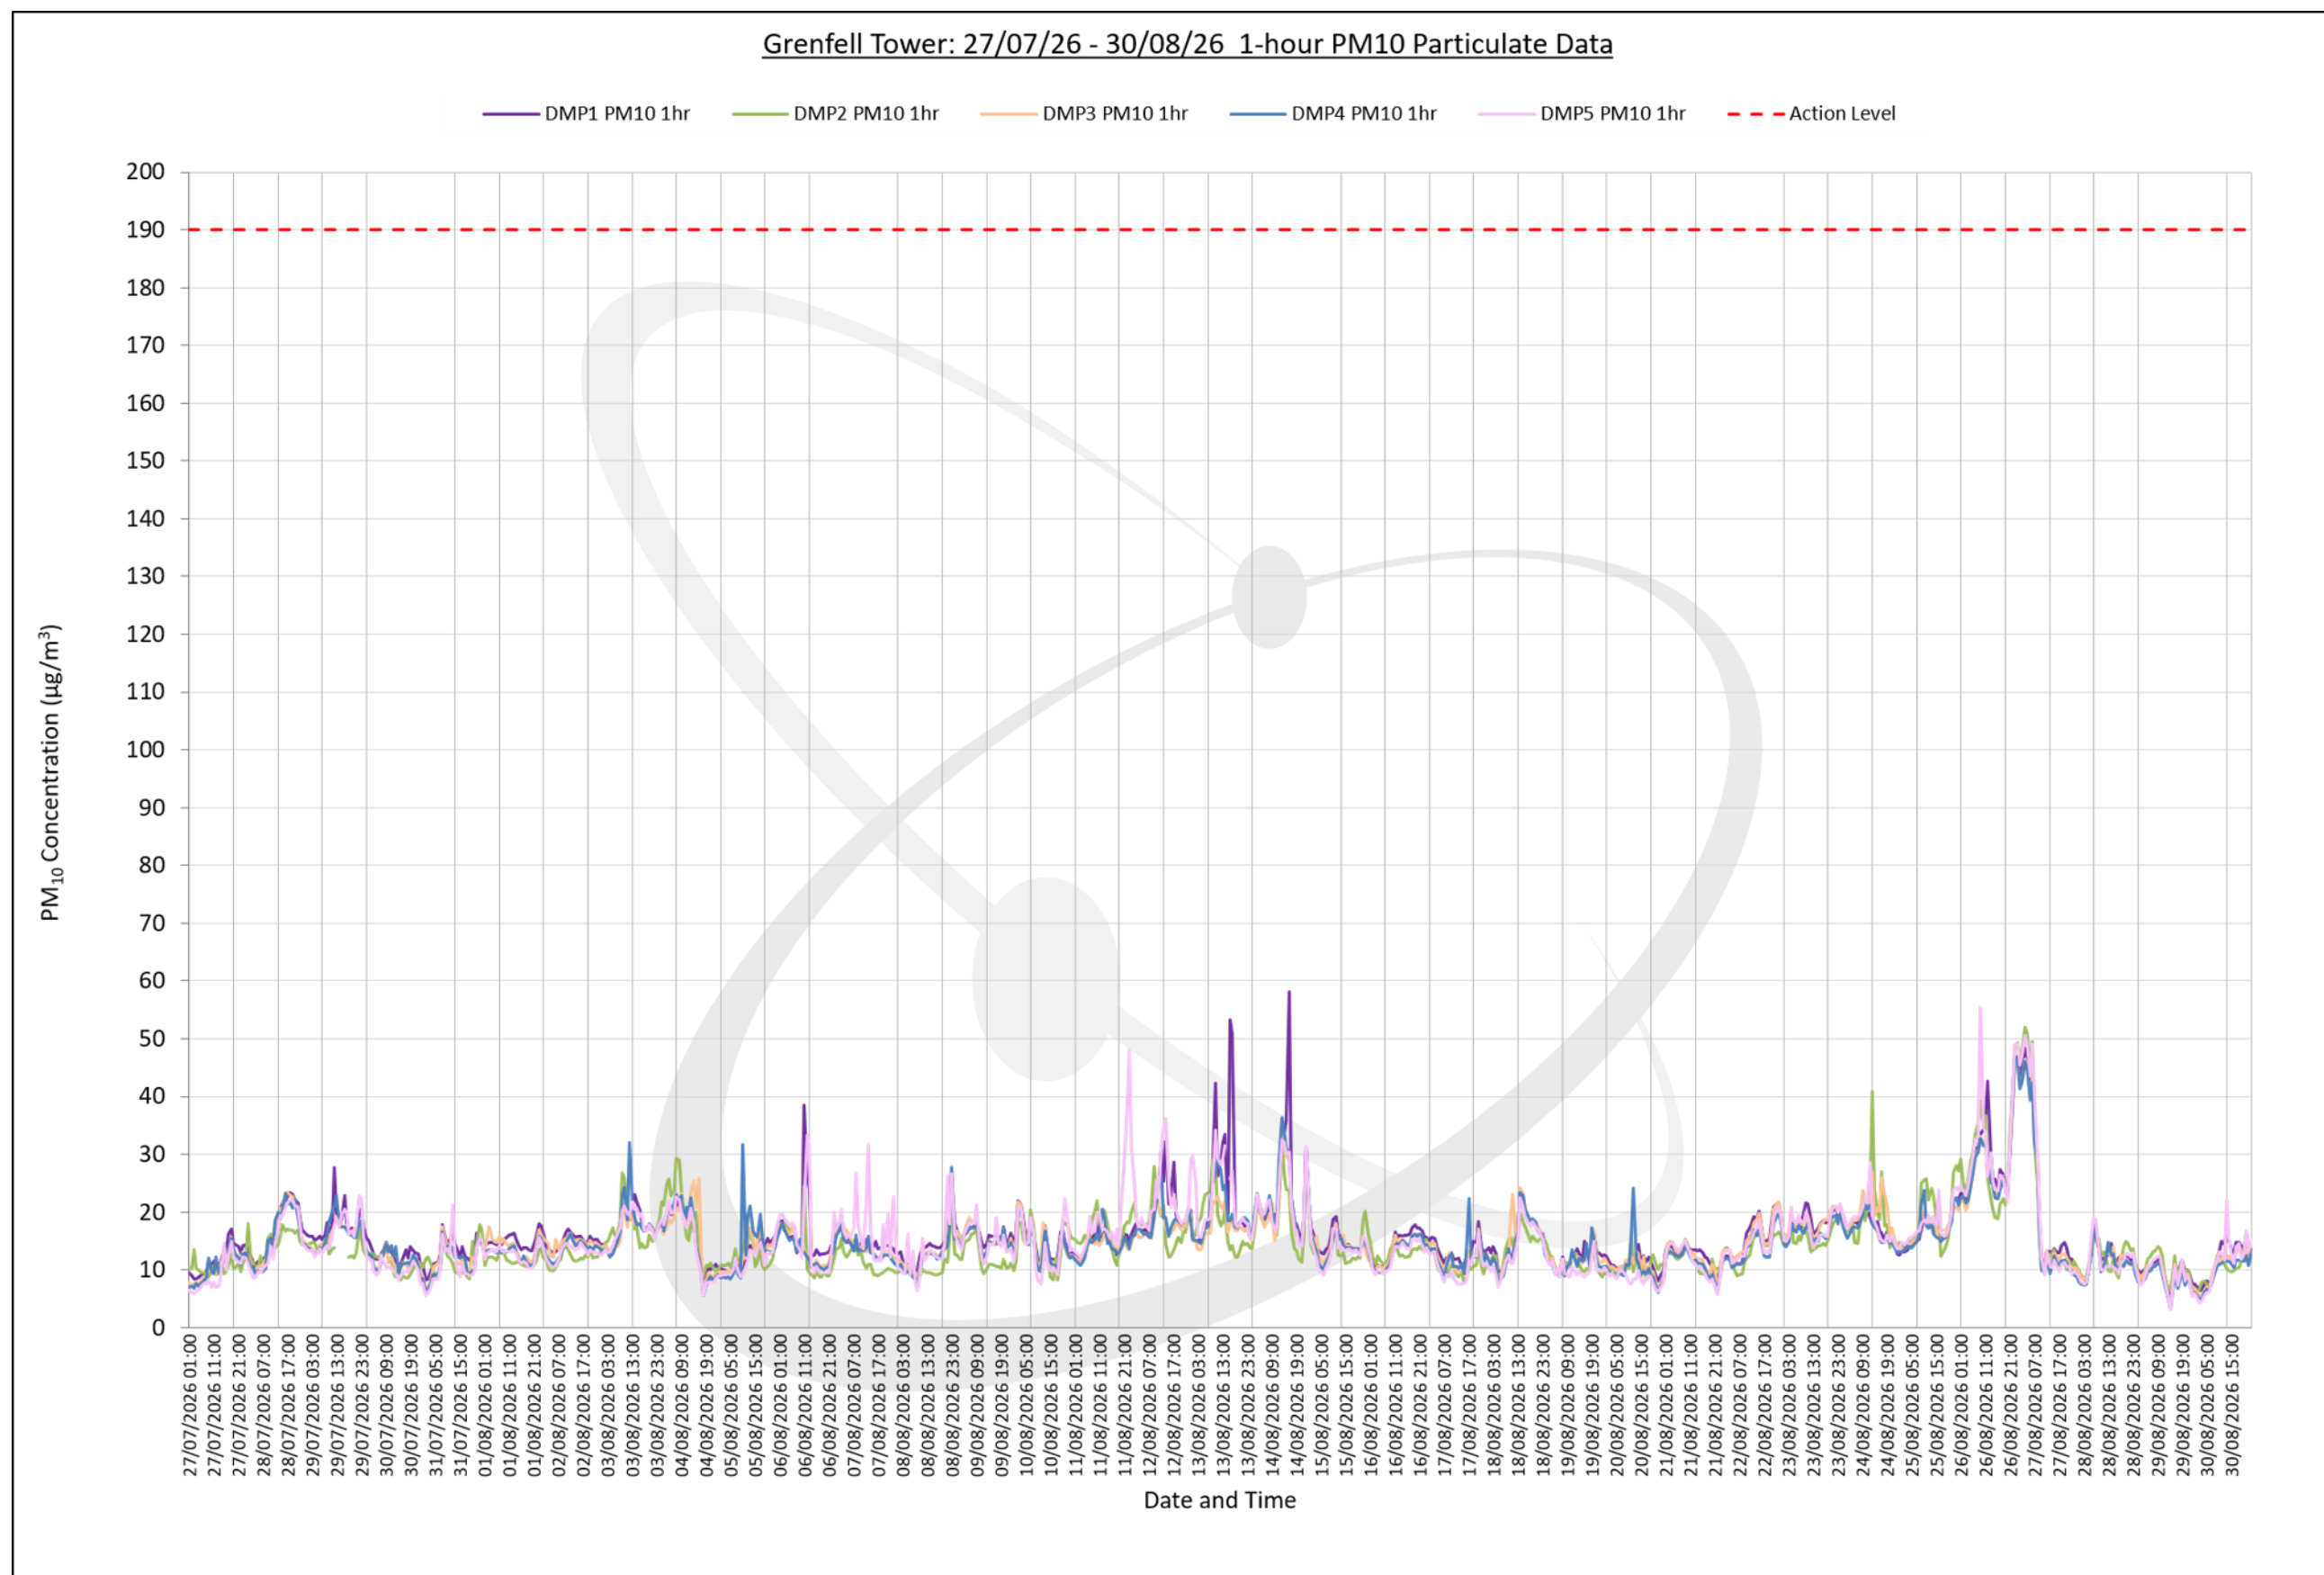
## 7. PM<sub>10</sub> Dust Monitoring Graphs

The results of the dust measurements in this period are presented graphically for PM<sub>10</sub> and PM<sub>2.5</sub> in Sections 7 and 8, respectively, of this report.
