# Abbreviated Dust Monitoring Report

Monitoring Period: 27 July 2026 to 30 August 2026

**Project:** Grenfell Tower

**Document Ref:** EEMC-DMR-201/112 – Grenfell Tower Rev 00

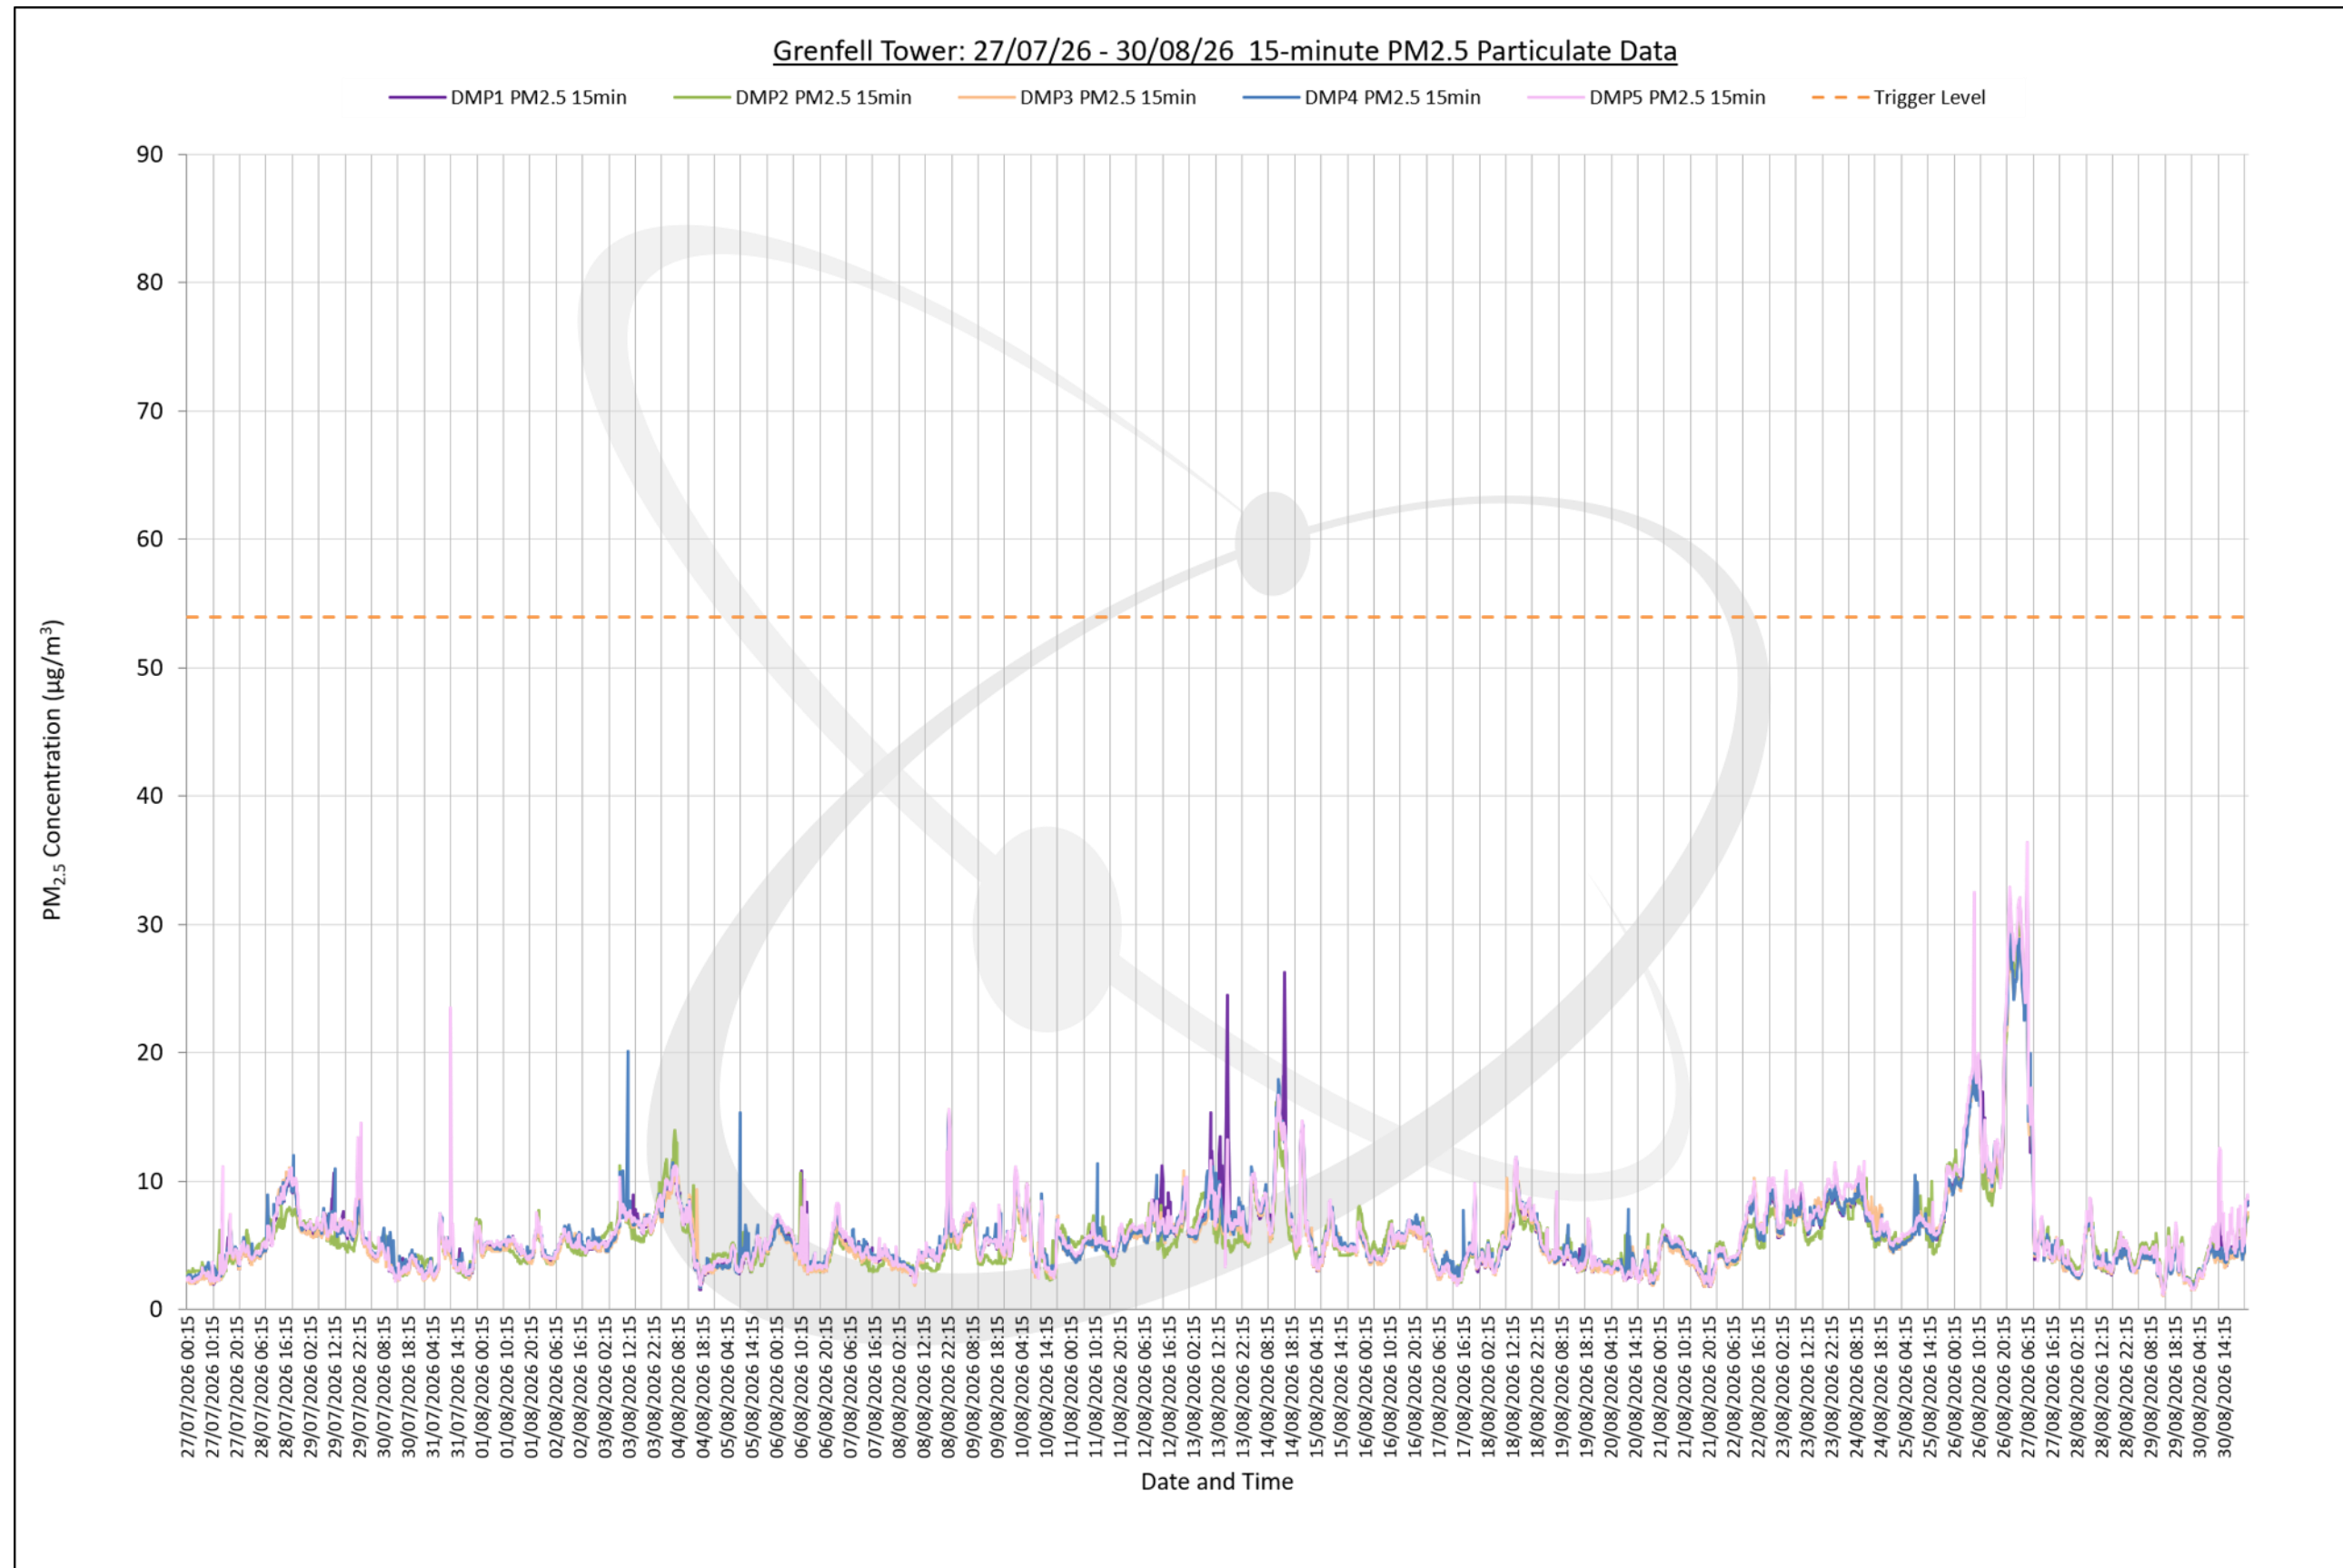
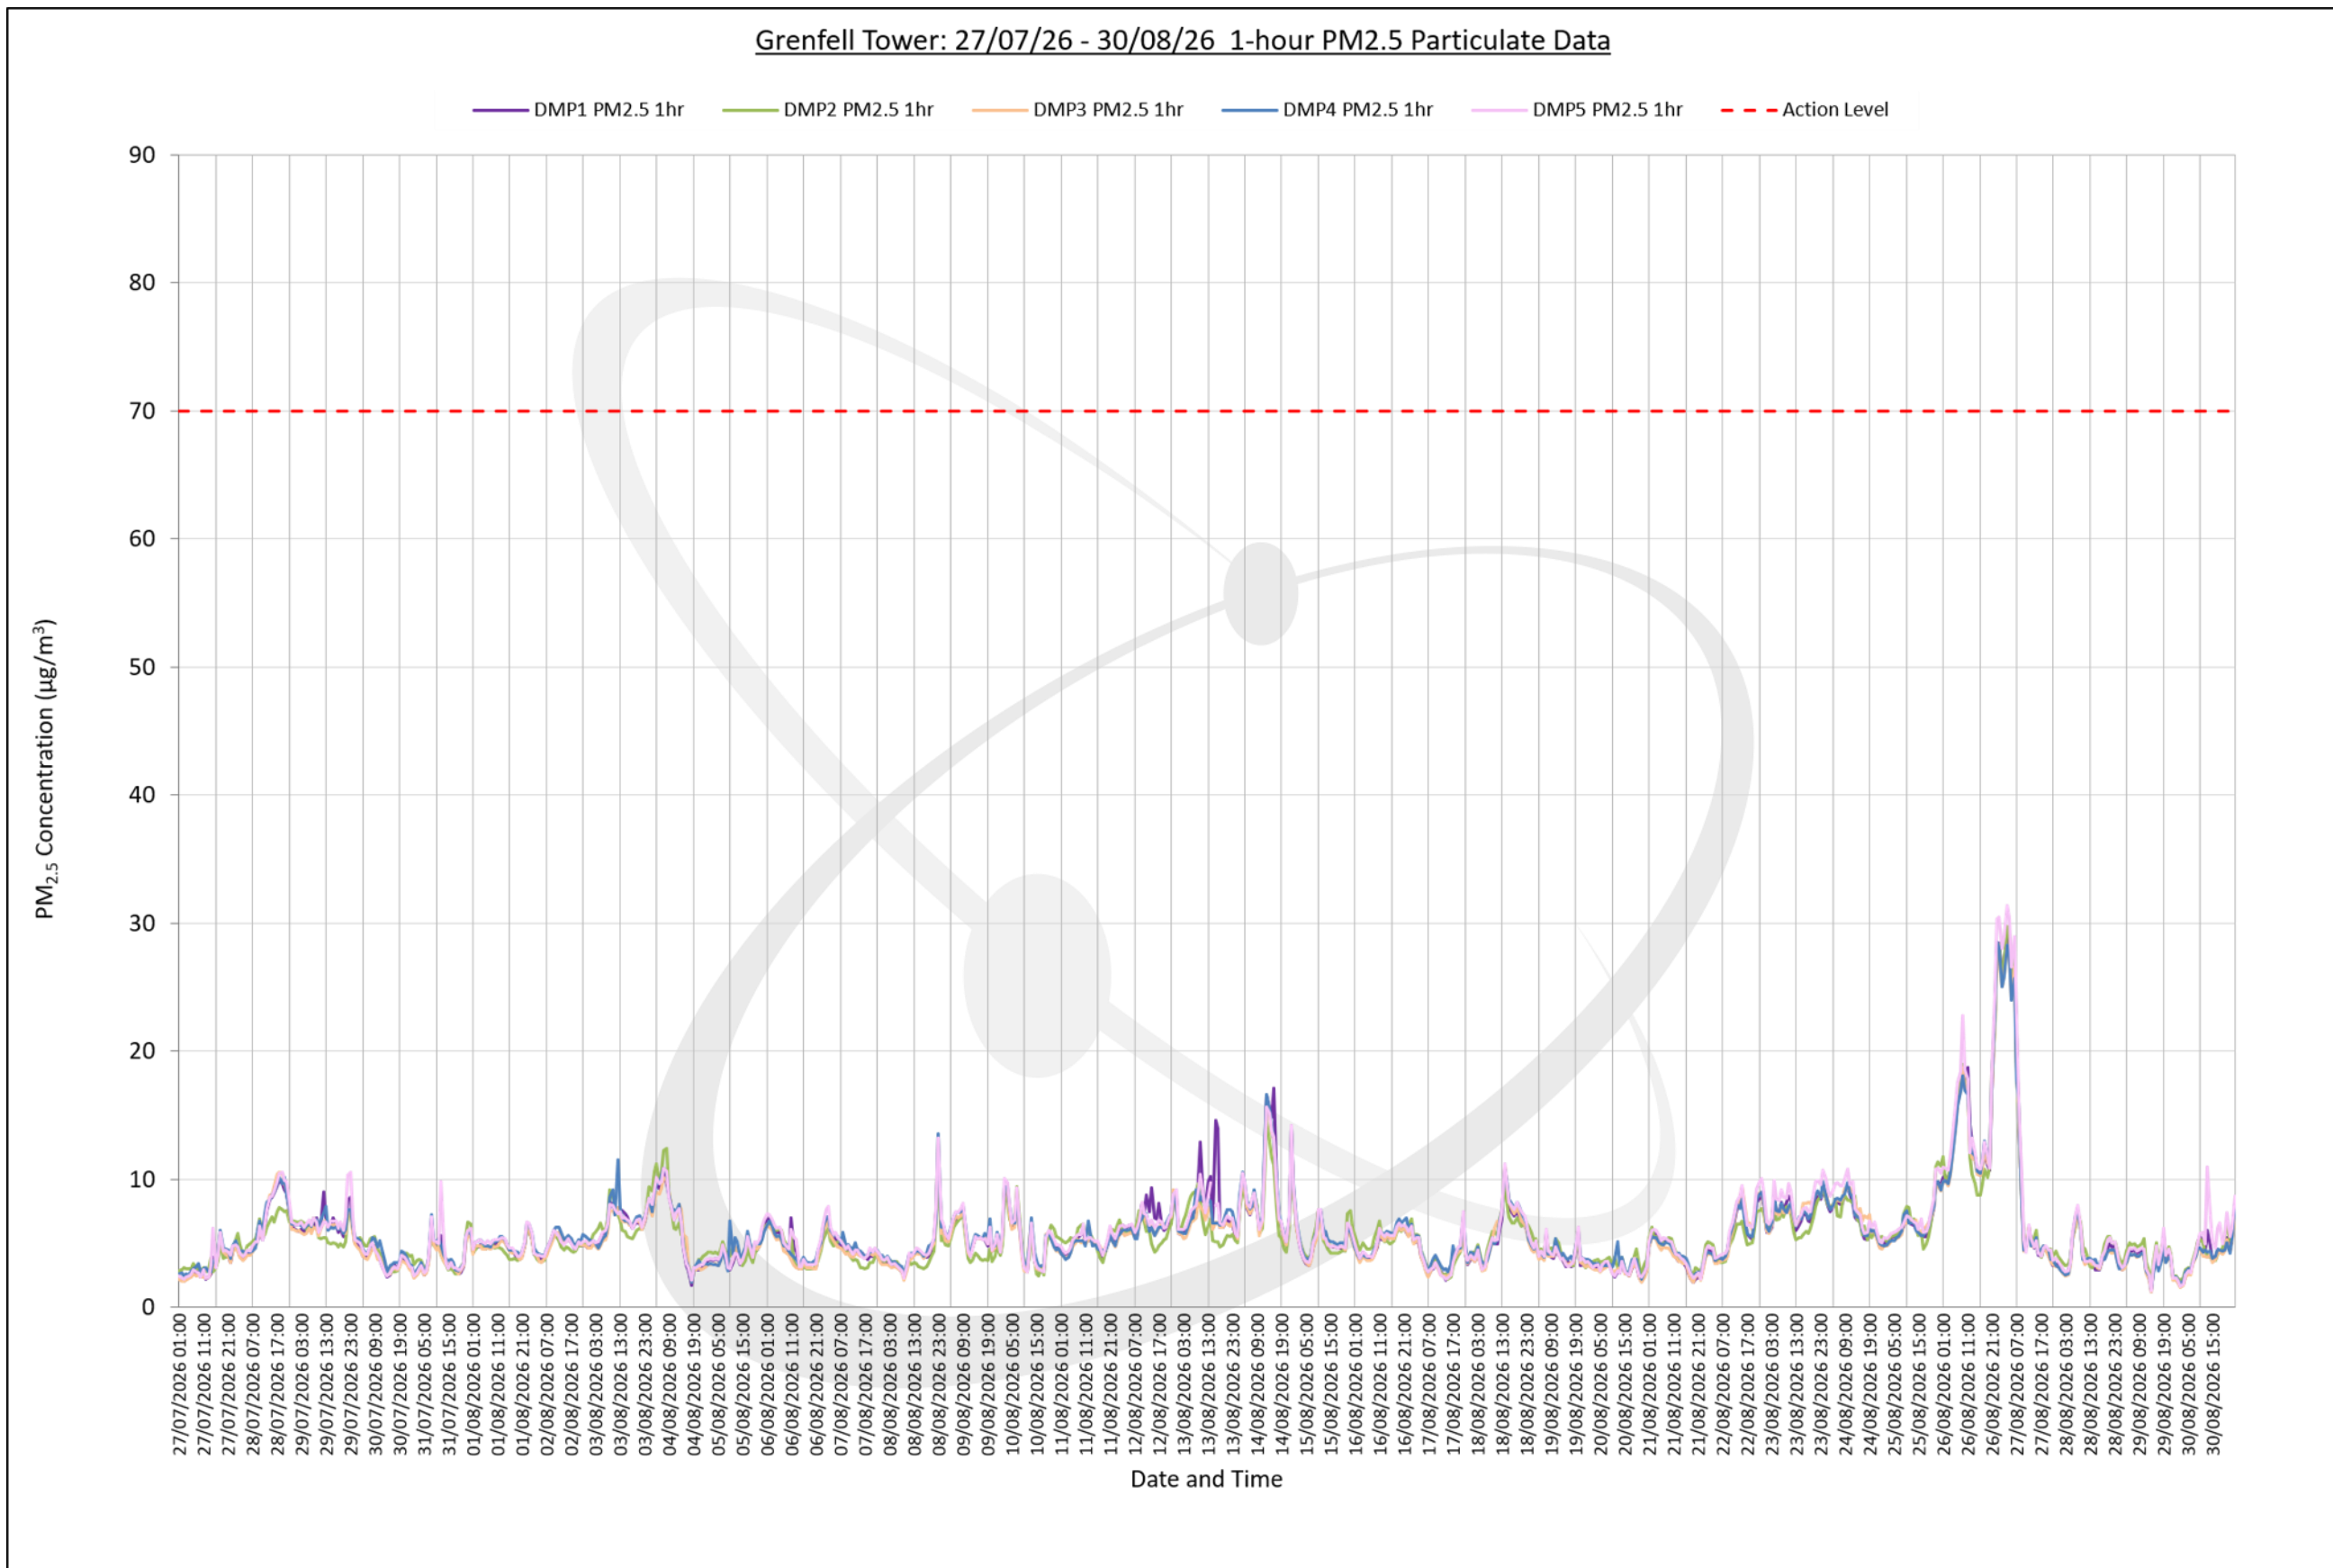
## 8. PM<sub>2.5</sub> Dust Monitoring Graphs

The results of the dust measurements in this period are presented graphically for PM<sub>10</sub> and PM<sub>2.5</sub> in Sections 7 and 8, respectively, of this report.
