Survey Report
no. 091909

According to the commissioning by **[REDACTED]**, company of Zeppelin Baumaschinen GmbH, on April 14, 2009, the cause which led to the destruction of a hydraulic motor shall be examined.

Hydraulic drive for a combined windlass and mooring winch:

**EXAMINATION OF A FRACTURED
AXIAL DISPLACEMENT
HYDRAULIC MOTOR CYLINDER
BLOCK AND ASSOCIATED
ITEMS FROM THE ANCHOR
WINDLASS OF
*MT STELLAR VOYAGER***

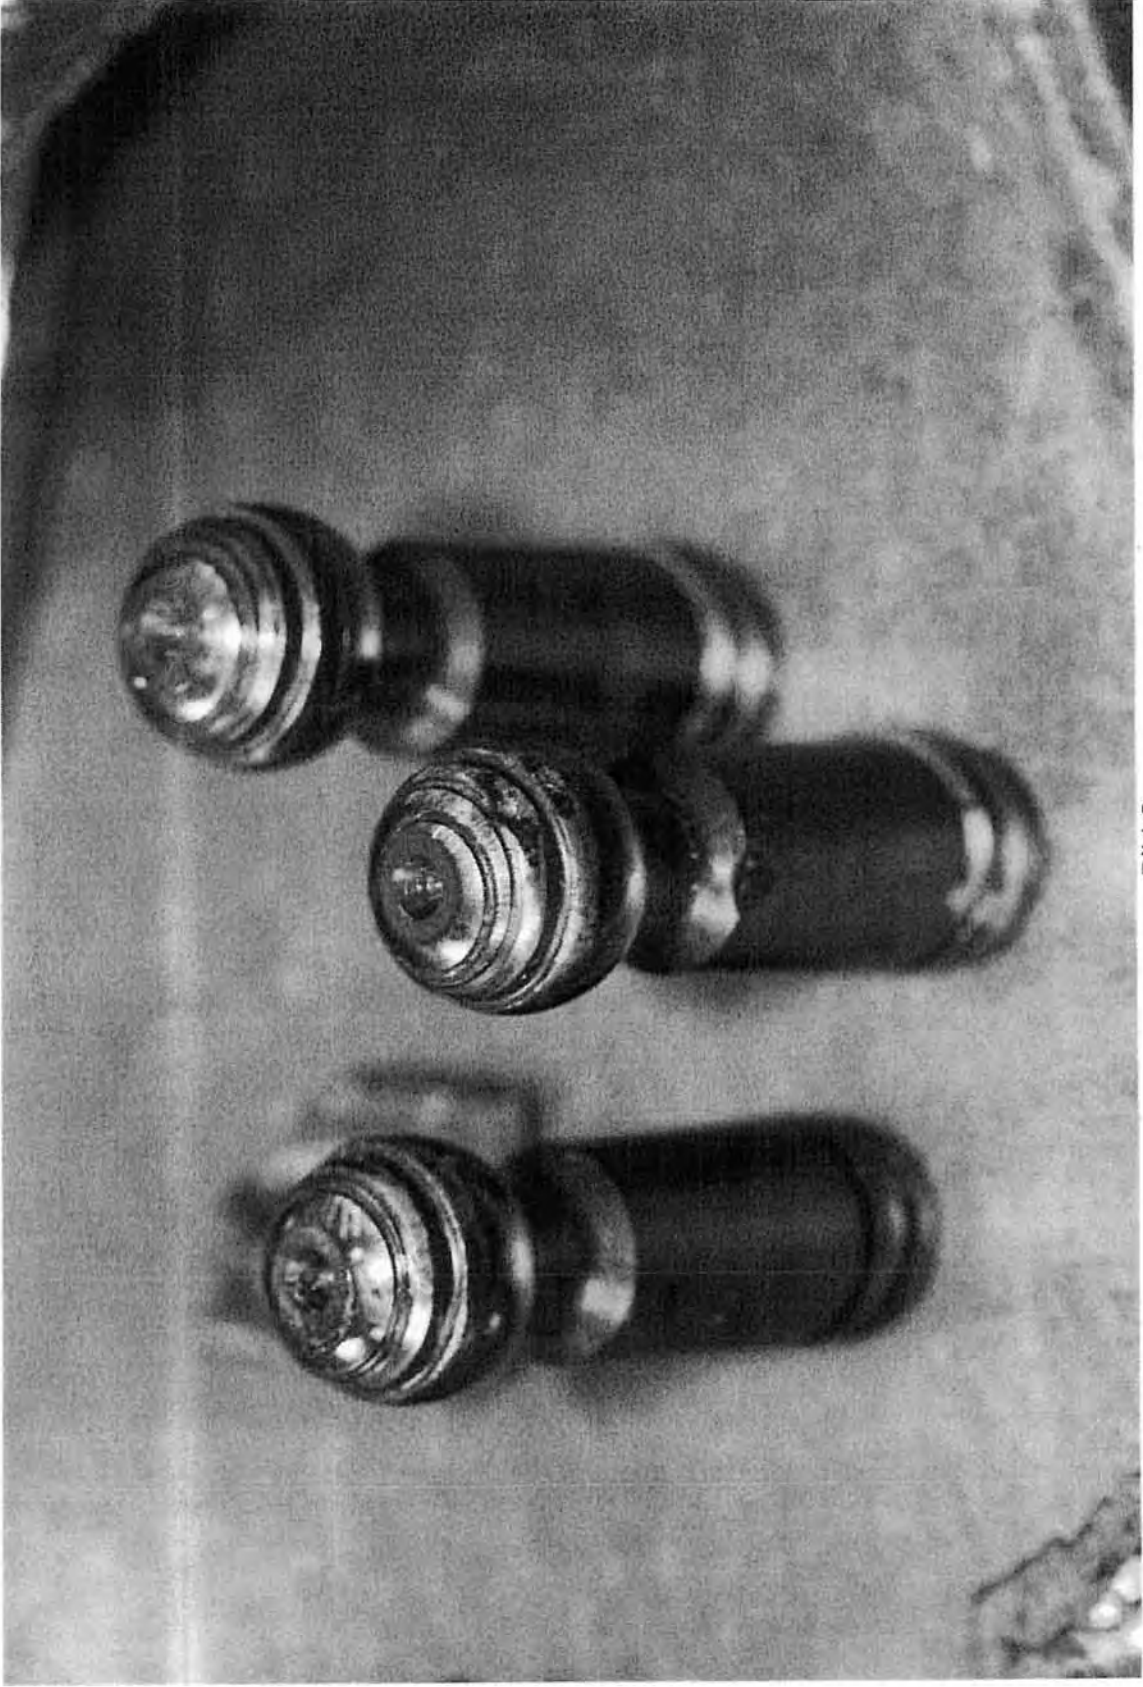
Bild 6

Piston – see picture 6
