History of the failed mooring line

Bridon comments in response to the condition of *Al Ghuwairiya* mooring lines

## LNG Mooring Line Failures

**Mooring line failure resulting in serious injury to a  
deck officer on board  
*Zarga*  
alongside South Hook LNG terminal,  
Milford Haven  
on 2 March 2015**

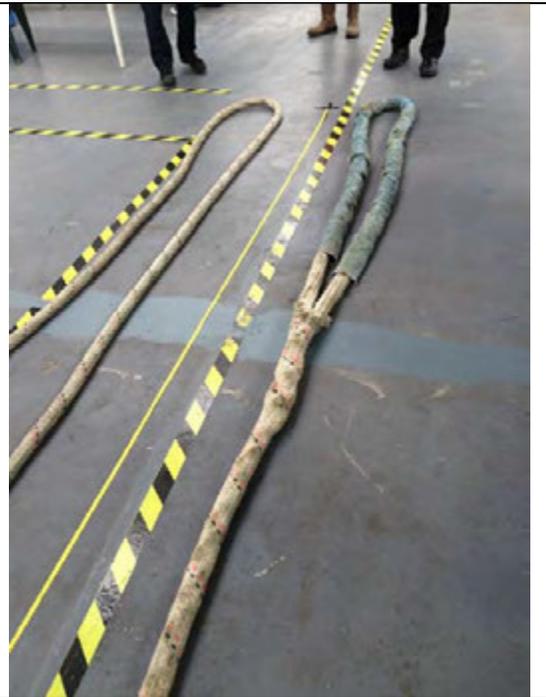
Figure 3.1.2 – Factory finished eye and splice

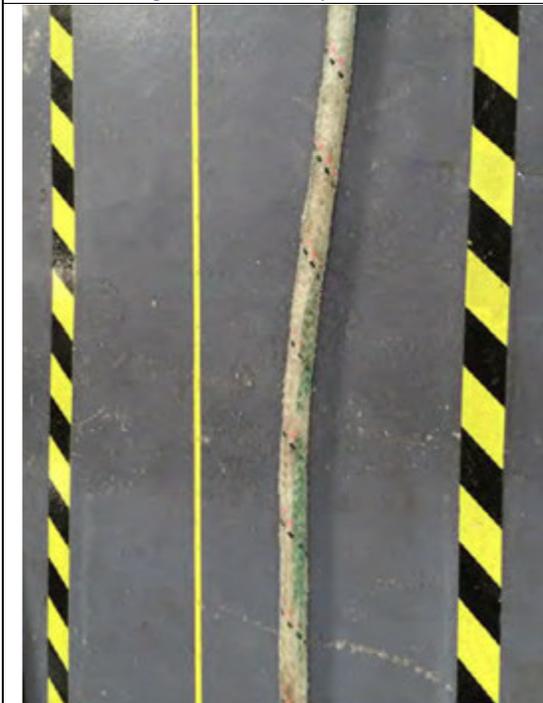
A 25 metre section was now also identified for removal for subsequent splicing into a full rope break test sample. This was originally proposed to be placed immediately after the residual sample however a section of paint had been identified as noted earlier. This section was moved 6 metres further down the line to ensure that the painted section fell within the segment to be removed. Both the residual sample and the spliced section were marked with similar labels '5147 MAIB Shore End. Yarn Realisation Sample' and 5147 MAIB Shore End.

Figure 3.1.3 – Green paint on rope

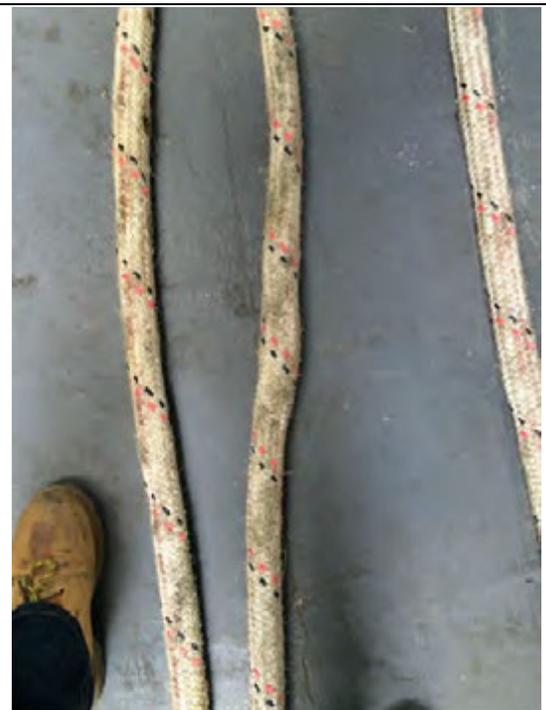
Three further sections of rope were removed. Sample 4, a 25 metre section taken 14 metres from the remaining eye at the winch end. Sample 5, a 25 metre section taken from a position that was approximately in the middle of the rope and sample 6, a 3 metre section taken adjacent to sample 5 to be used for realisation and possible SEM testing.

Figure 3.2.1 – Vessel end rope section laid out

Figure 3.2.2 – Vessel end rope section laid out

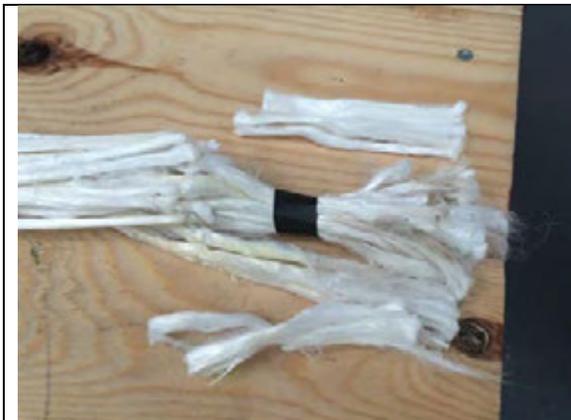
Following identification of the yarn failures within the strands on the shore side sample and the severe 'kink bands' noted in the other original samples removed, a number of additional sections of the rope were visually inspected throughout the rope length. Further yarn failures and damage to yarn were seen, consistent with what would be expected from axial compression fatigue. Section 6 includes photographs of these visual inspections. Sections 8 and 9 discusses the evidence and causes of axial compression fatigue in greater detail.

Figure 4.1.1 – Original Shore side sample – yarn failures

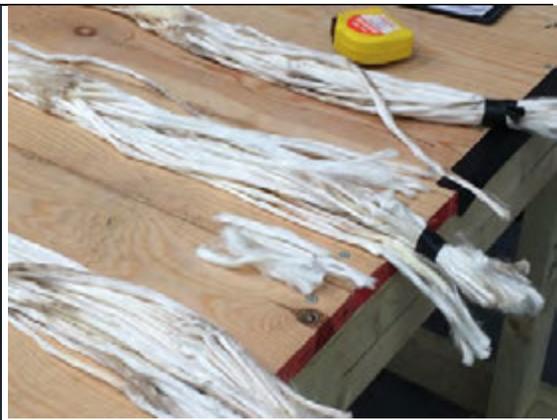
Figure 4.1.2 – Original Shore side sample - Multiple yarn failures in core yarn of one strand

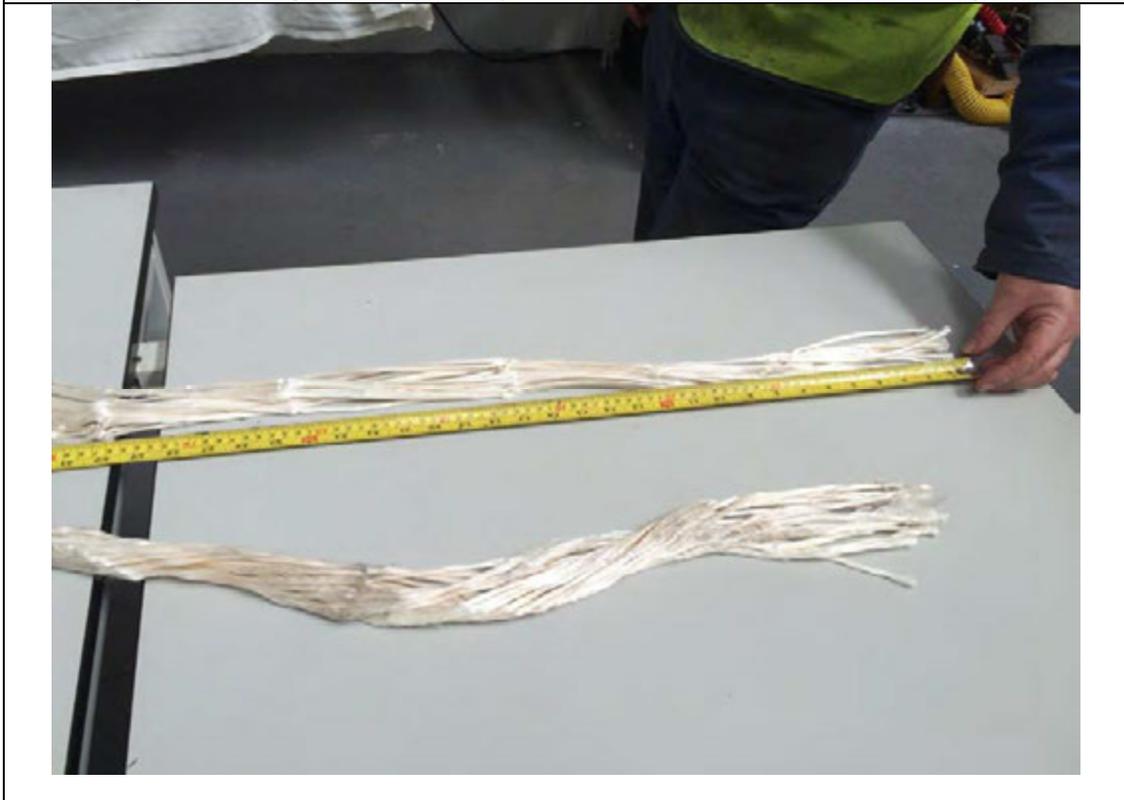
Figure 4.1.4 – Original Shore Side Sample - Kink band frequency measurement

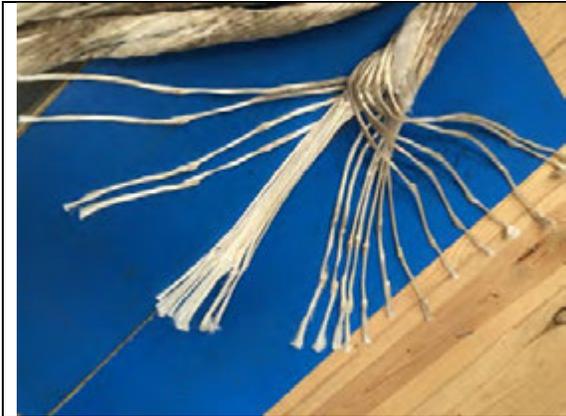
Figure 6.3 – Shore end – Outer yarns – kinks evident

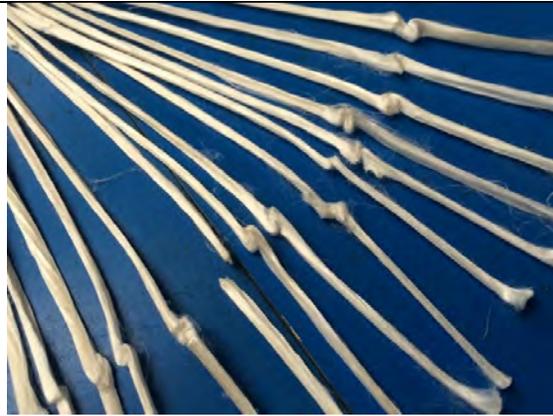
Figure 6.4 – Shore end – inner yarns - single yarn failure and partial failure failures

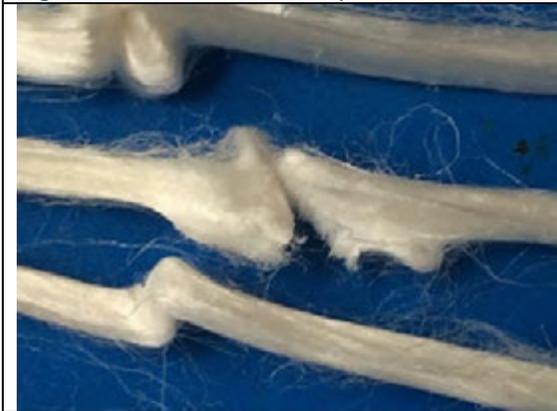
The following photographs shows evidence of yarn distortion and partial and full yarn failure particularly in the shore end sample. Figure 6.5 shows a partial failure at a kinkband, confirming the failure mechanism gives a regular end as shown in figure 6.6 where complete yarn breakage has occurred.

Figure 6.5 – Shore end - partial yarn failure

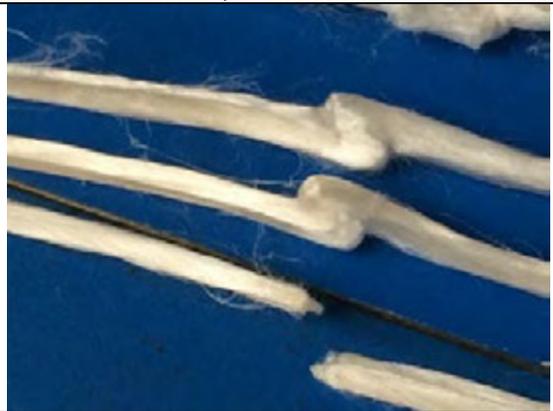
Figure 6.6 – Shore end - failed end

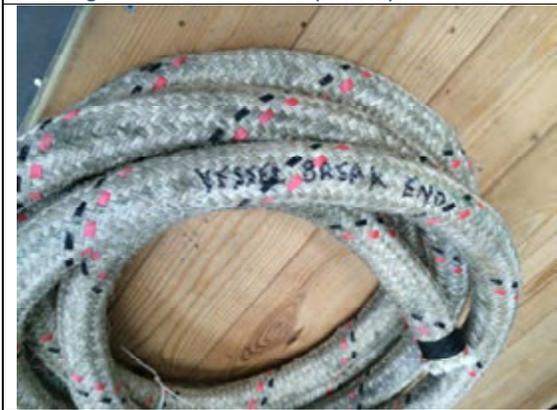
Figure 6.7 – Vessel break end

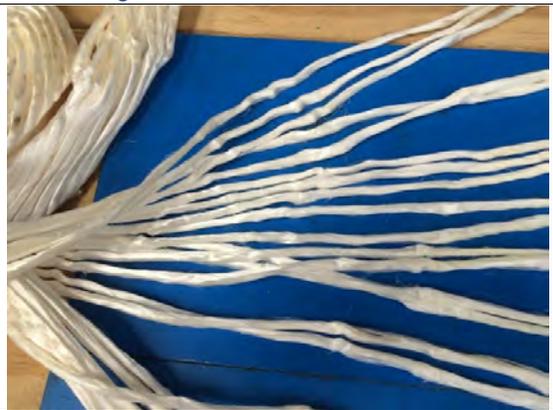
Figure 6.8 – Outer yarns – All strands similar condition

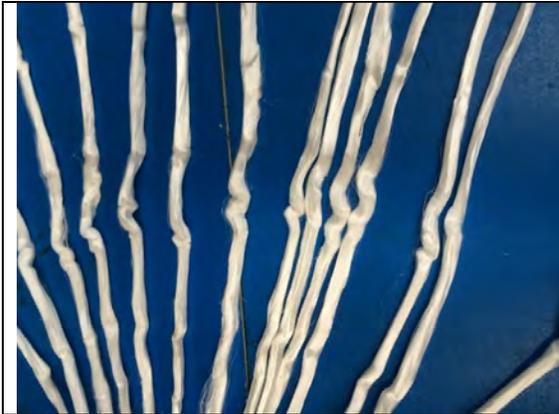
Figure 6.9 – Vessel Break end - Inner yarns with moderate kinks

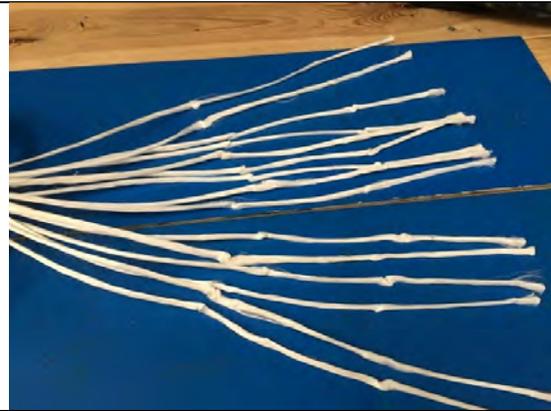
Figure 6.11 – Vessel end middle – outer yarns. All strands with similar small kinks

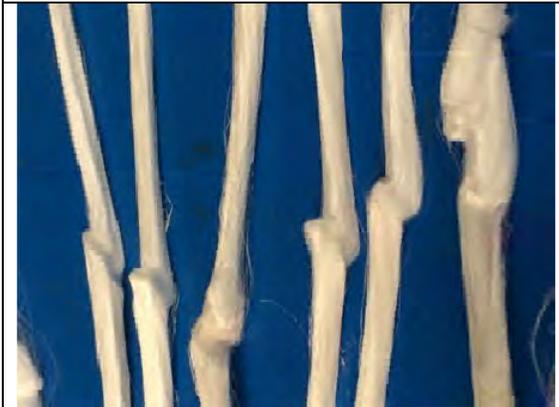
Figure 6.12 – Vessel end middle – severe kinks found in one strand

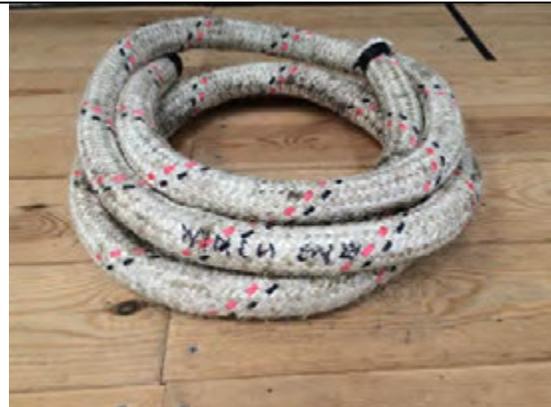
Figure 6.13 – Vessel end middle – severe kinks found but no evidence of yarn failure

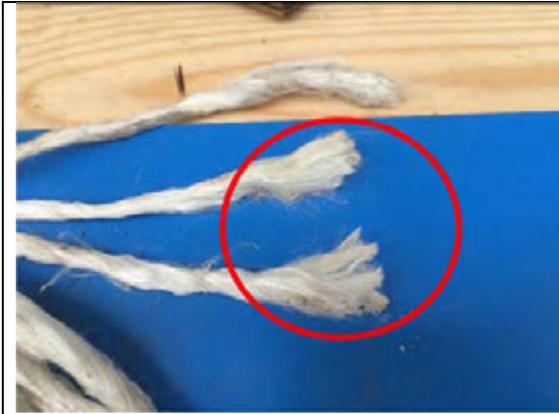
Figure 8.5 – Shore side possible kinkband failure

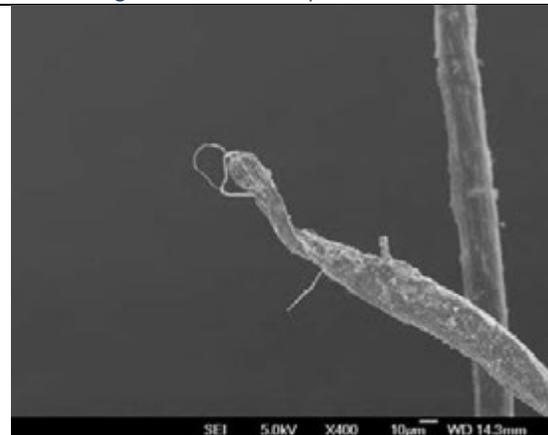
Figure 8.12 – Close up of filament failure

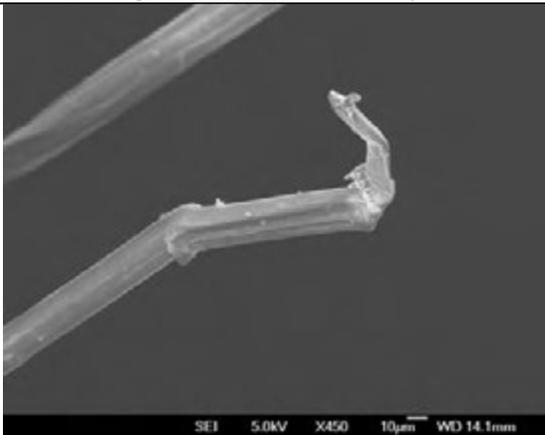
Figure 8.16 – Area A – Kinkband filament failure

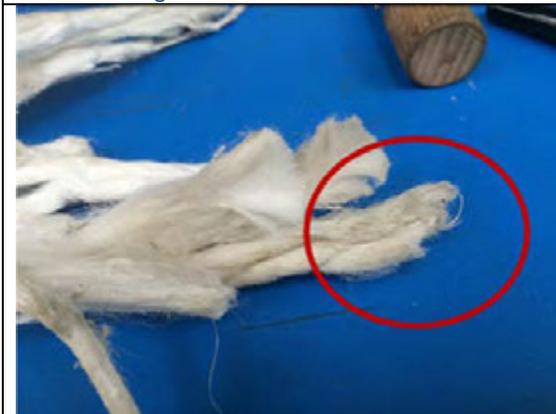
Figure 8.27 – Vessel end possible tensile failure

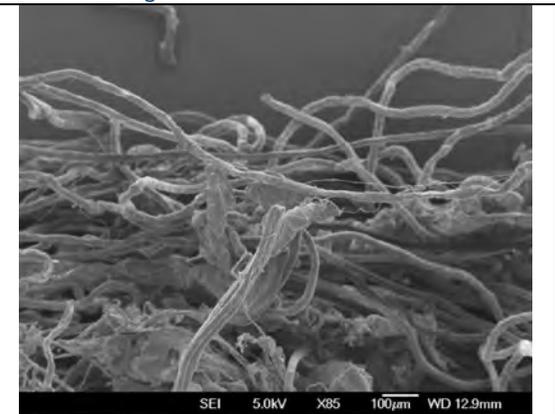
Figure 8.28 – close up of tensile failure end

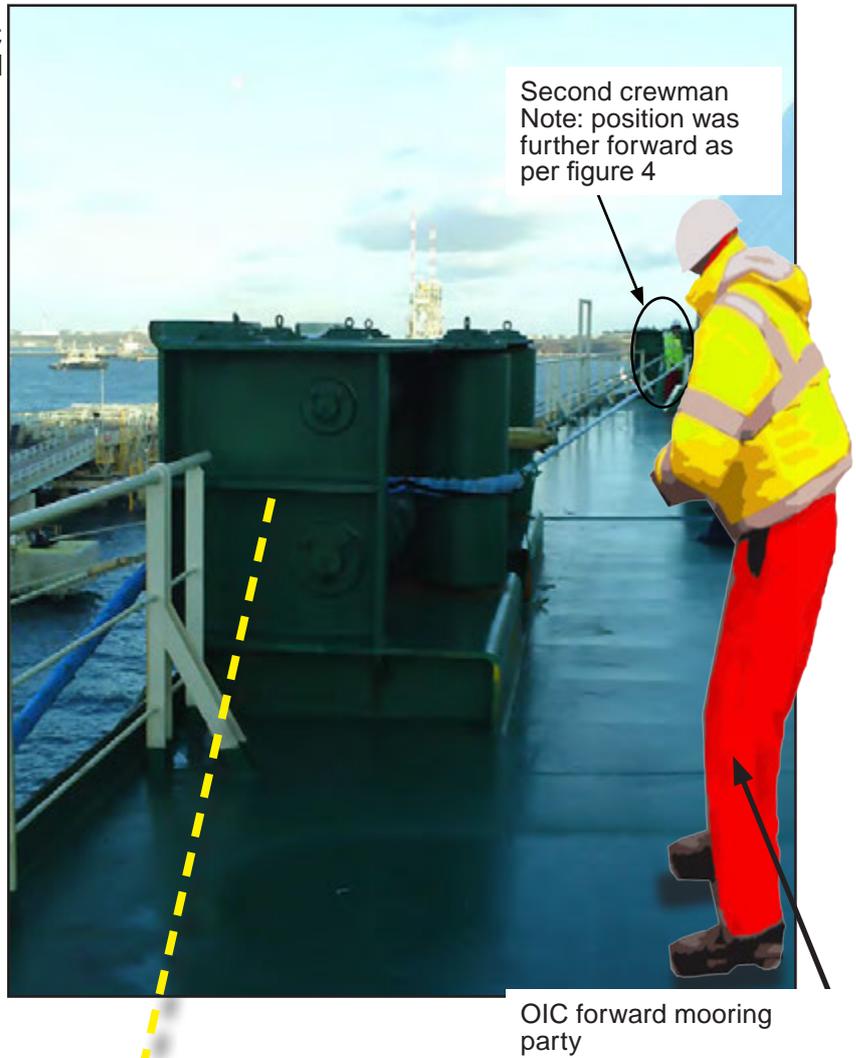
**Figure 3:** Forward mooring party OIC at port-shoulder roller fairlead

**Figure 4:** Port side forward mooring deck

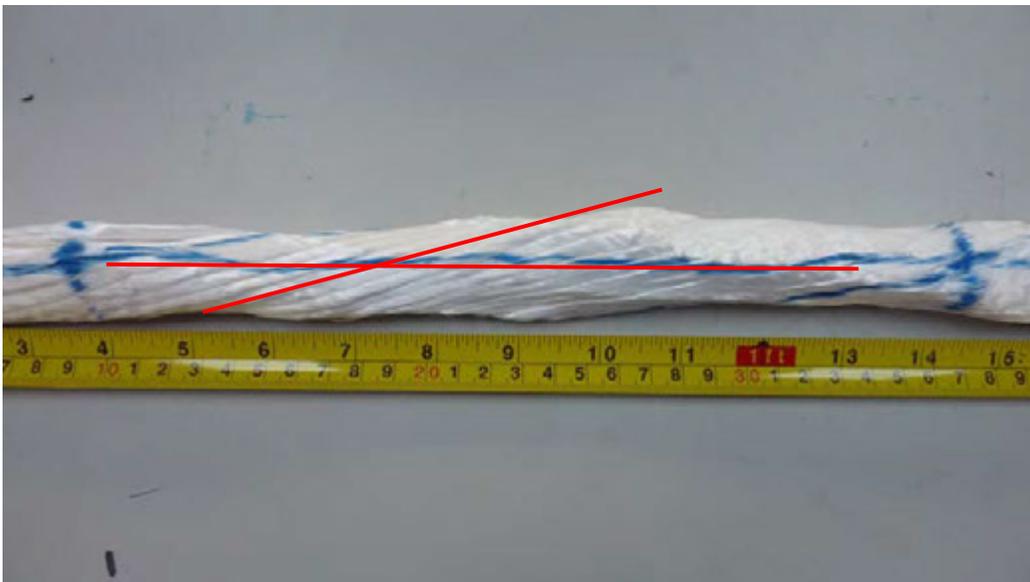
Figure 4.1.2: Sample 1, strand unlaidd, and showing only minor buckling to the outer layer yarns (cannot really see from this side of strand, see figure 4.1.5). Lay angle approx. 15 degrees and pitch 260mm.

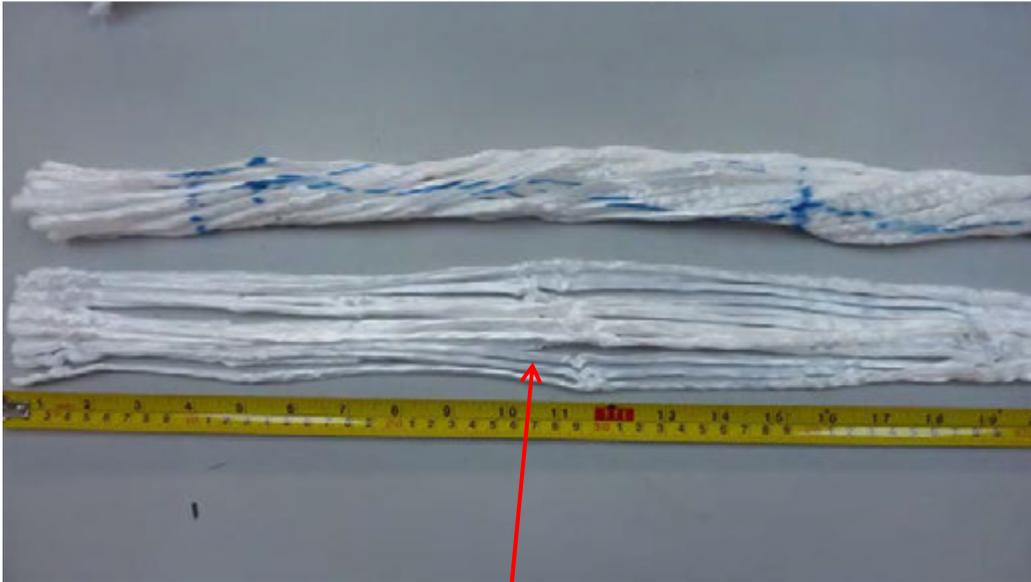
Figure 4.1.3: Sample 1, strand unlaidd to rope yarn, inner layers zero twist and severely buckled

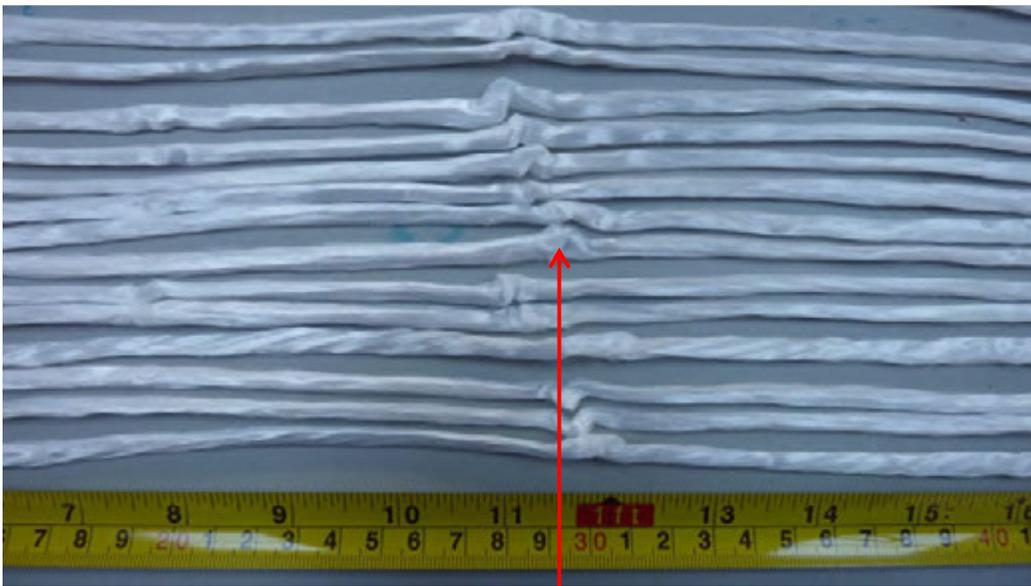
Figure 4.1.4: Sample 1, inner rope yarns, close up of severe buckles shown in figure 4.1.3

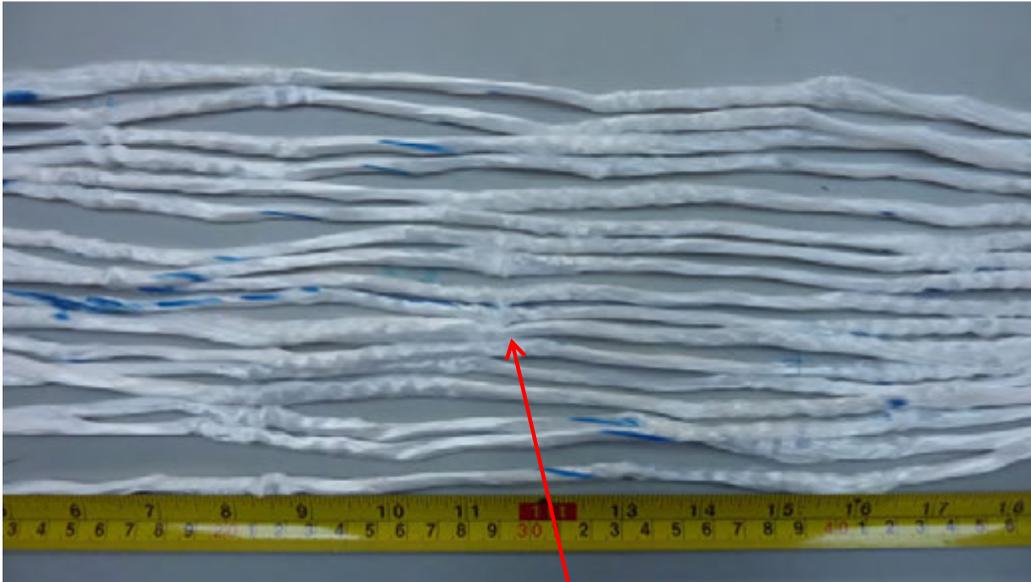
**Figure 4.1.5:** Sample 1, outer rope yarns, close up of mild buckles shown in figure 4.1.3.  
Note not all rope yarns buckled

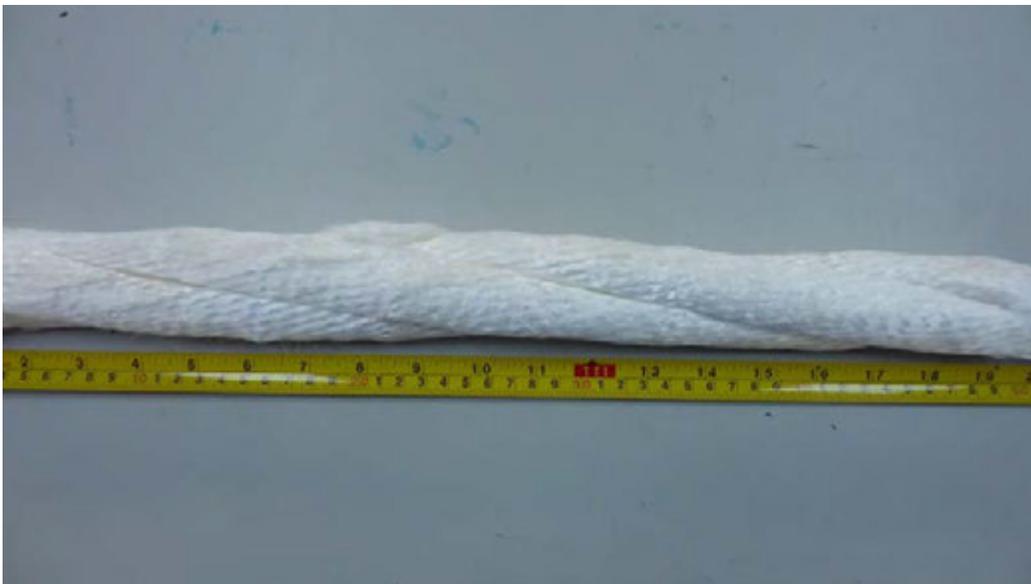
**Figure 4.1.6:** Sample 2, 3 strand subrope, very minor buckling in outer layer

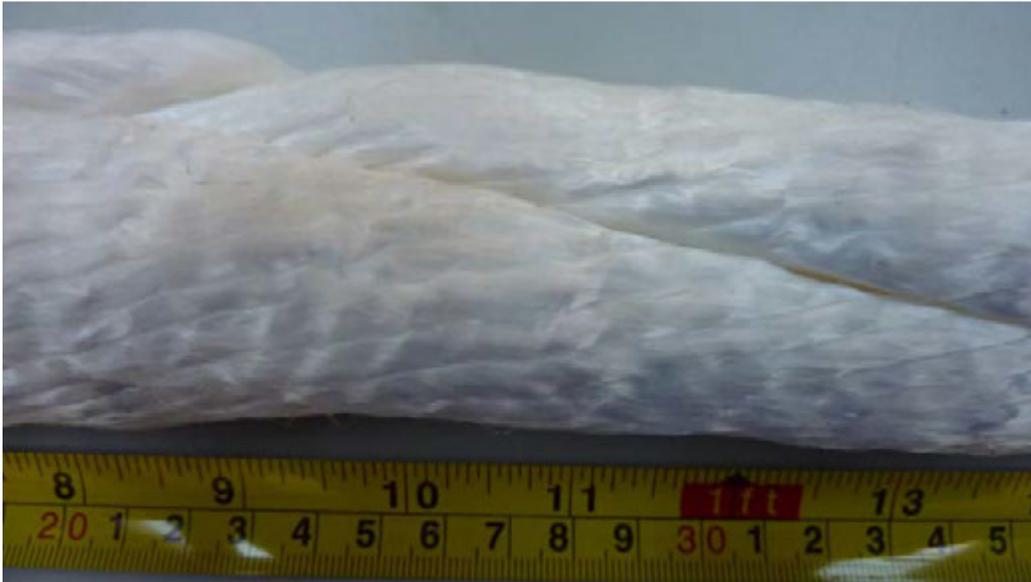
Figure 4.1.7: Sample 2, 3 strand subrope, close up of very minor buckling in outer layer

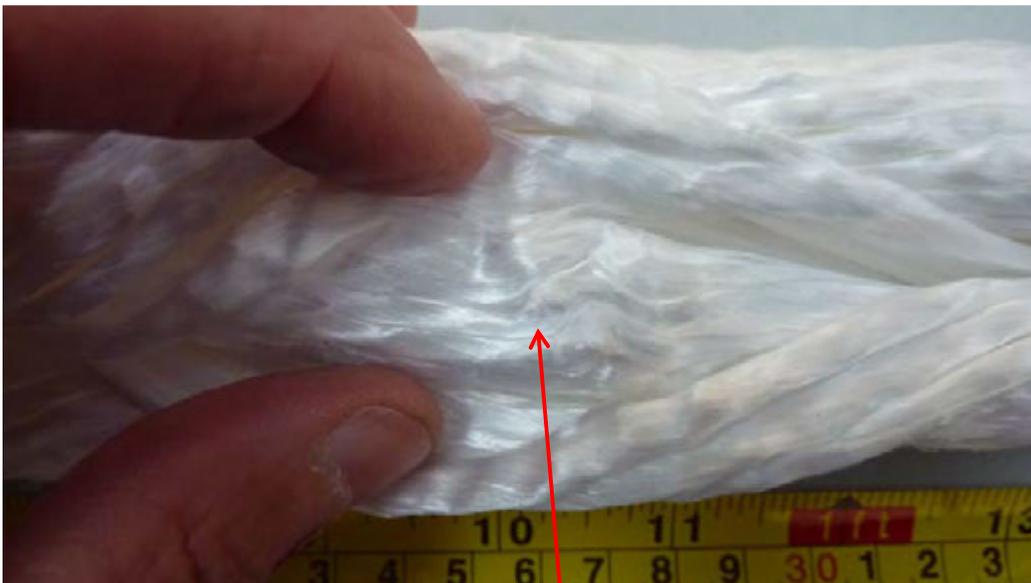
Figure 4.1.8: Sample 2, opened outer layer strand to reveal inner rope yarns, close up of severe buckling

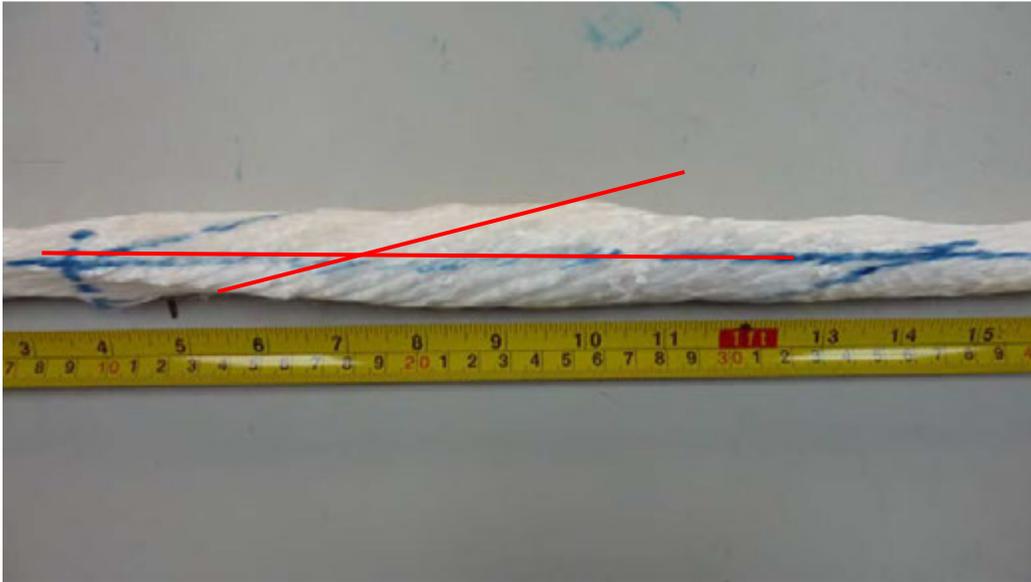
**Figure 4.1.9:** Sample 2, Strand unlaidd, very mild buckling in outer layer rope yarns, 15 degrees and pitch 255mm.

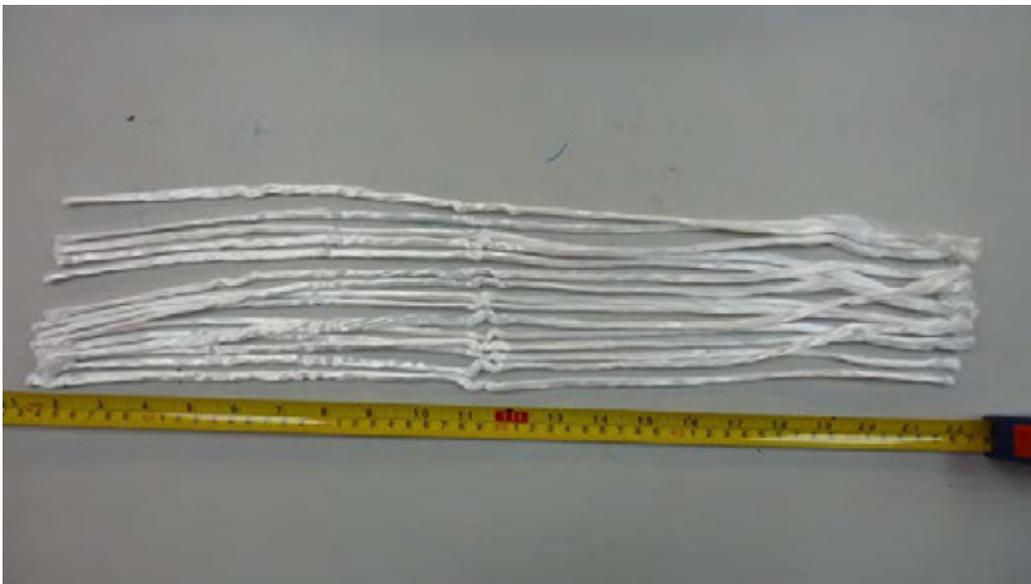
**Figure 4.1.10:** Sample 2, unlaidd strand to reveal inner rope yarns, most severely buckled.

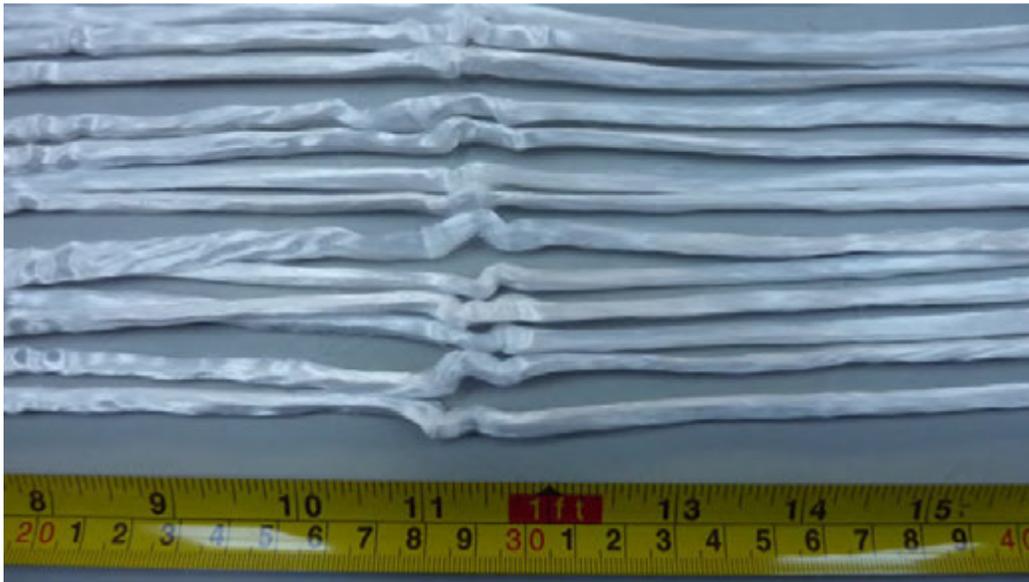
Figure 4.1.11: Sample 2, close up of severe buckling in figure 4.1.10

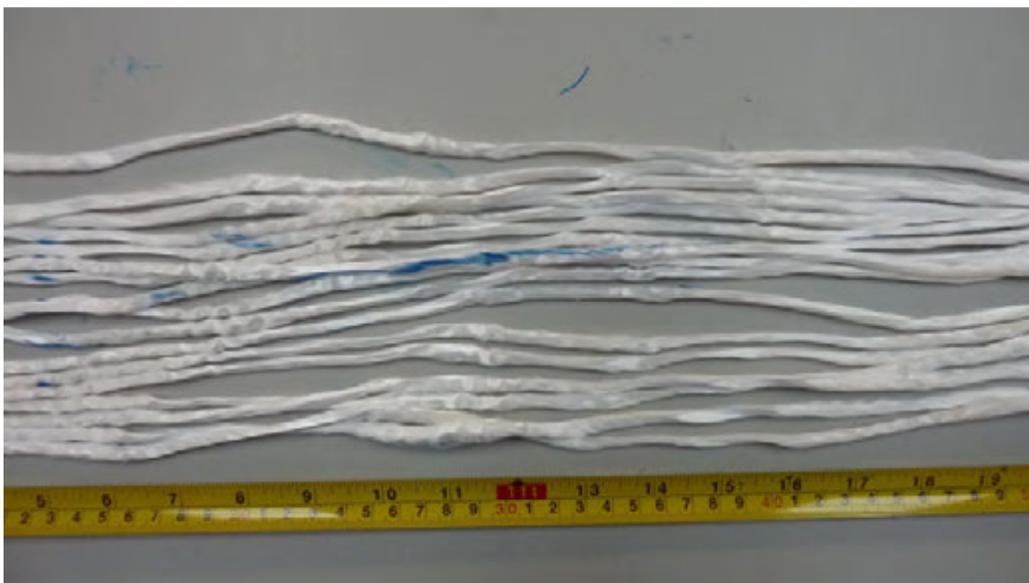
Figure 4.1.12: Sample 2, outer rope yarns, mild buckles shown in figure 4.1.9, note not all yarns buckled

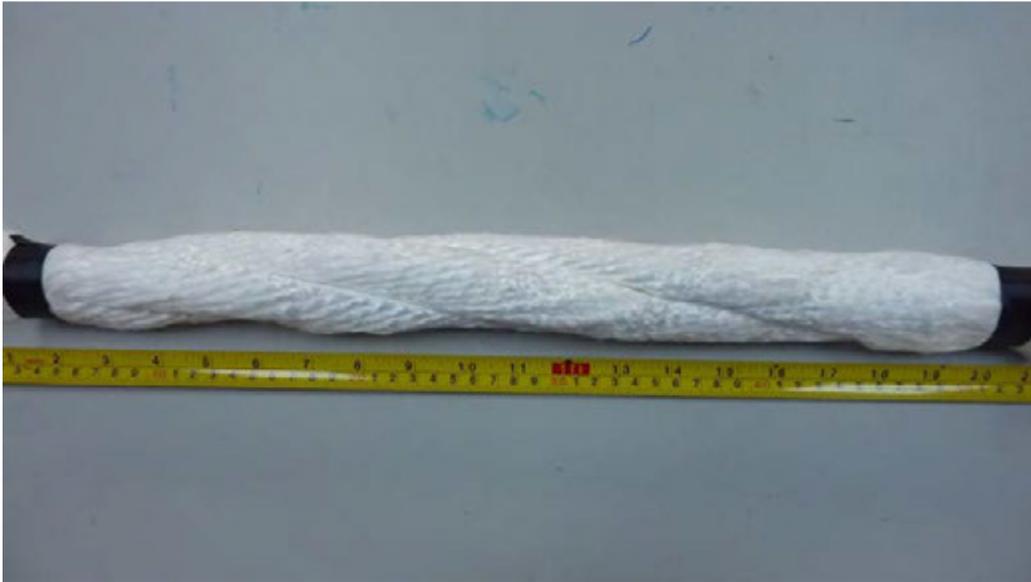
**Figure 4.1.13:** Sample 3, 3 strand subrope, very minor buckling in outer layer

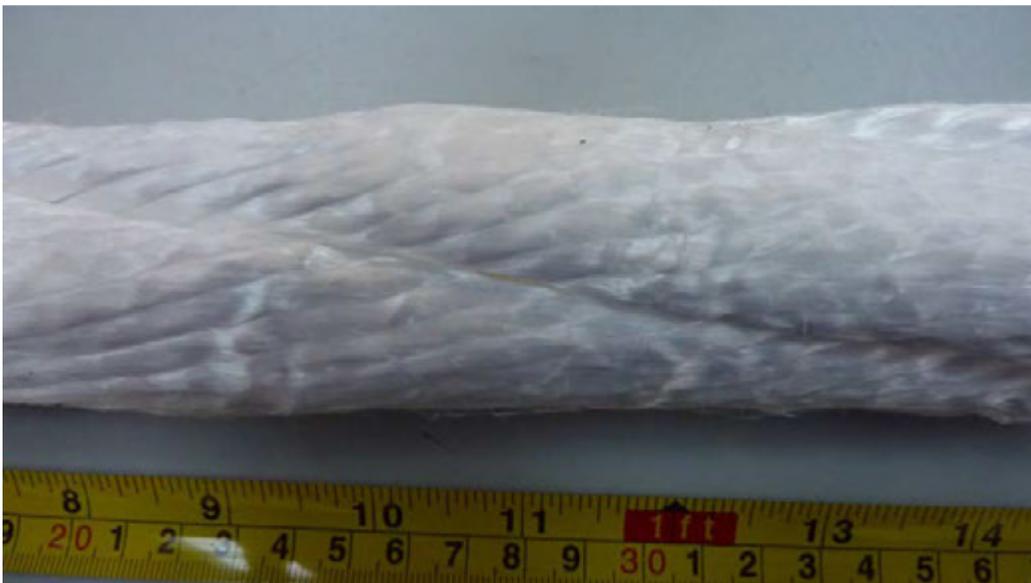
**Figure 4.1.14:** Sample 3, 3 strand subrope, close up of figure 4.1.13, very minor buckling in outer layer

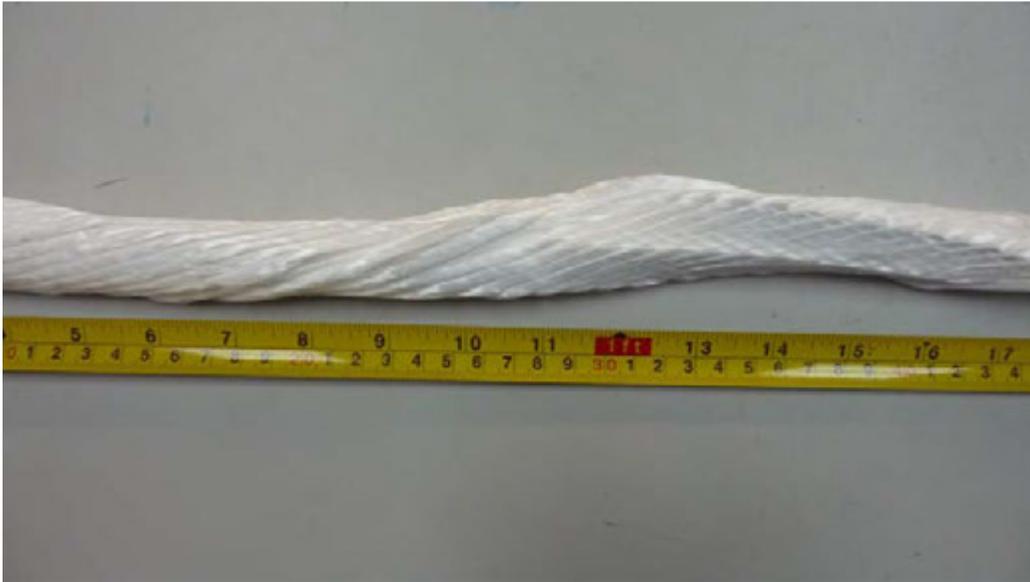
Figure 4.1.15: Sample 3, strand unlayed, very minor buckling outer layer rope yarns (cannot really see from this side of strand, see figure 4.1.19).

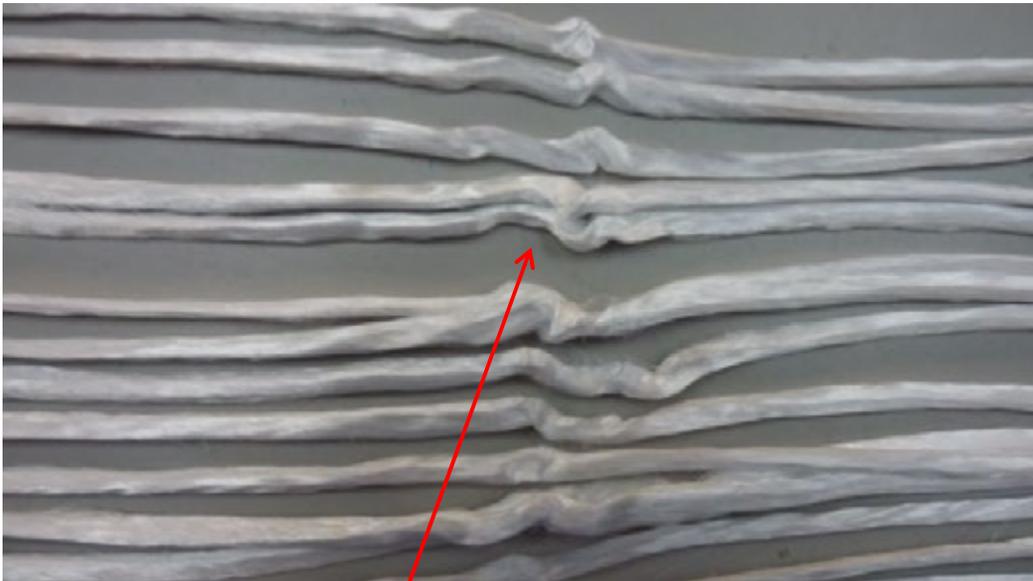
**Figure 4.1.18:** Sample 3, close up of severe buckling in figure 4.1.17

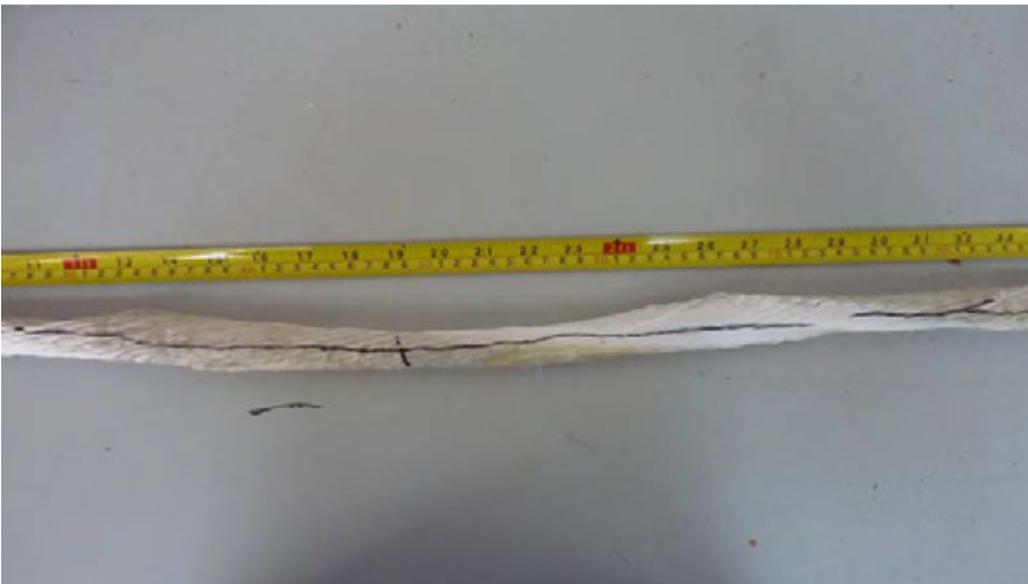
Figure 2.1 Strand removed from subrope to measure pitch

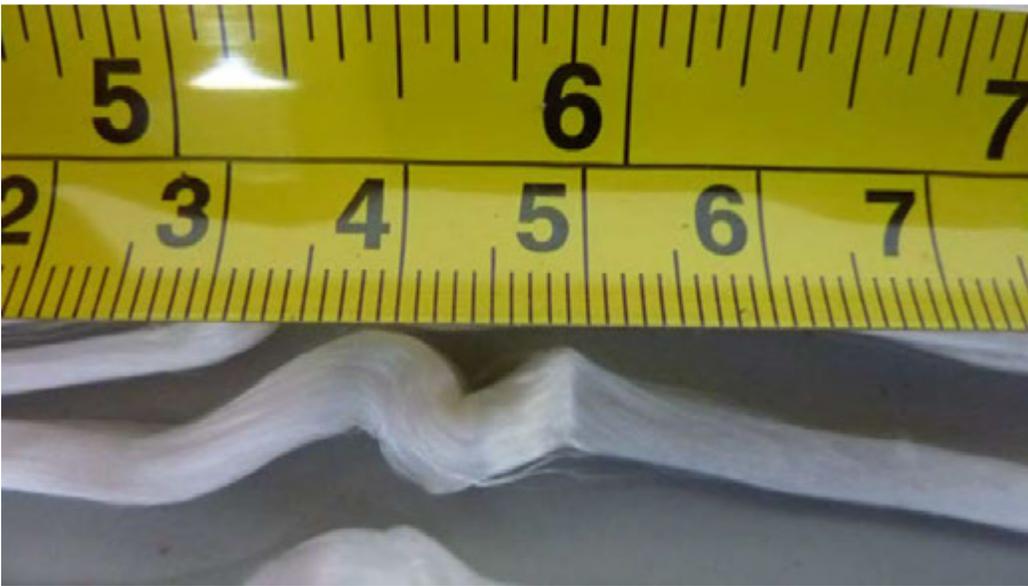
Figure 2.3. Close-up of an inner yarn buckle (Mode 4, see below) with a characteristic length of about 10mm

More importantly, the characteristic buckle lengths (ranging from 12mm at 10MPa to 6mm at 80MPa) bracket the 10mm seen in Figure 2.3. This fact suggests that displacements that could be precursors to elastic buckling rapidly turn into the substantial plastic (kinkband) buckles with the wavelength seen in the dissected rope.

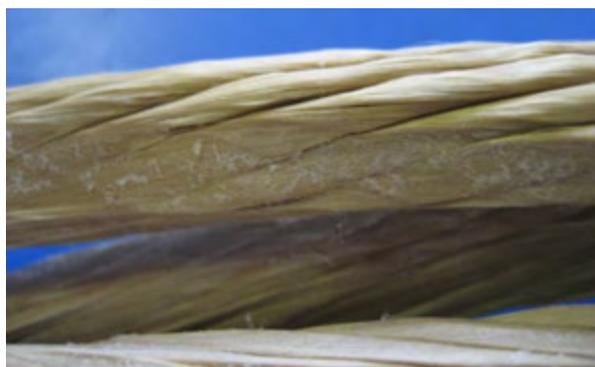
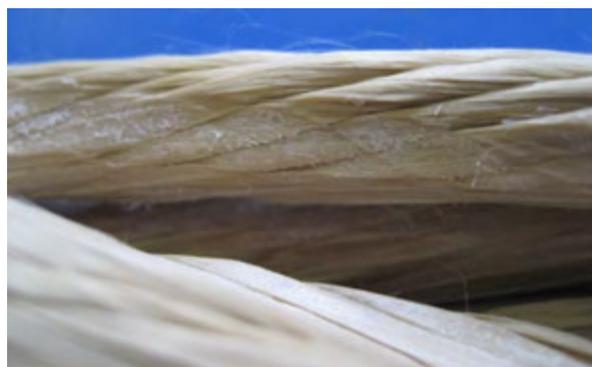
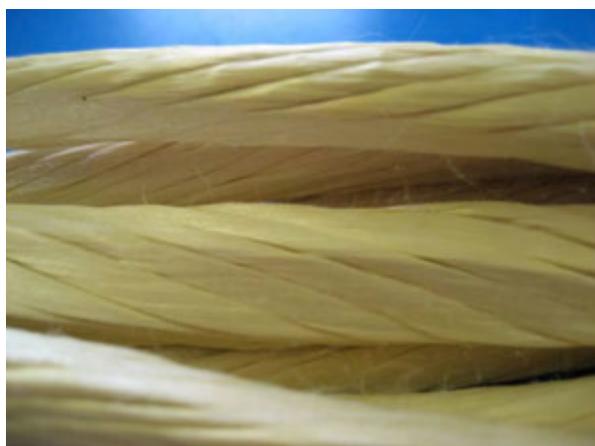
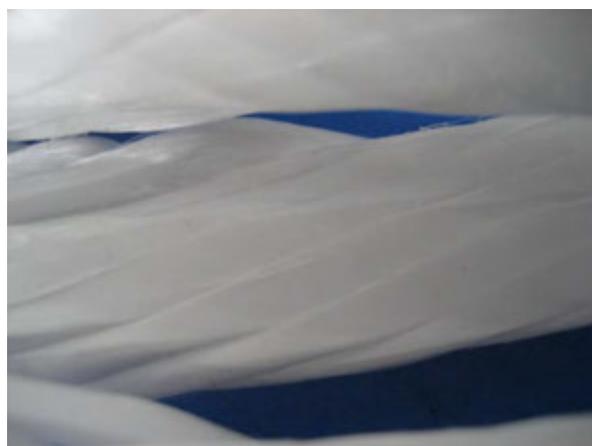
The samples were then examined for inter-strand abrasion. Figure 10 shows the condition of each in the region of the T3 position. Both of the T200 samples had similar levels of inter-strand abrasion. The inter-strand abrasion on the Twaron 2304 sample seemed slightly lower. The condition of the HMPE rope was very good, with little abrasion and only a few broken filaments noted (Figure 10d).

**Figure 10:** Internal condition of the ropes on completion of the block loading fairlead tests.

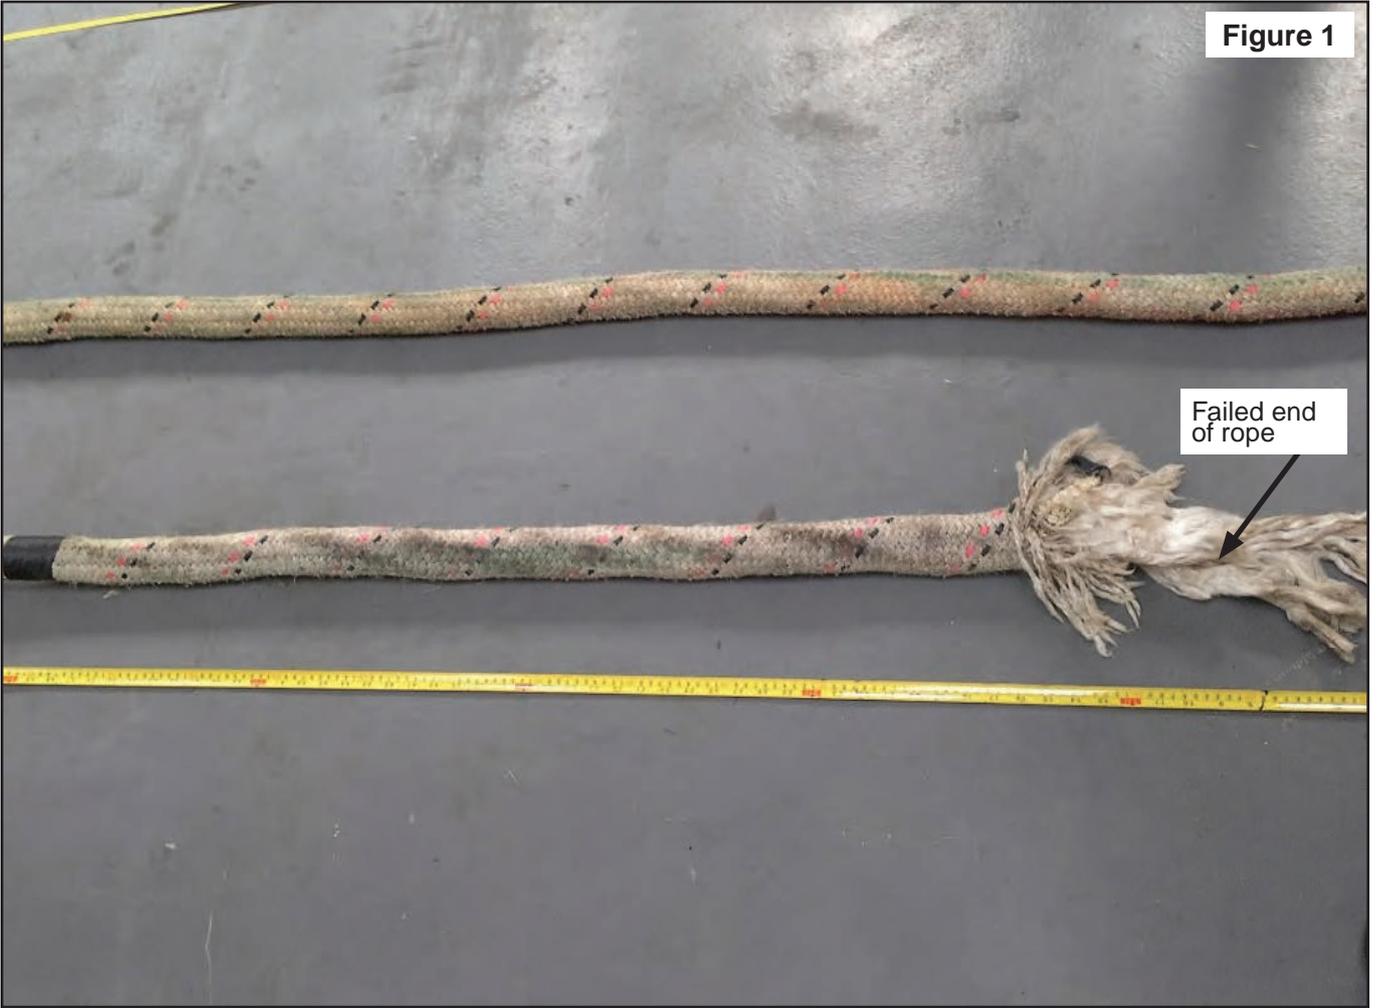
Figure 1

The rope failed at an indicative load of 24 tonnes. Subsequent non-destructive assessment of the rope by an industry expert did not identify any defects that would indicate that it had been used or operated incorrectly (**Figure 1**).
