Grenfell Tower

Final Design Validation

Ministry of Housing, Communities, and Local Government

5186876-ATK-XX-XX-RP-SE-000003

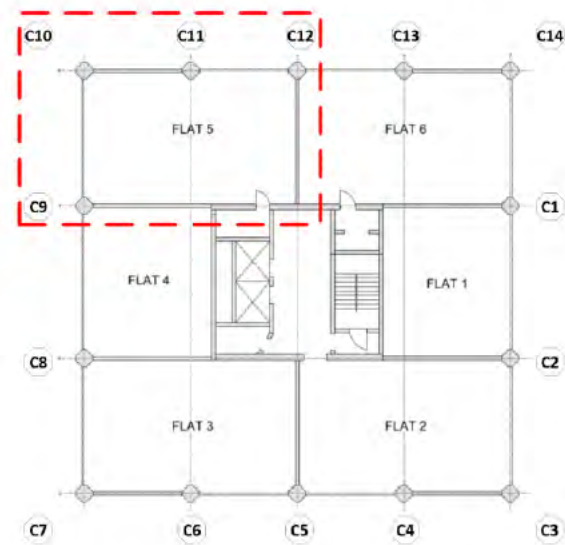
Figure 5.7 – Load path examination

The corner column, C10, in Flat 5 between Levels 13 and 14 suffered significant damage during the fire as shown in Figure 5.14. It is assumed that prior to installation of the Stage 1 propping around this column, the dead load would have redistributed to other parts of the structure.

In order to investigate the likely effect of this load distribution, analysis results for the floors and columns above Level 12 at Flat 5 have been examined in more detail; this zone is shown in Figure 5.7.
