RE: Request for Information – RFI4832

Specialist Field:	Marine Consultant and Surveyor
On behalf of:	Homes and communities Agency
Subject:	Condition / Cost of Disposal

INSPECTION OF SRN4 HOVERCRAFT FOR HAZARDS

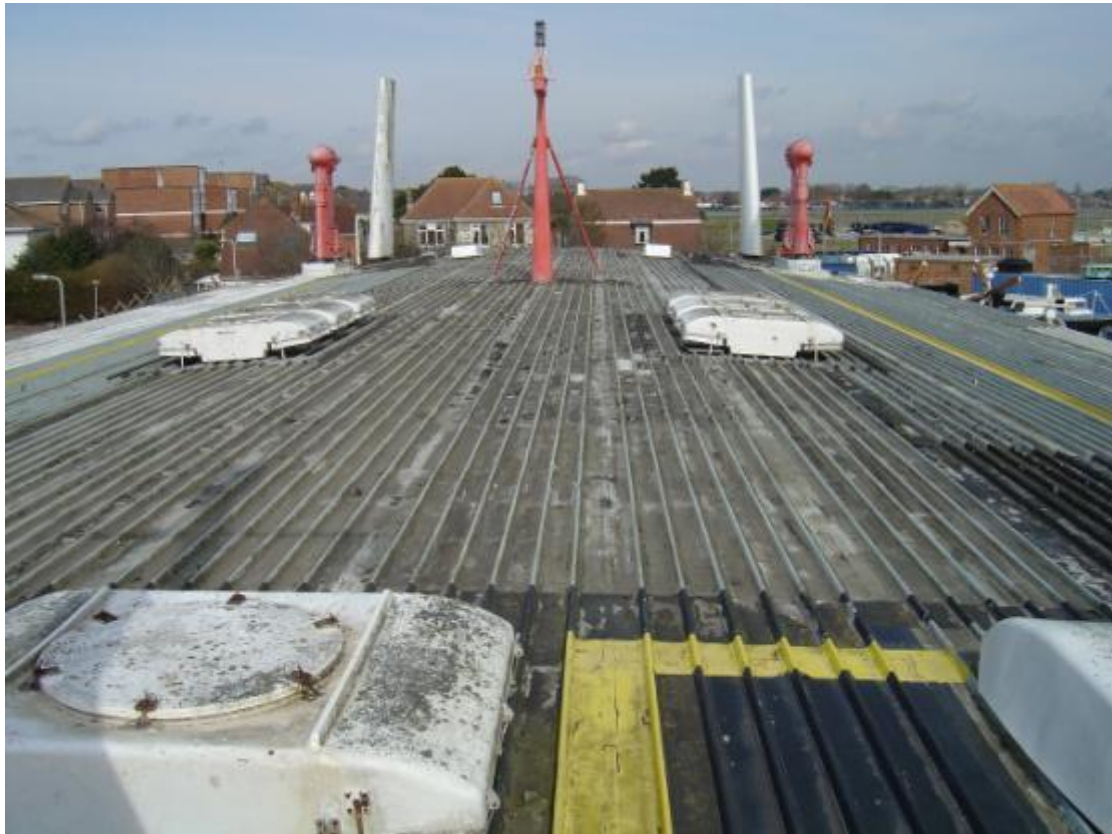
Photograph 1 - Upper deck showing masts and pylons

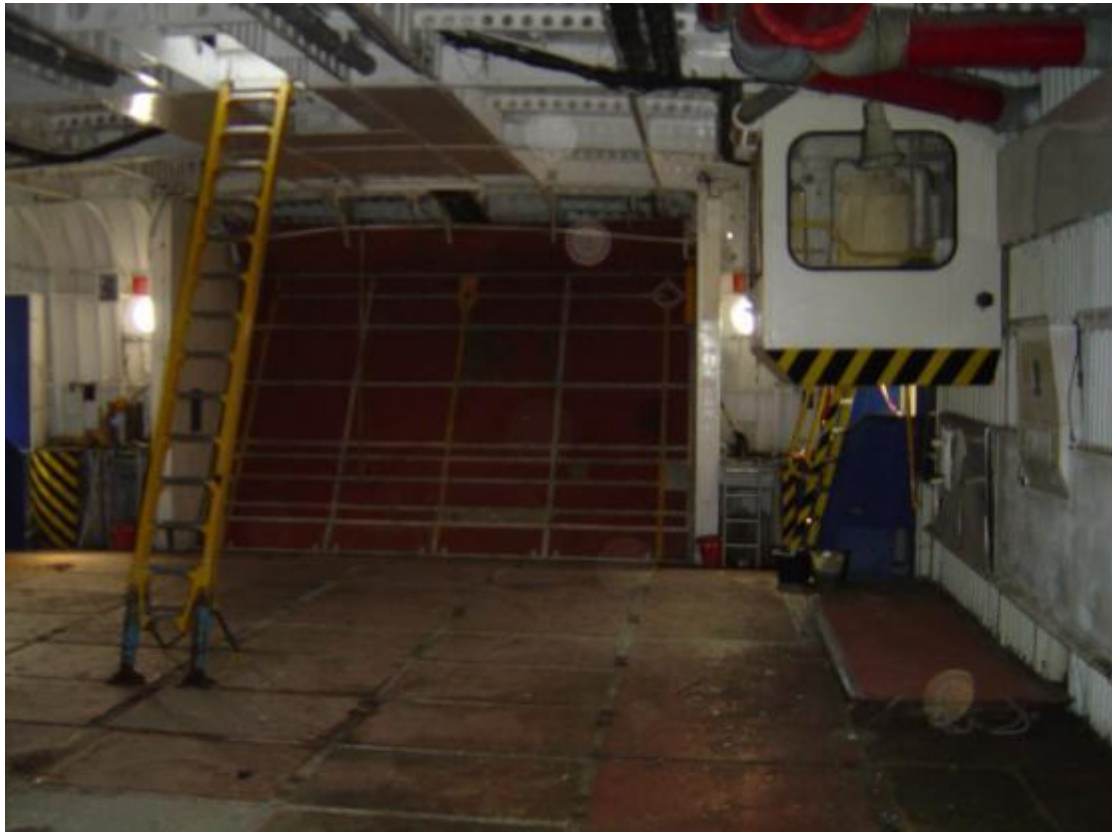
Photograph 2 - Vehicle deck looking forward showing control cabin and ladder to cockpit

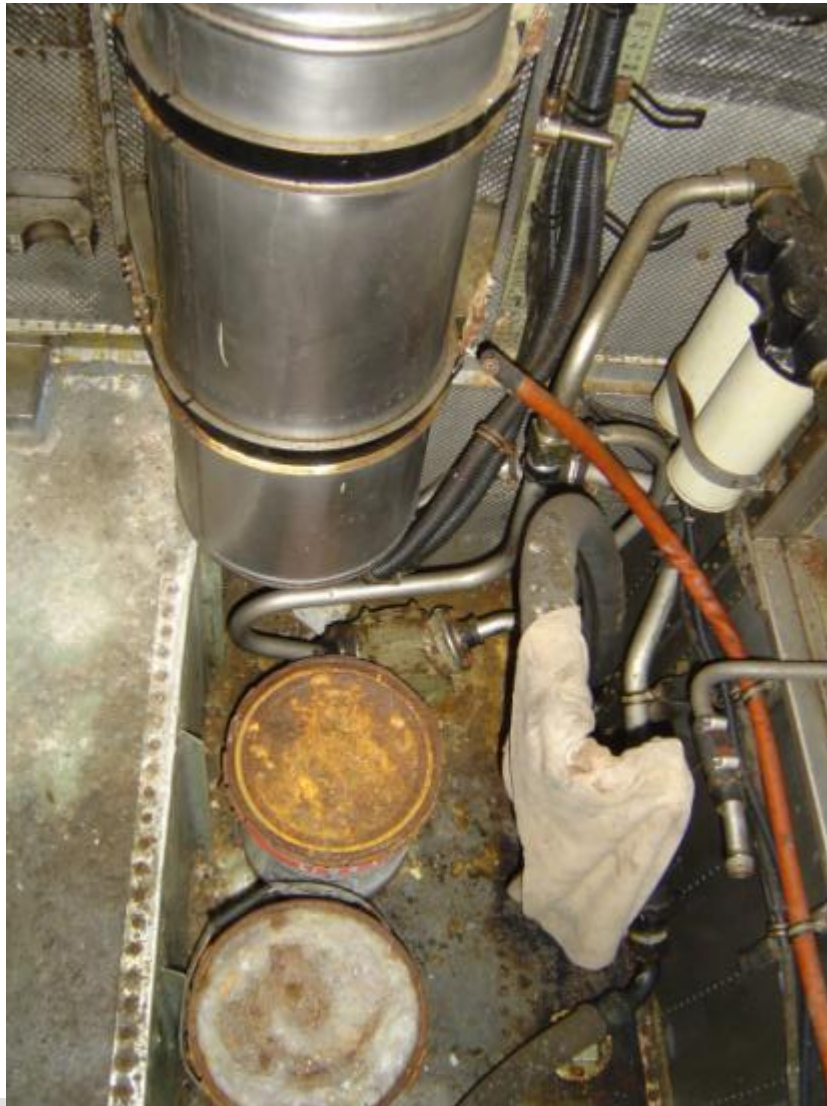
Photograph 3 - Fuel filters (cream) and associated pipework. Paint cans in well

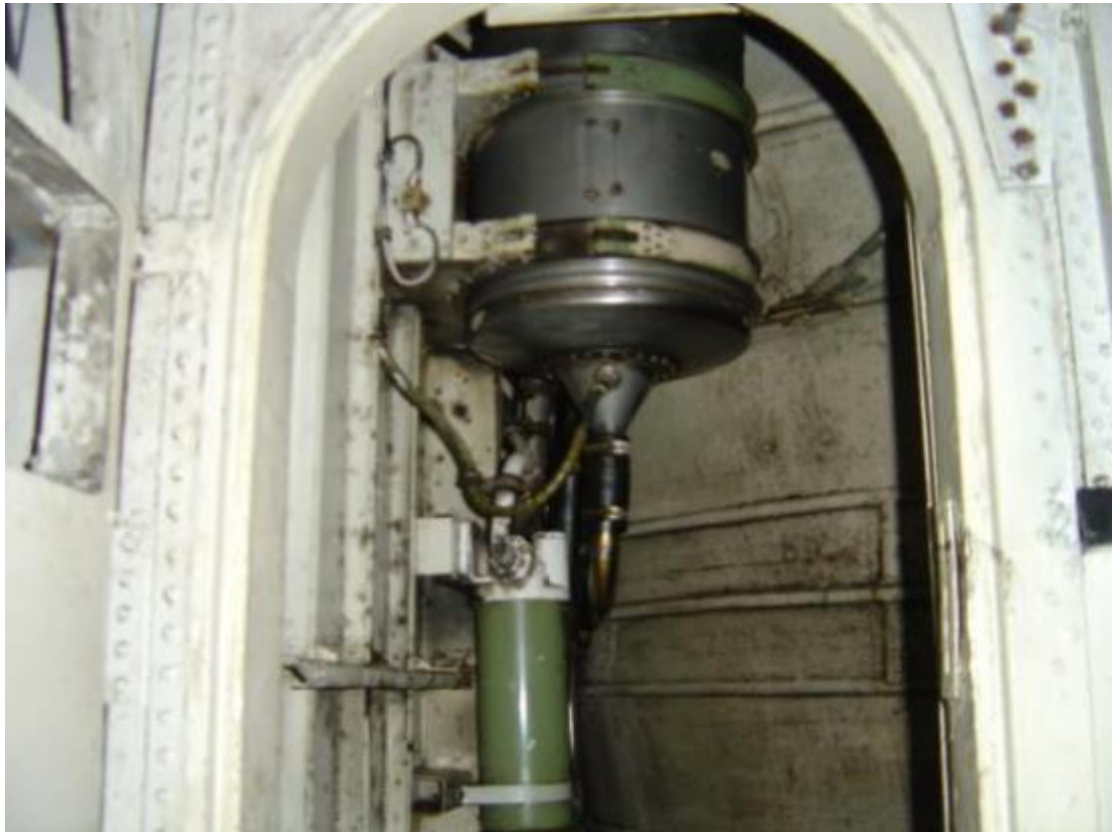
Photograph 4 - Starboard forward hydraulic fluid tank in fan volute space

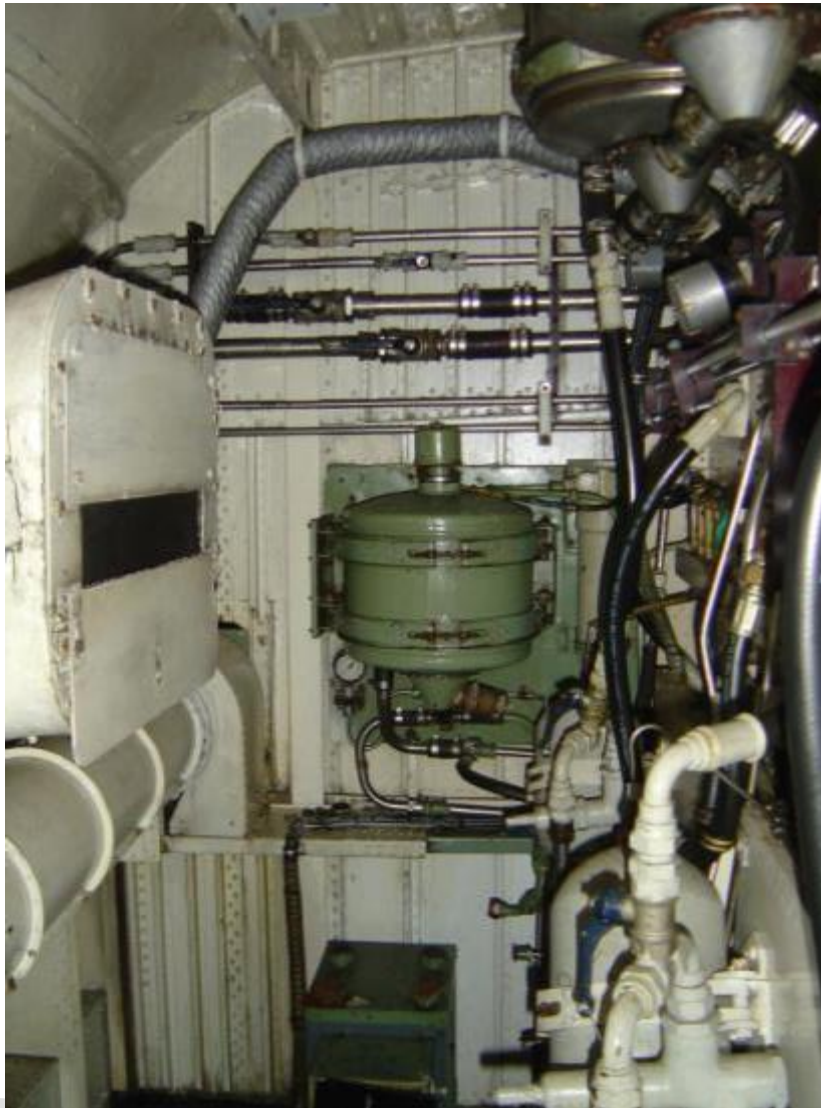
Photograph 7 - Hydraulic compartment port aft – with fin and pylon control lines, tank and accumulators

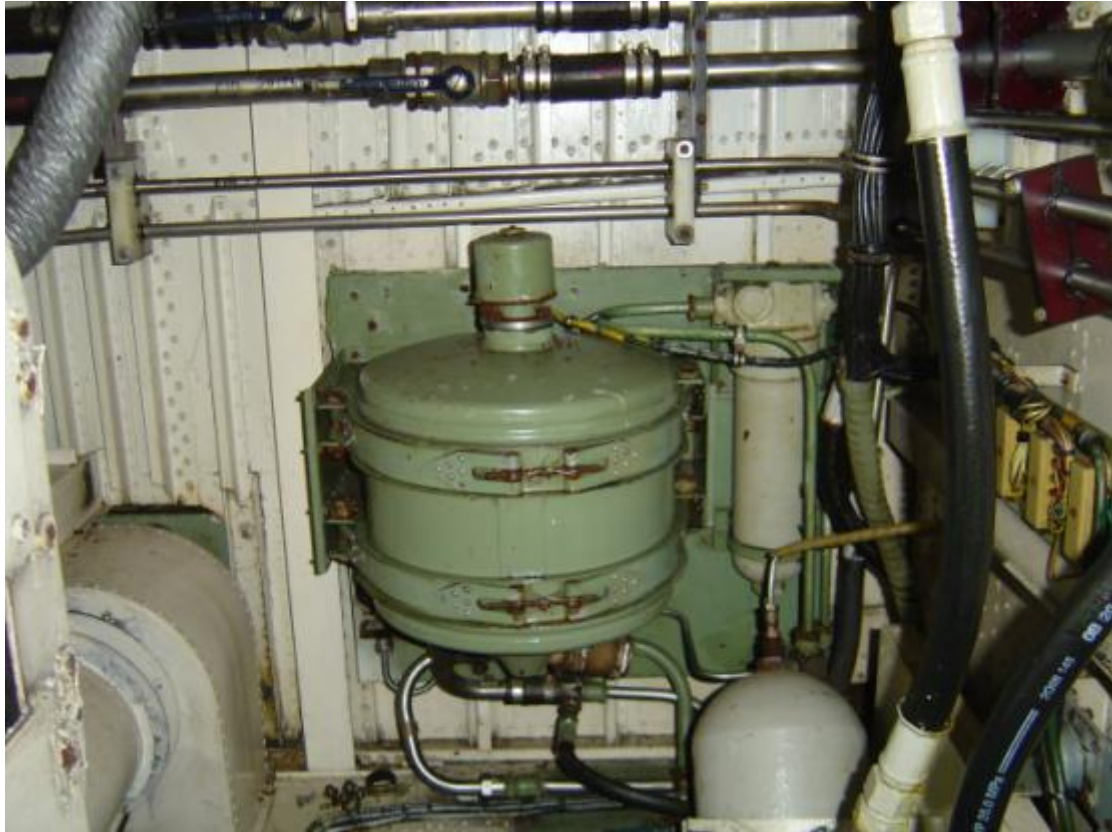
Photograph 8 - Detail of hydraulic tank

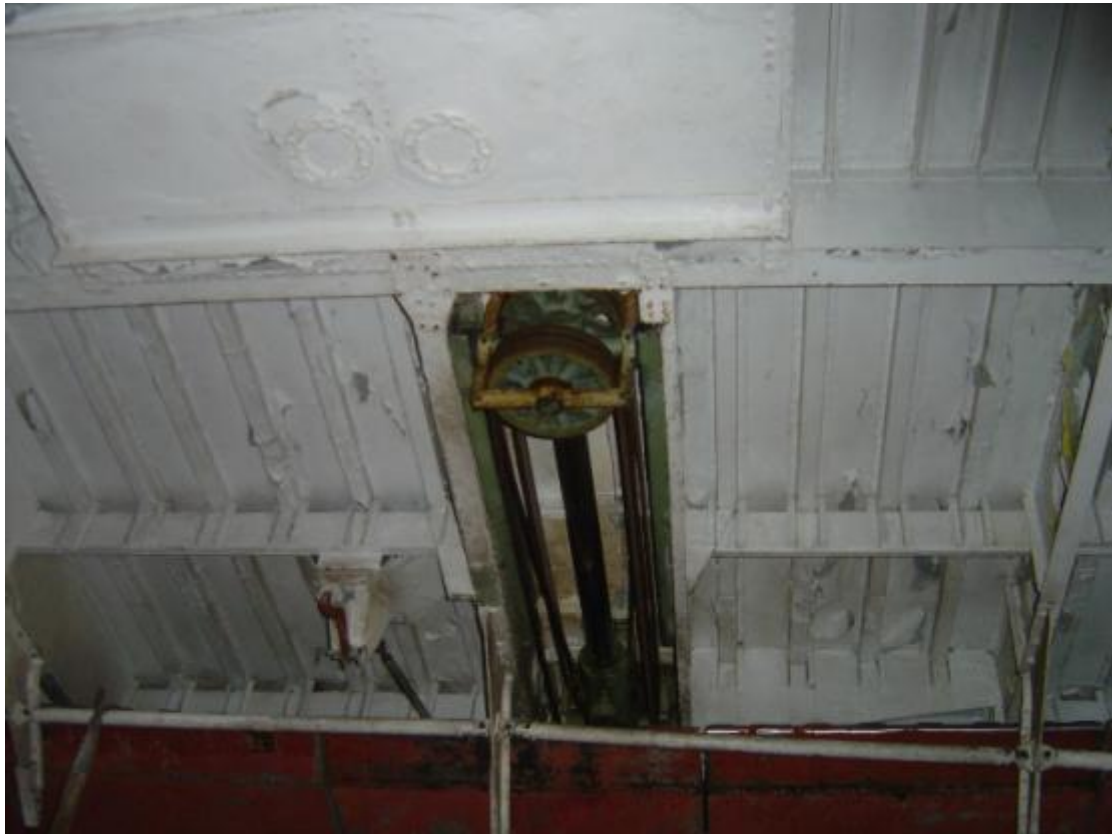
Photograph 10 - Bow door operating ram and pulley

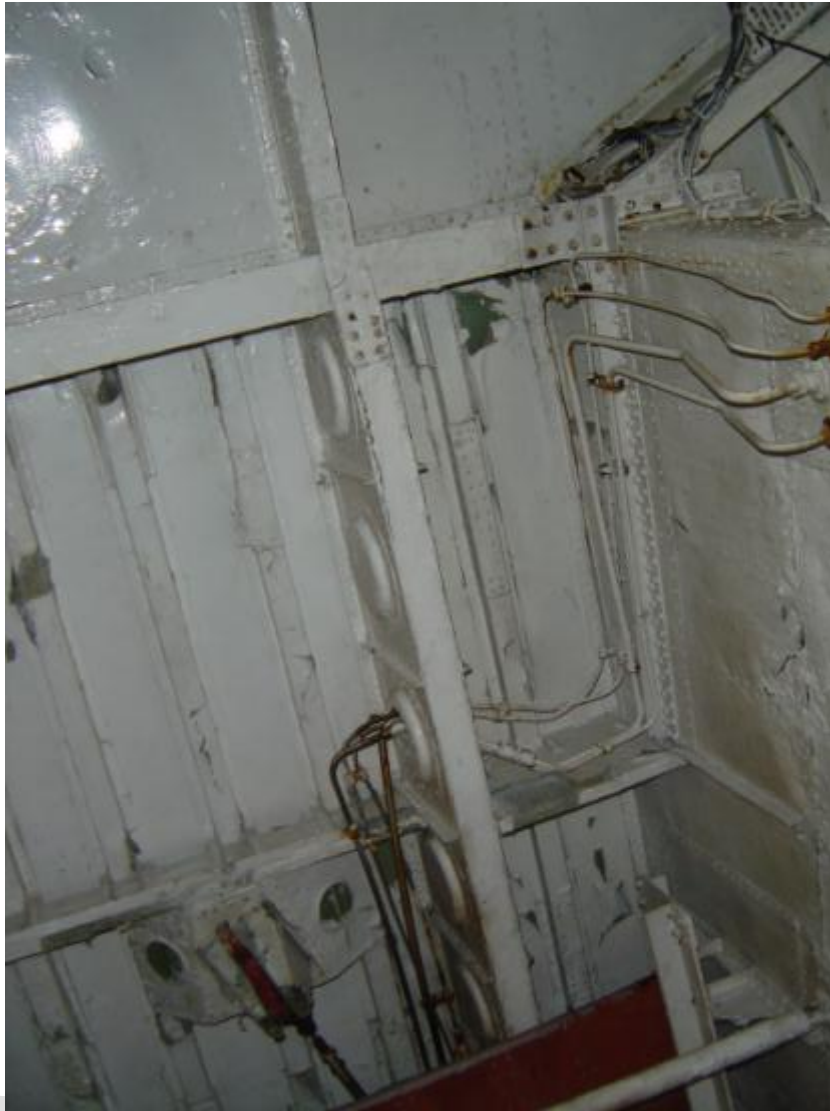
Photograph 11 - Hydraulic lines

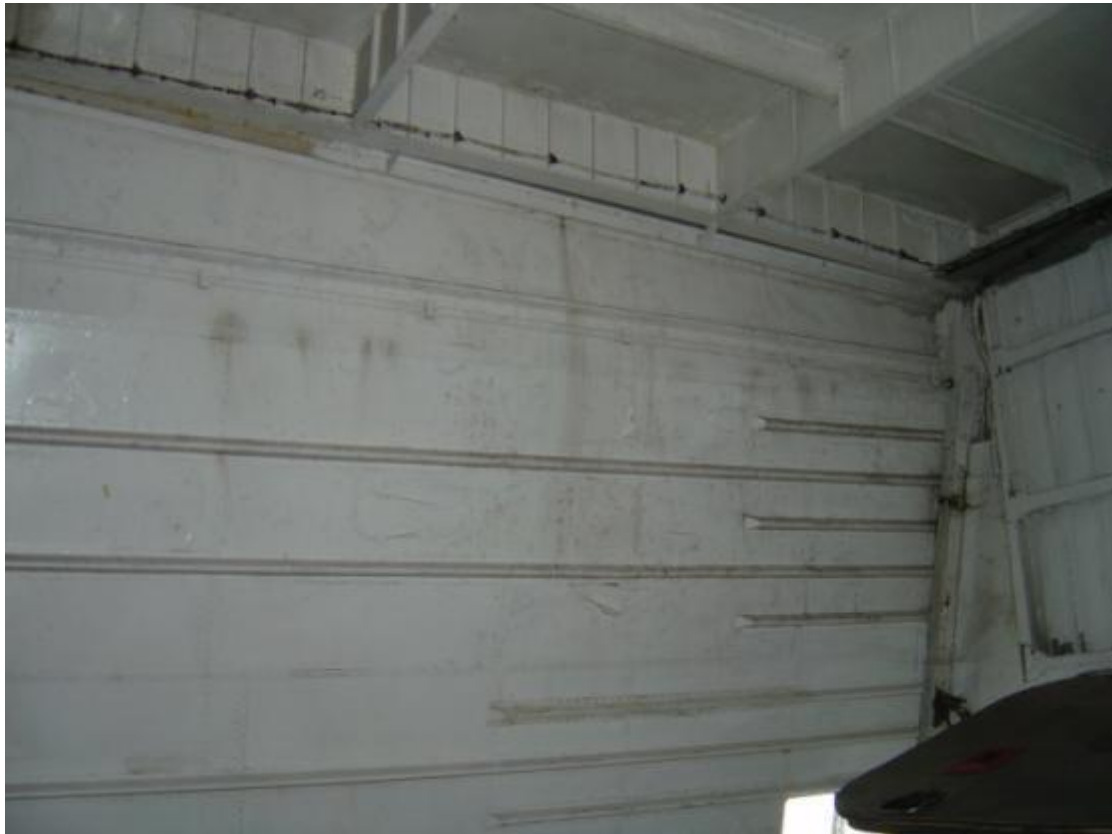
Photograph 12 - Stern door showing upper hydraulic line

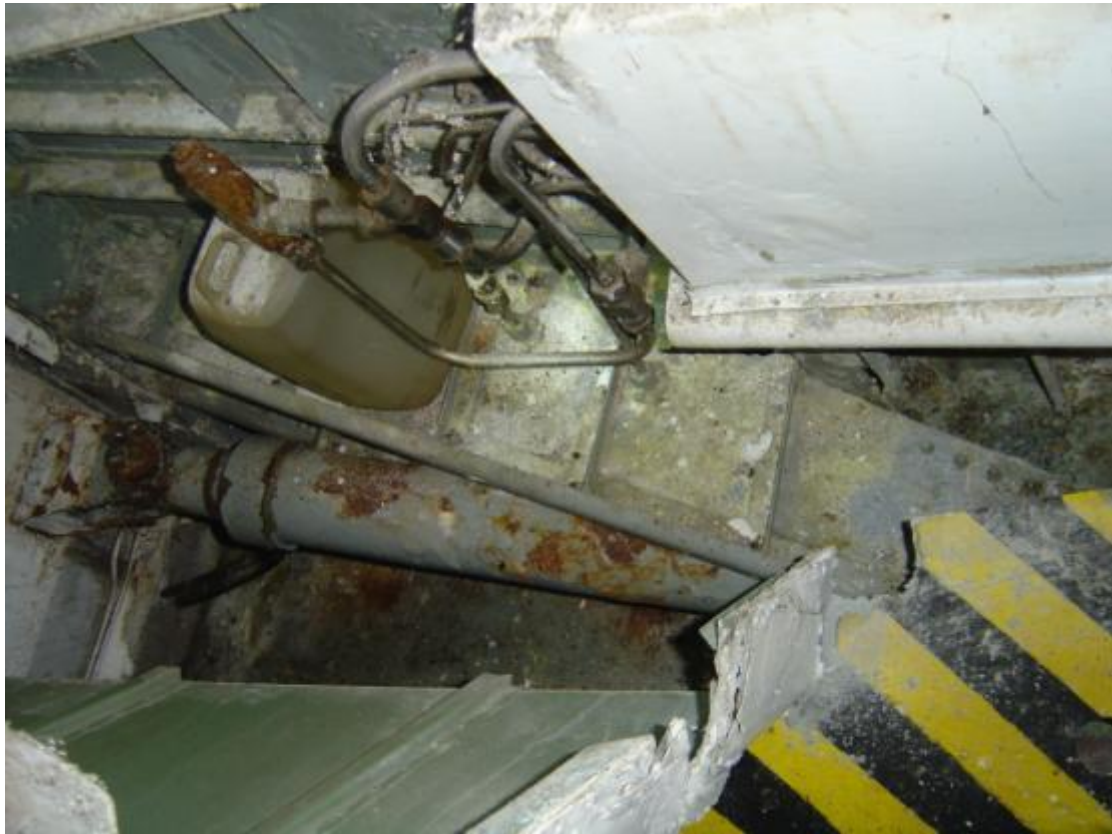
Photograph 13 - Stern door actuators

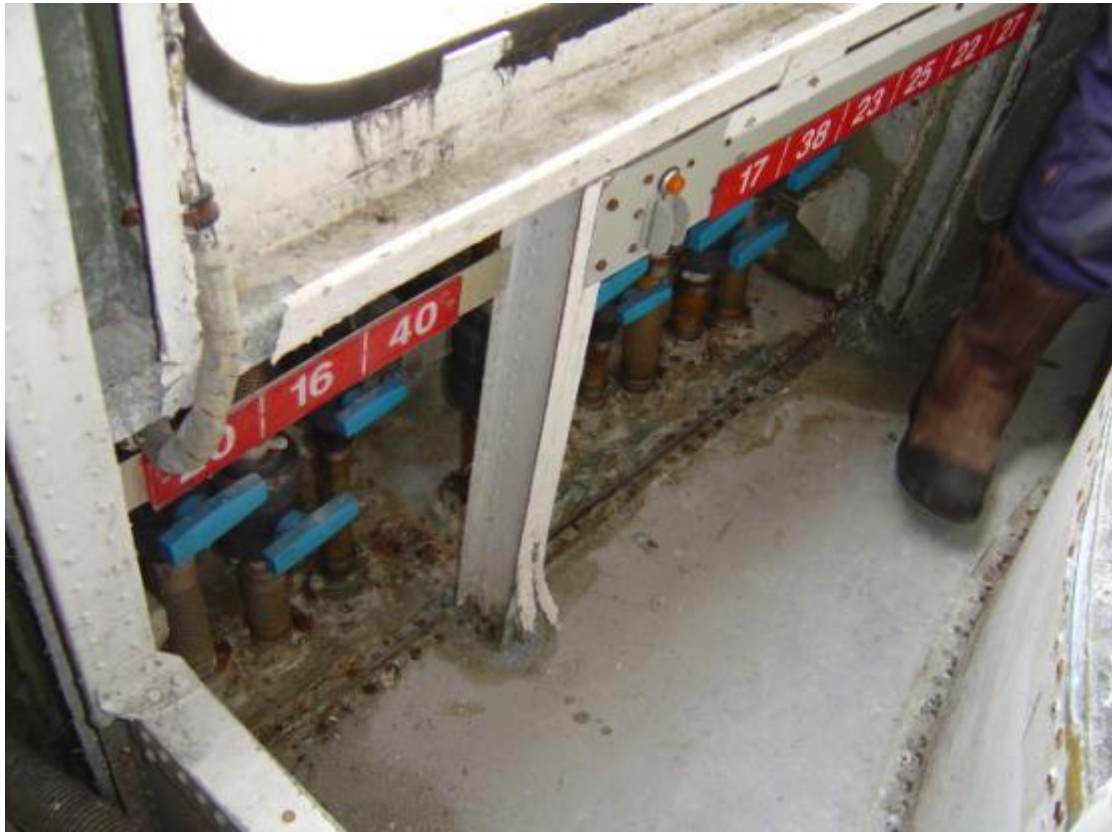
Photograph 14 - Water tank valves below filling trunk

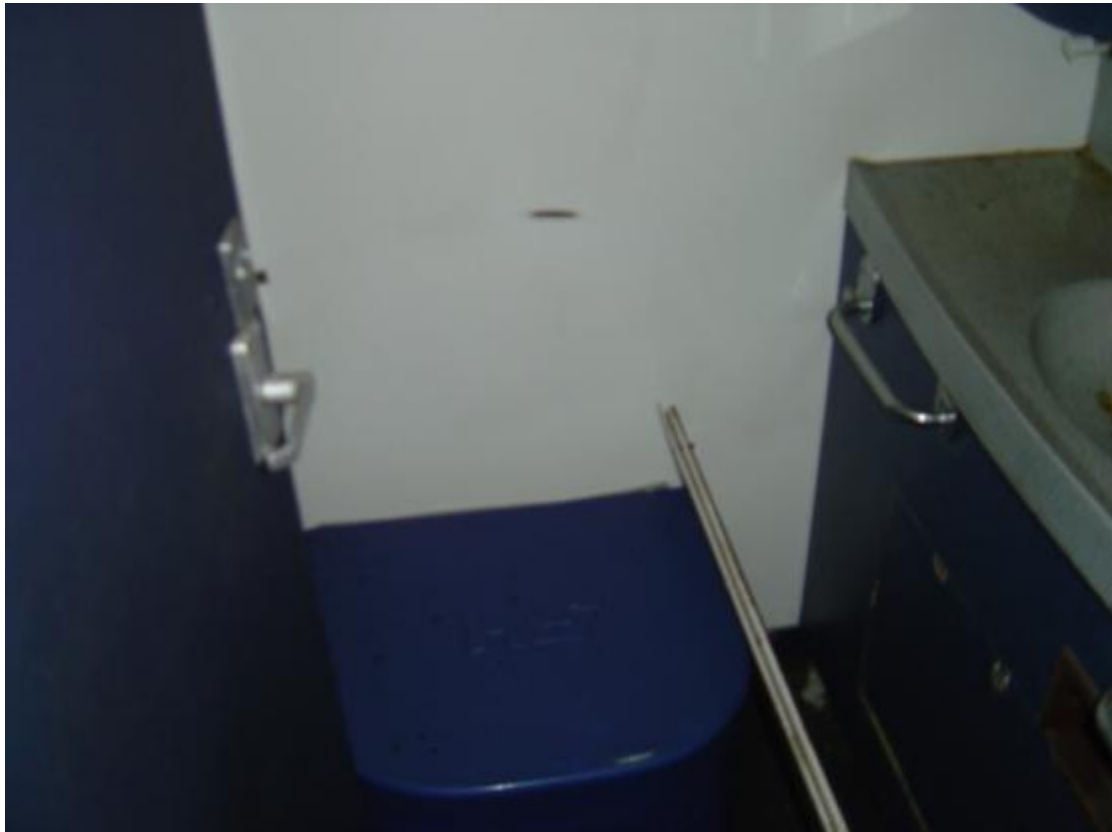
Photograph 15 - Heads compartment (vacuum system)

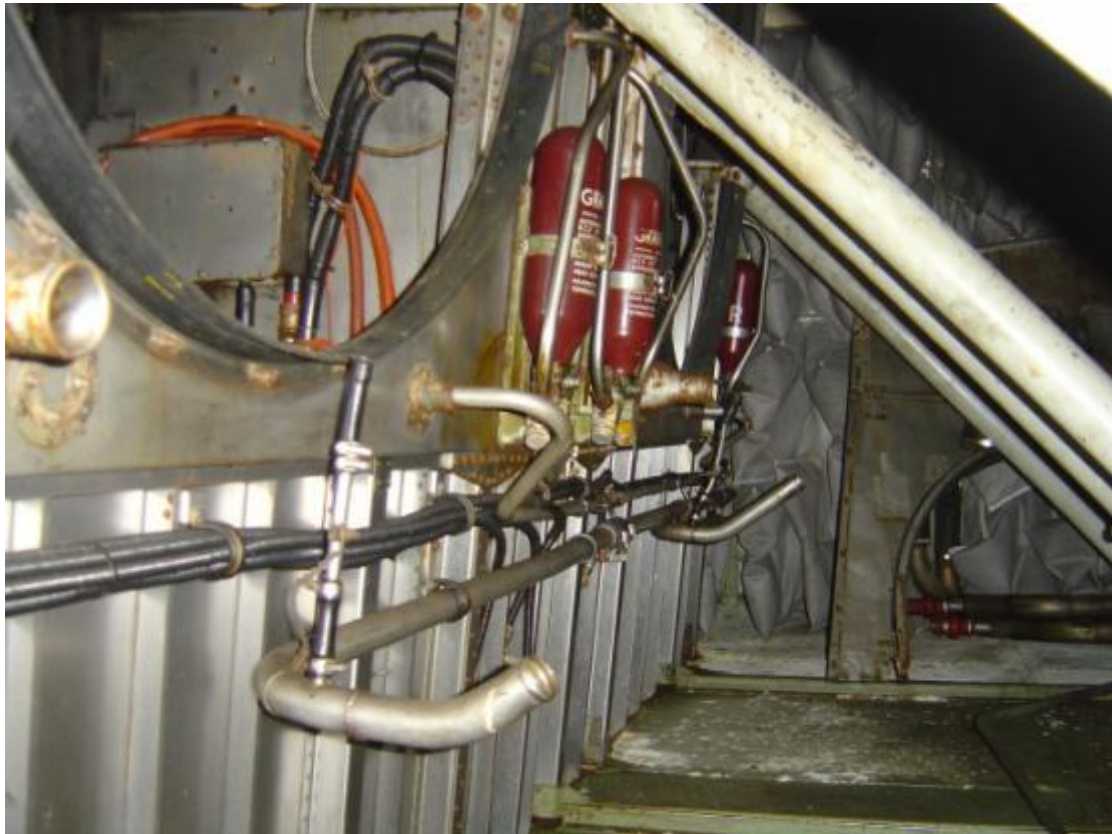
Photograph 16 - BCF extinguishers in machinery space

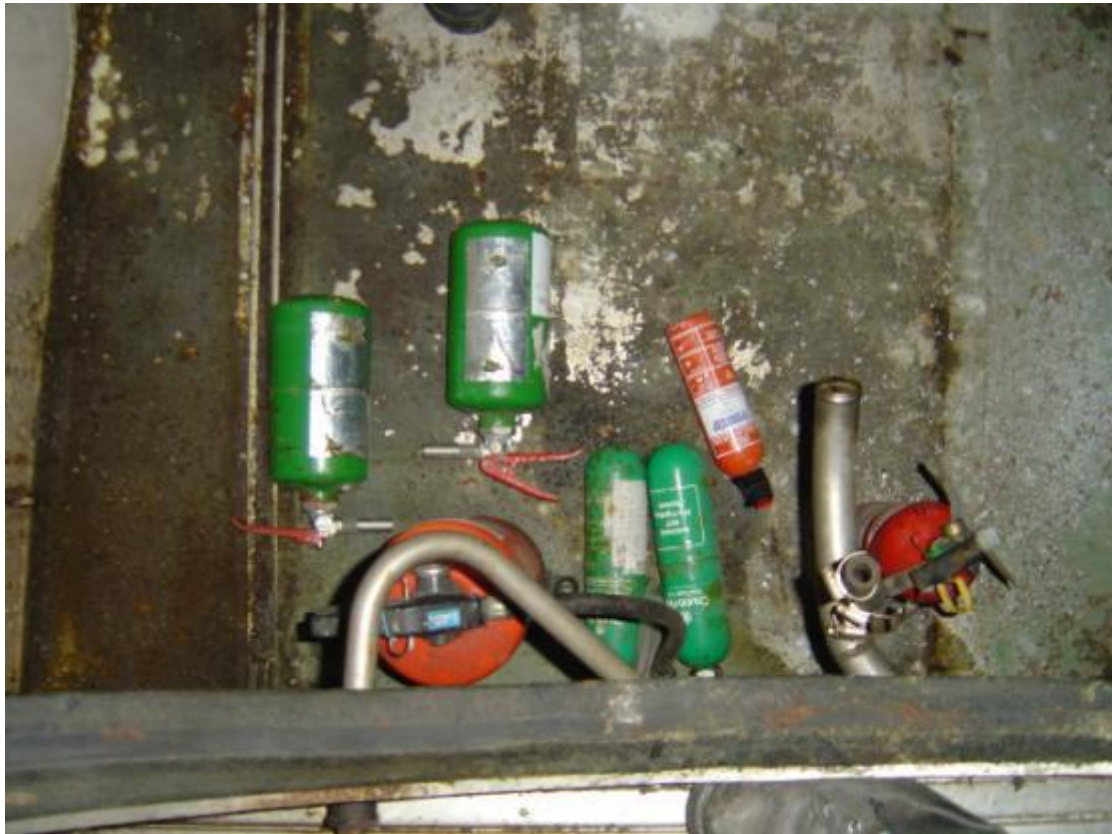
Photograph 17 - Halon and other portable extinguishers in port machinery space

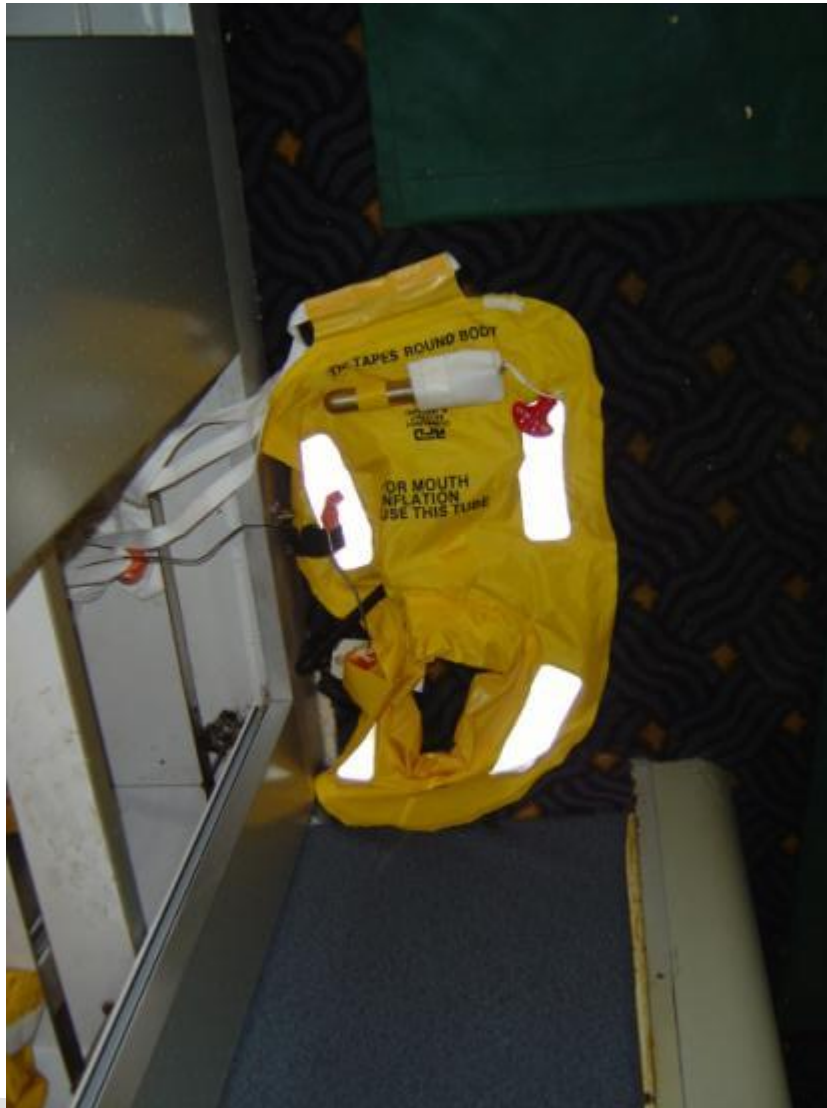
Photograph 18 – Life jacket

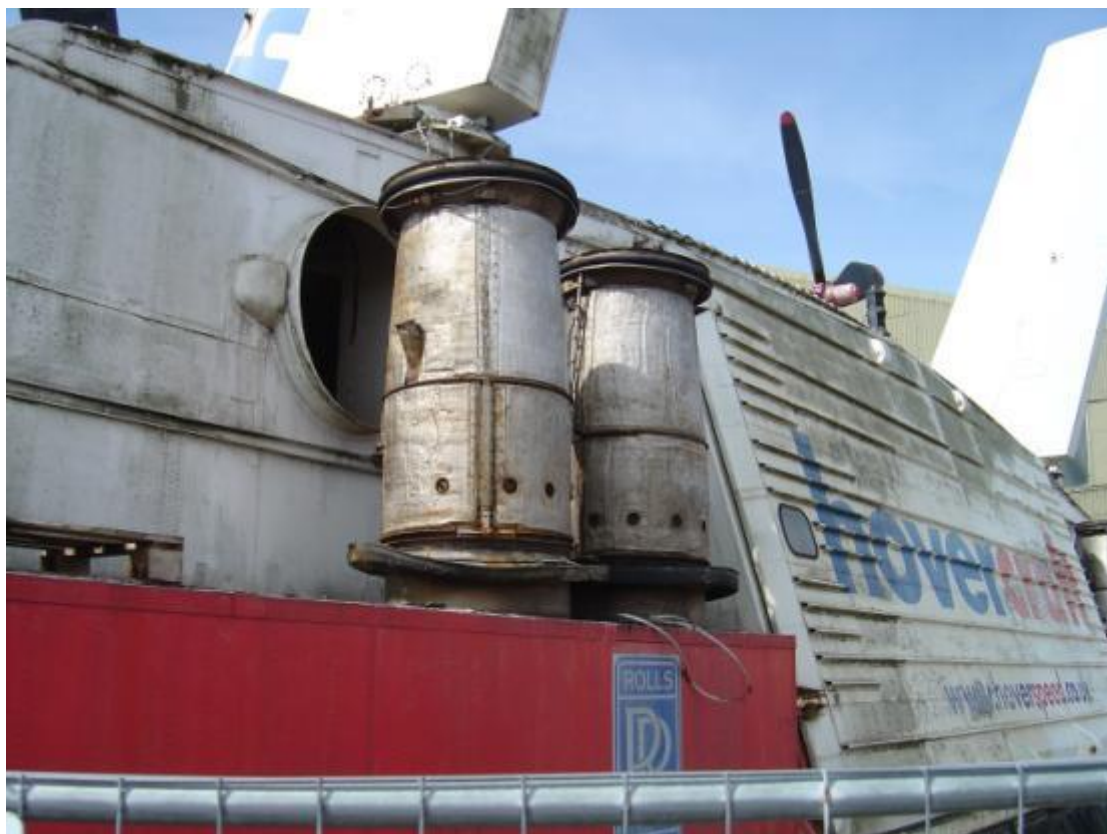
Photograph 20 - Insulation on exhausts of 'Princess Margaret'

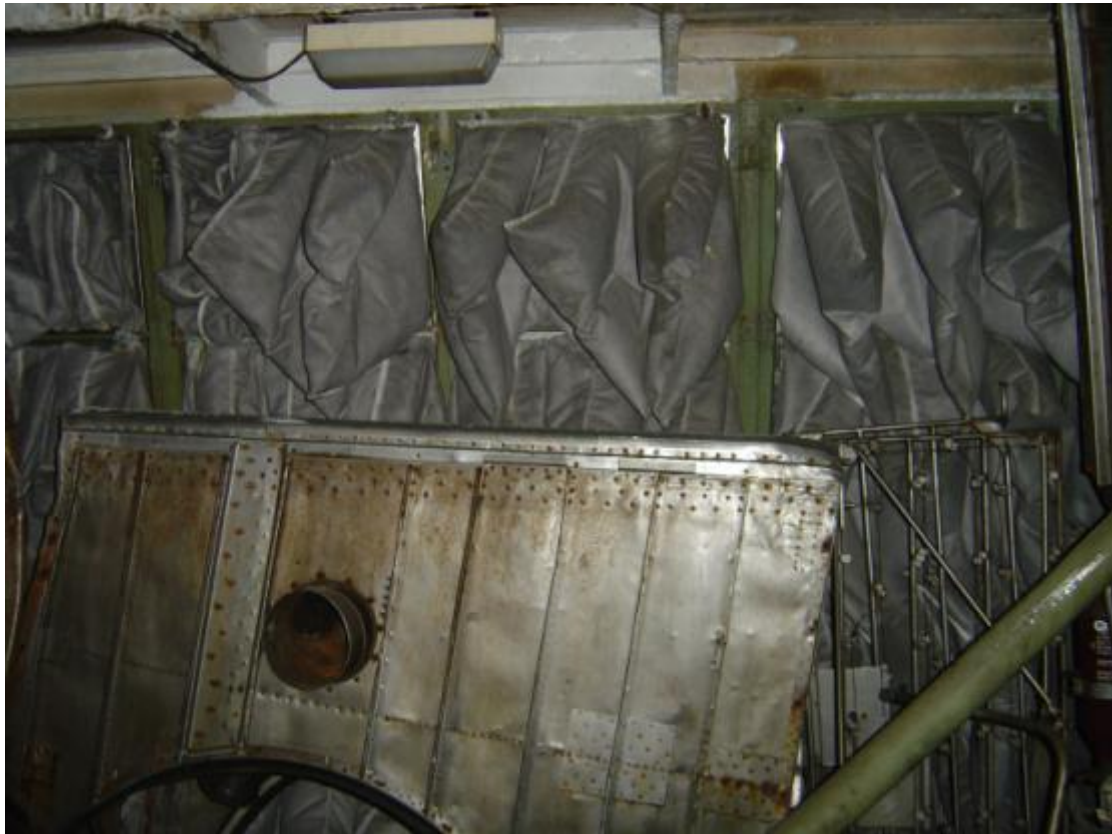
Photograph 21 - Air intake filters

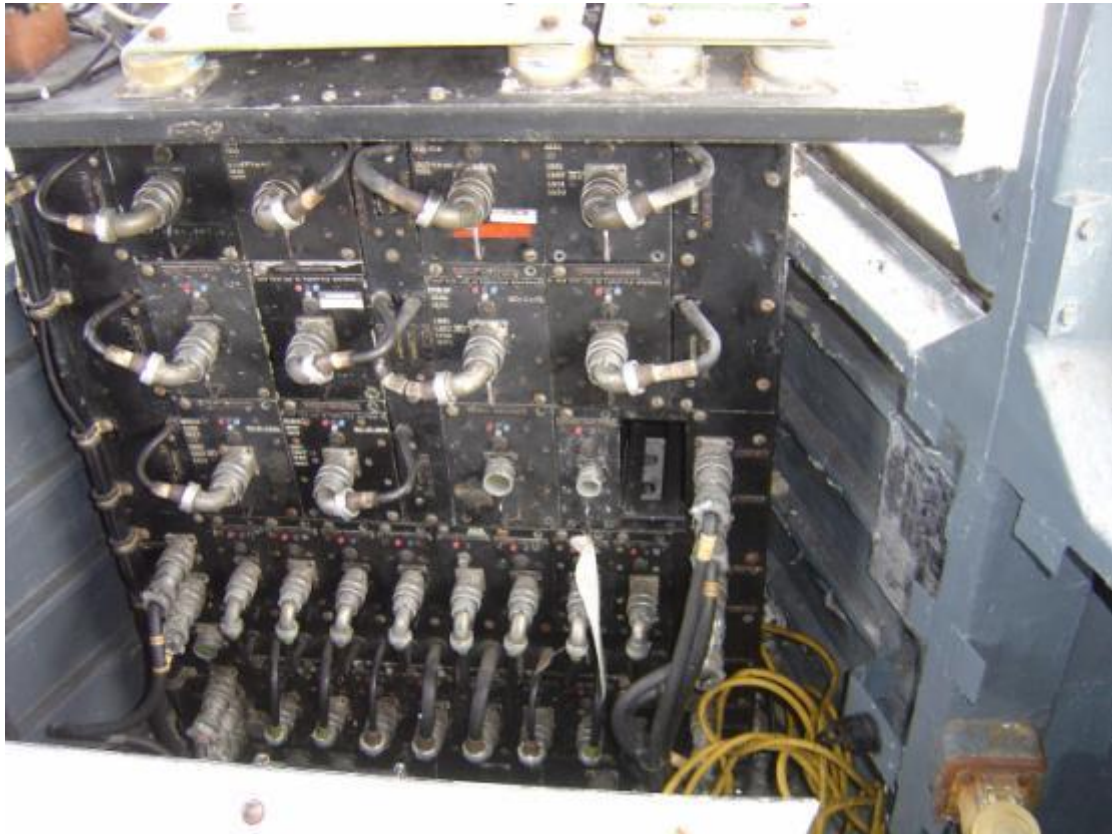
Photograph 23 - Servo amplifiers in cockpit

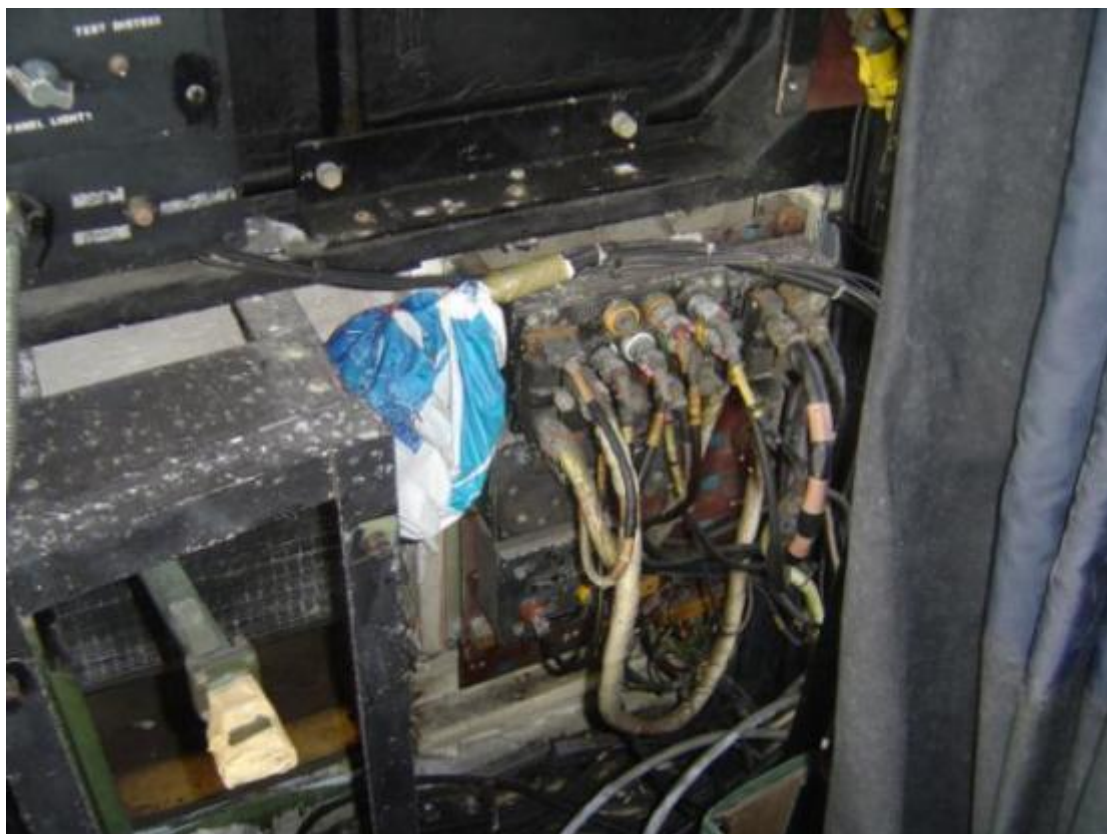
Photograph 24 - Radar and radio connections

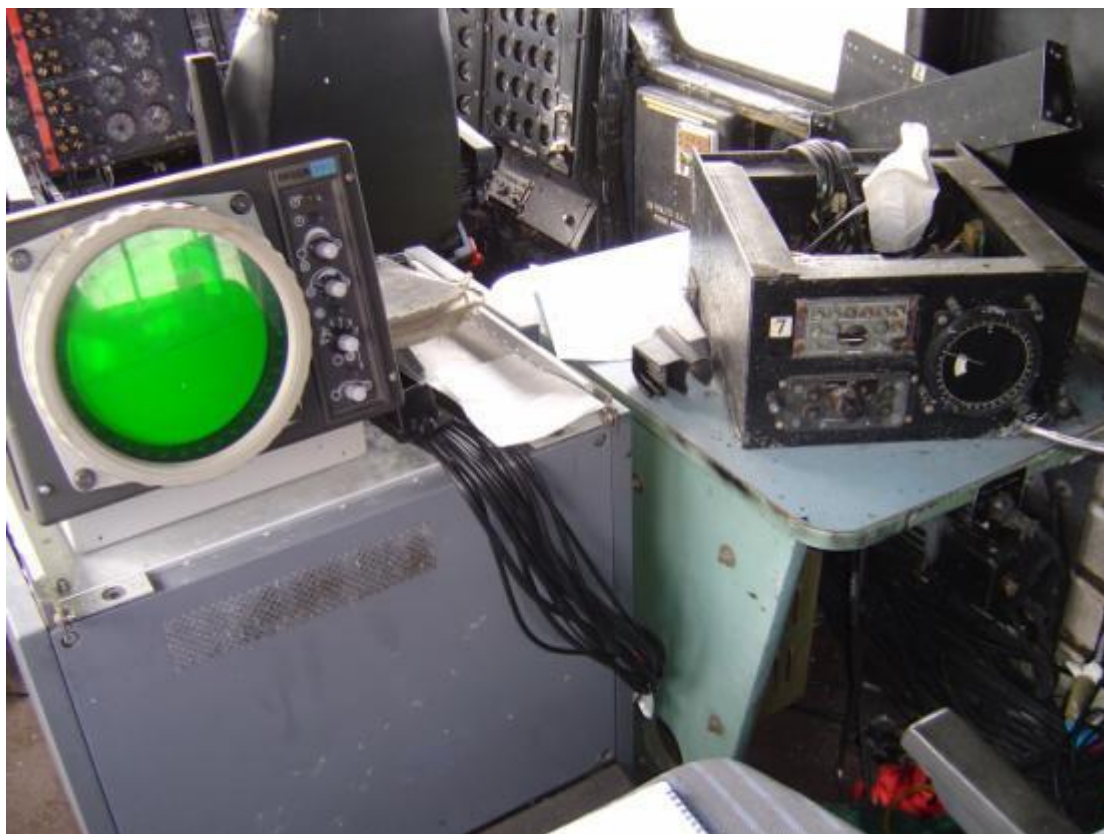
Photograph 25 - Decca 090 radar, radio transceiver and gyro-compass

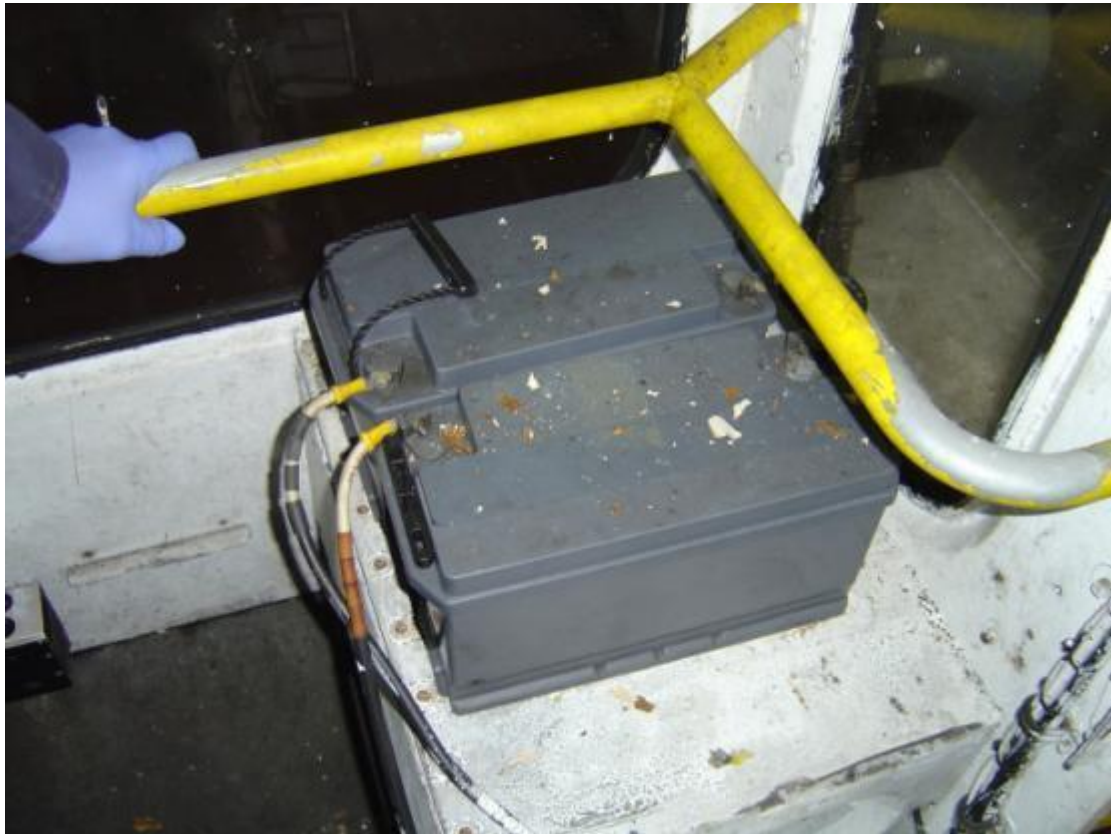
Photograph 26 - Batteries in vehicle deck control cabin

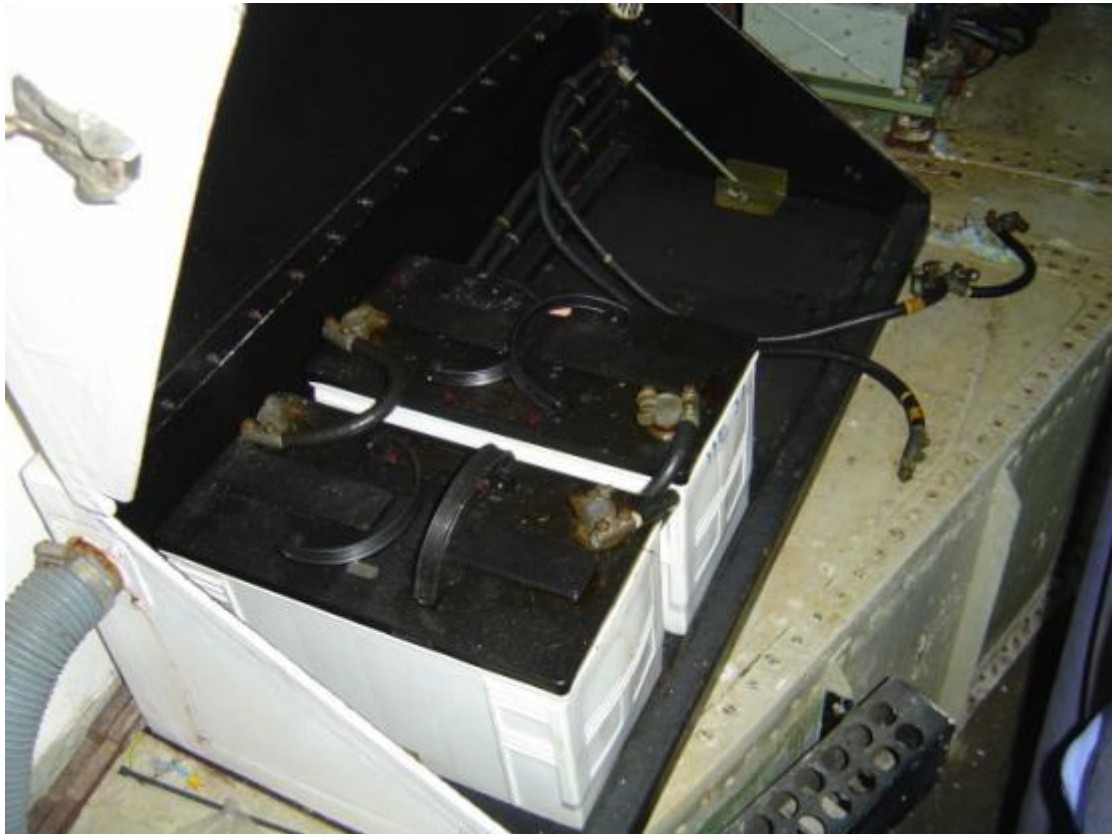
Photograph 27 - Batteries in starboard electrical bay

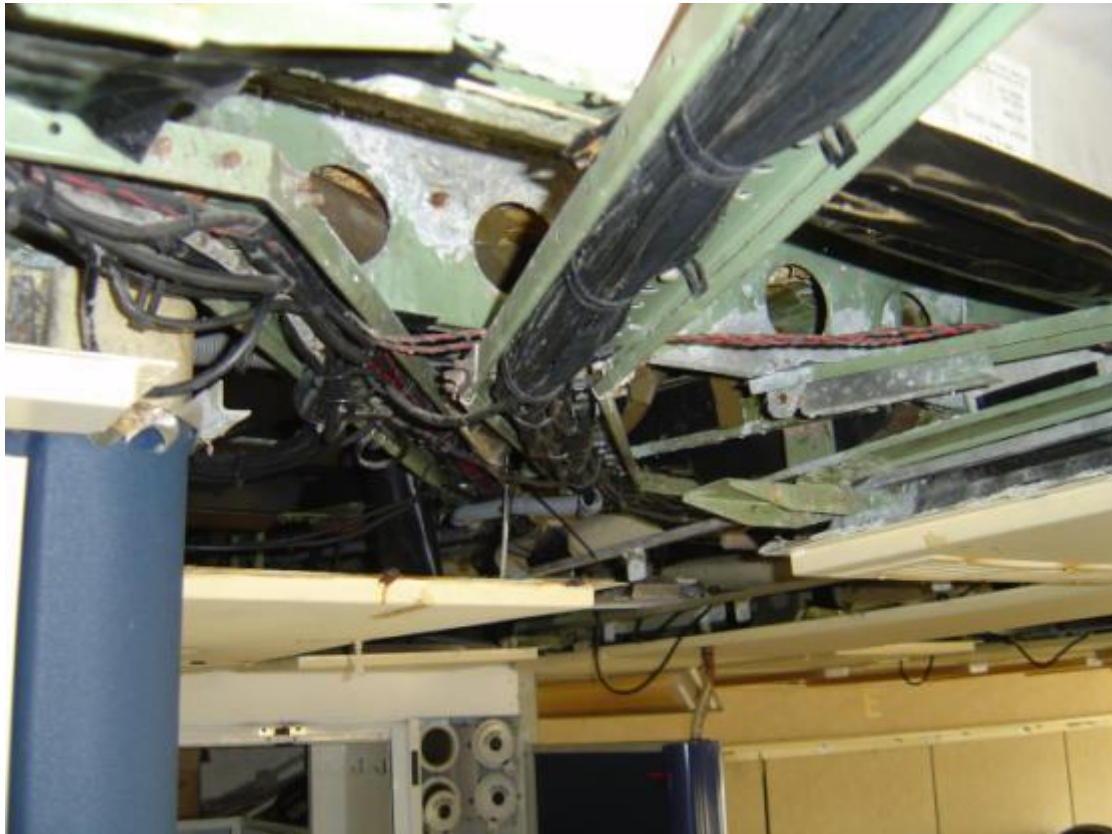
Photograph 28 - Deck head opened up showing cabling structure and trunking

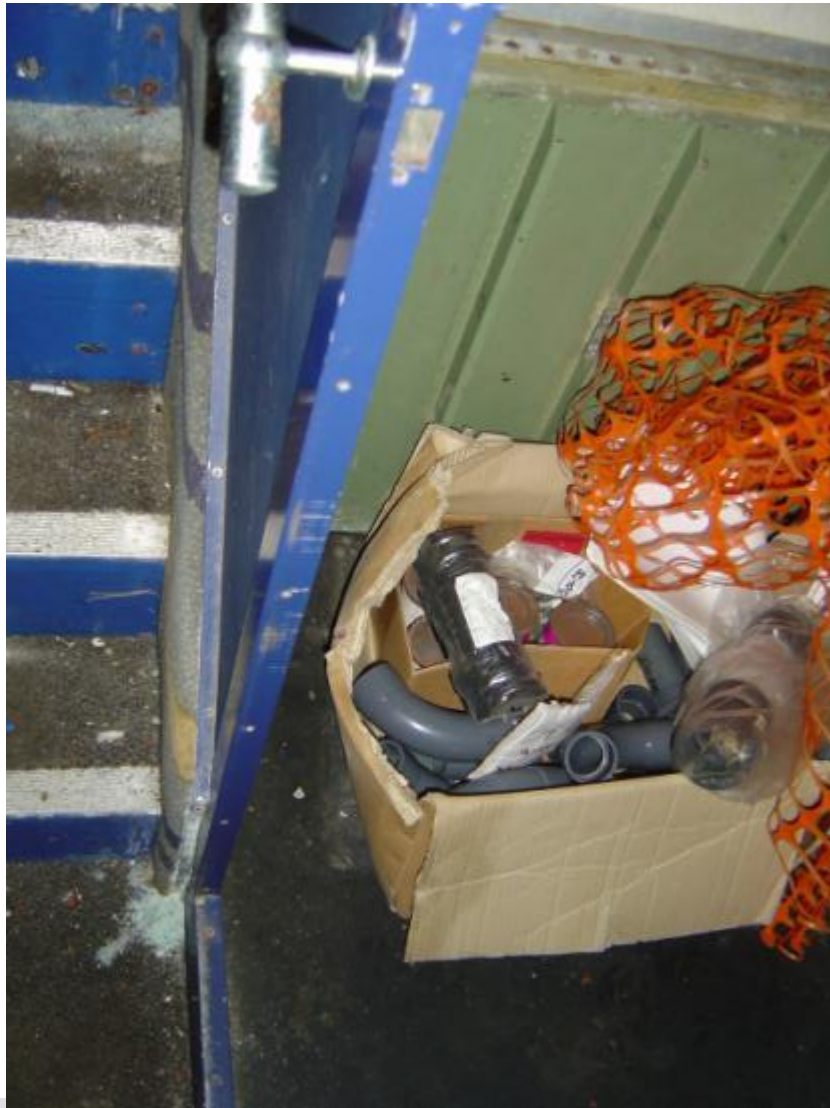
Photograph 32 - Box of pipe spares and associated adhesive
