RE: Request for Information – RFI4832

Specialist Field:	Marine Consultant and Surveyor
On behalf of:	Homes and communities Agency
Subject:	Condition / Cost of Disposal

INSPECTION OF SRN4 HOVERCRAFT FOR HAZARDS

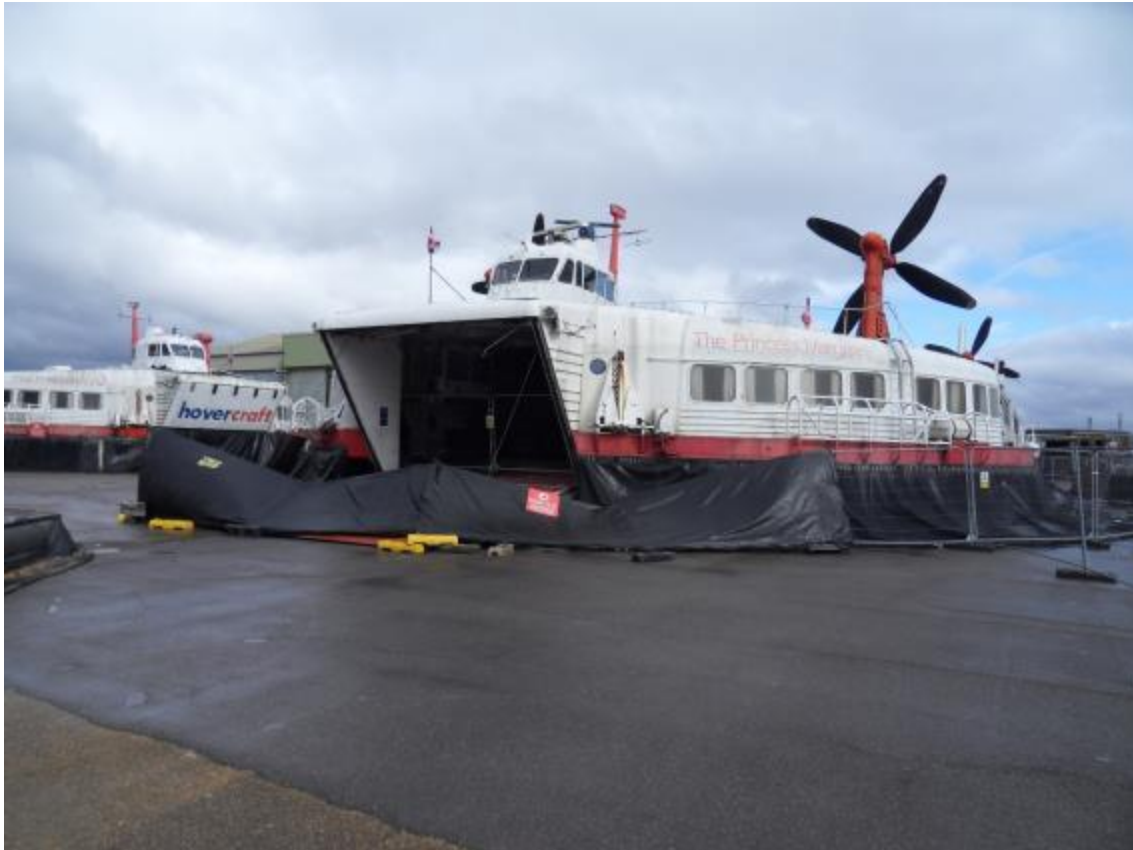
Photograph 1 - 'Princess Margaret'

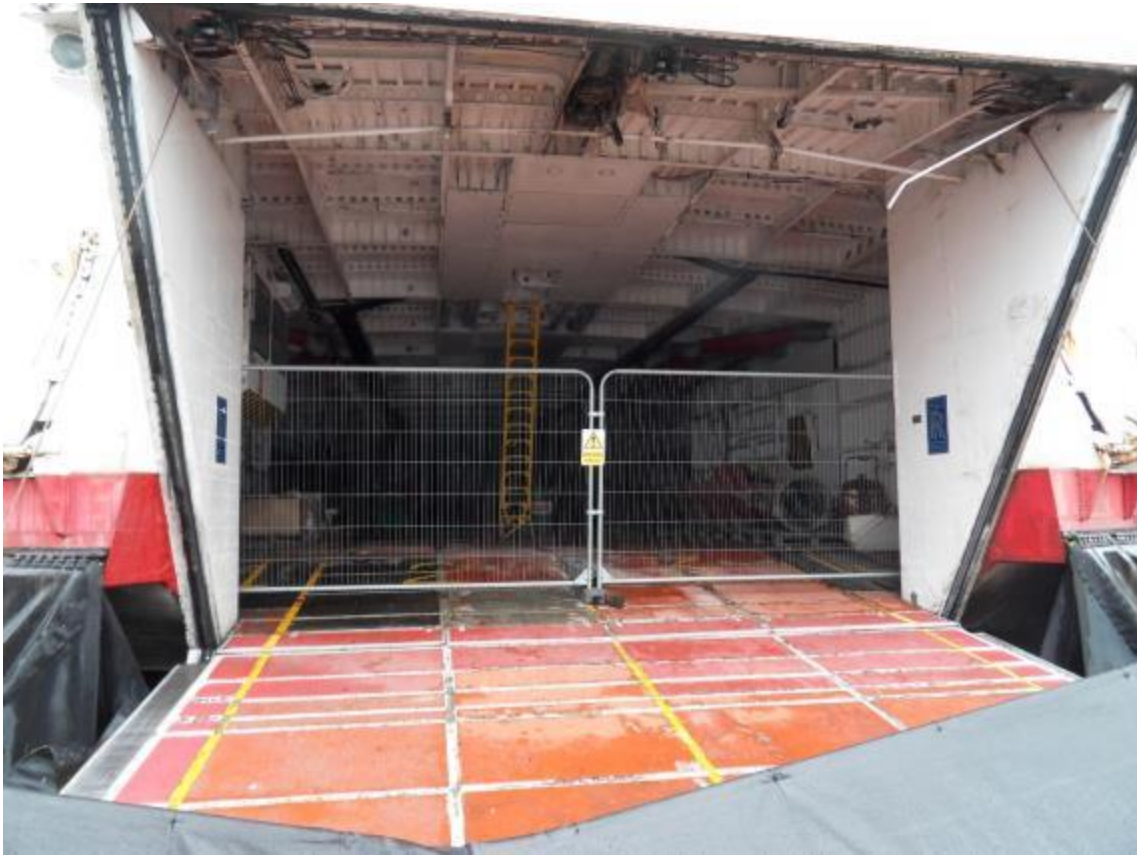
Photograph 7 – Open bow door

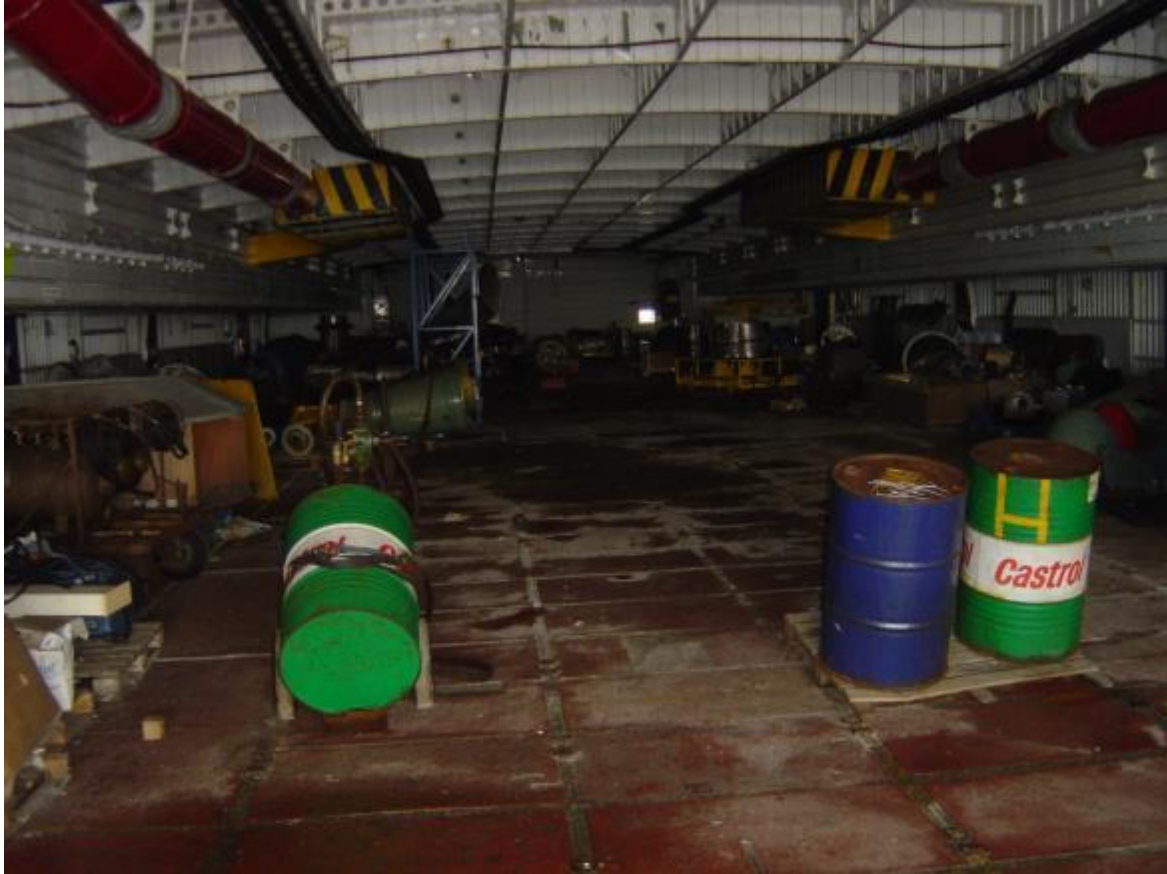
Photograph 8 – Vehicle deck showing oil drums and spare gear

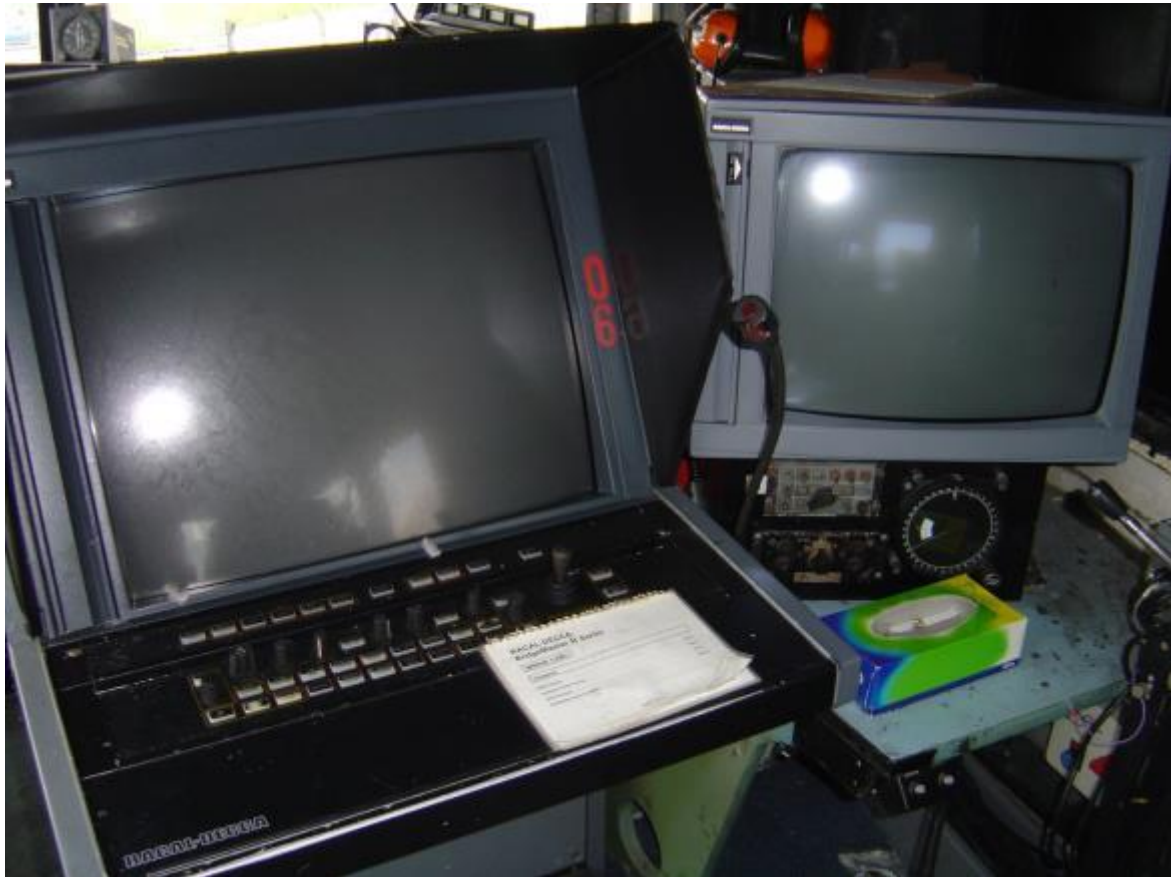
- 4.8 The cockpit is accessed by an unprotected ladder and is largely intact. Radar displays and instrumentation is present but some connections are missing, photographs 11 and 12. Power amplifiers for the control circuits are at the after end of the cockpit. The window to port is cracked.

Photograph 11 – Radar and gyro

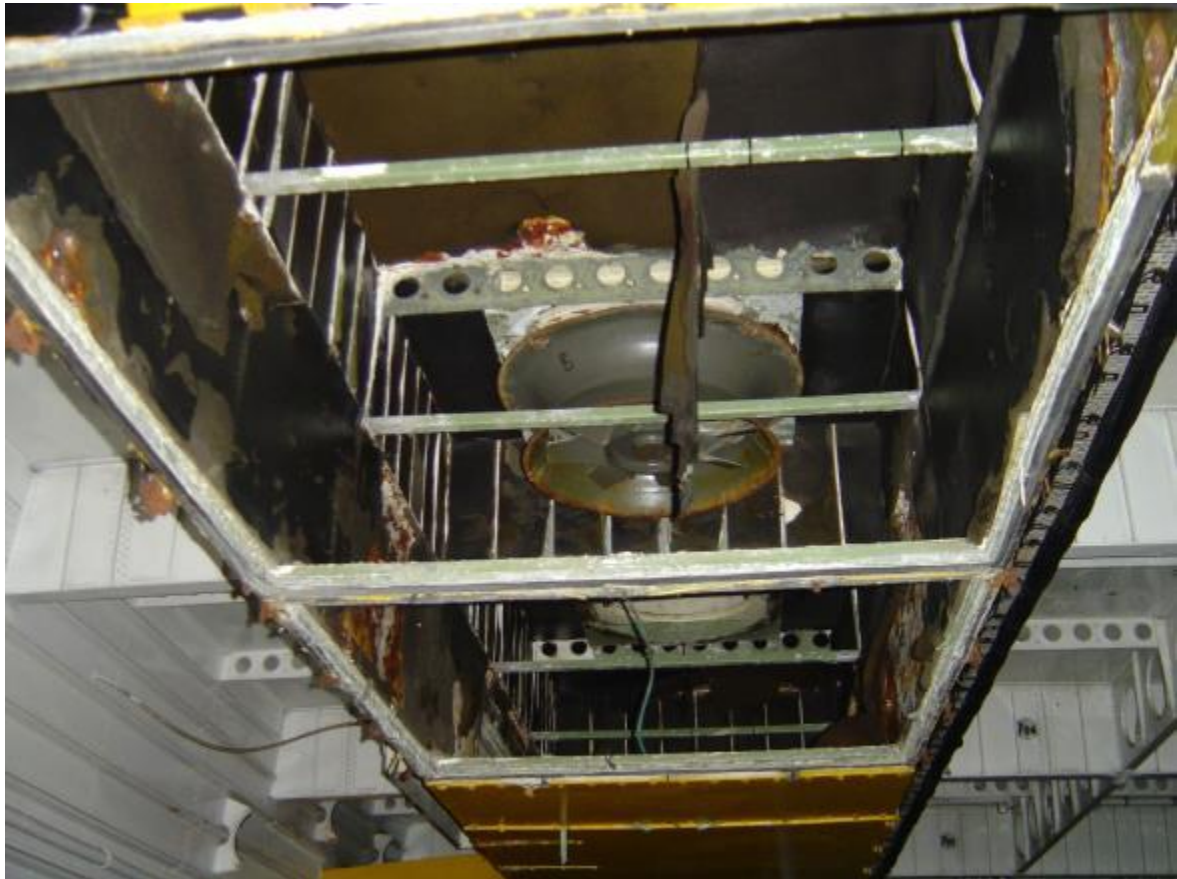
- 4.9 The high level ventilation trunking was opened to examine the arrangement. Fans above feed a rectangular plenum into which warm air is bled from the engine compartment through a stainless steel pipe, see photograph 13 and 14. The distribution is by tubular aluminium with flexible connectors. No asbestos was seen during any of the inspections.

Photograph 12 – Interior of high level fan trunking

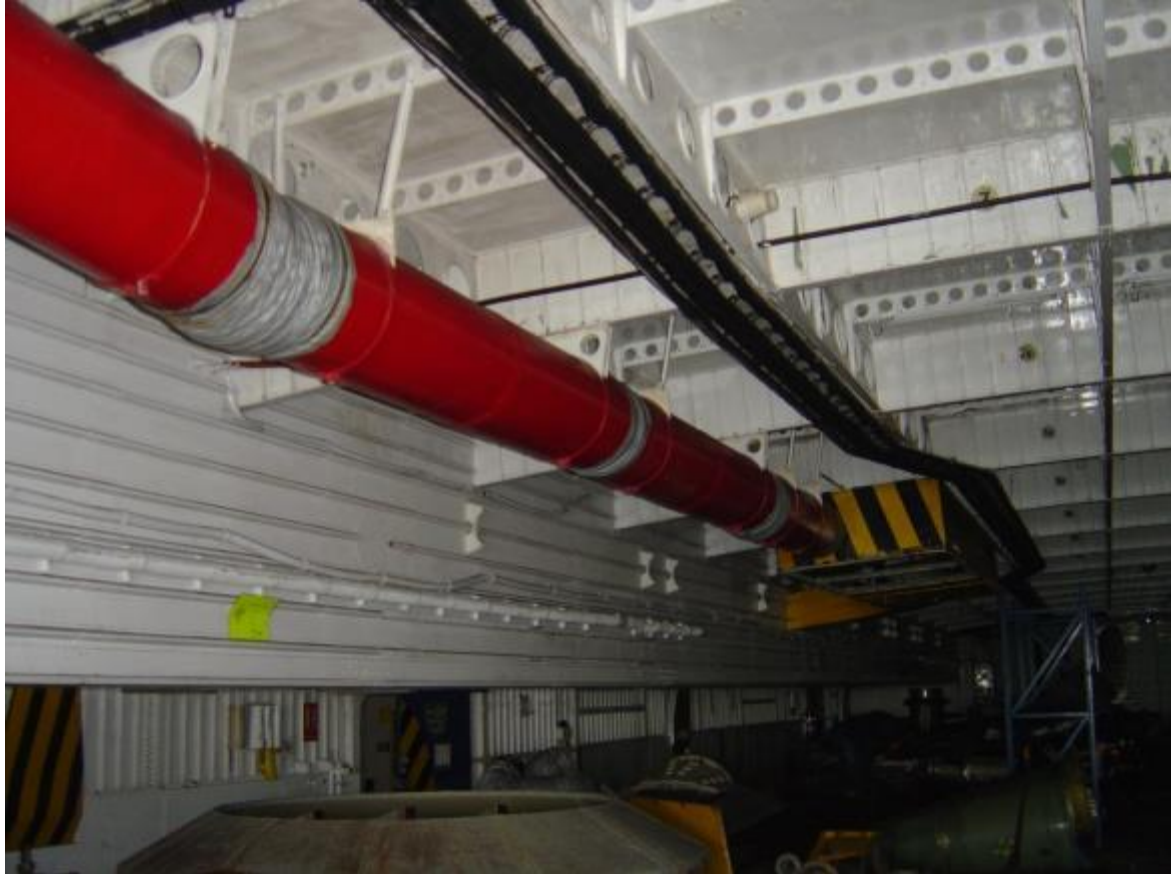
Photograph 13 – High level trunking

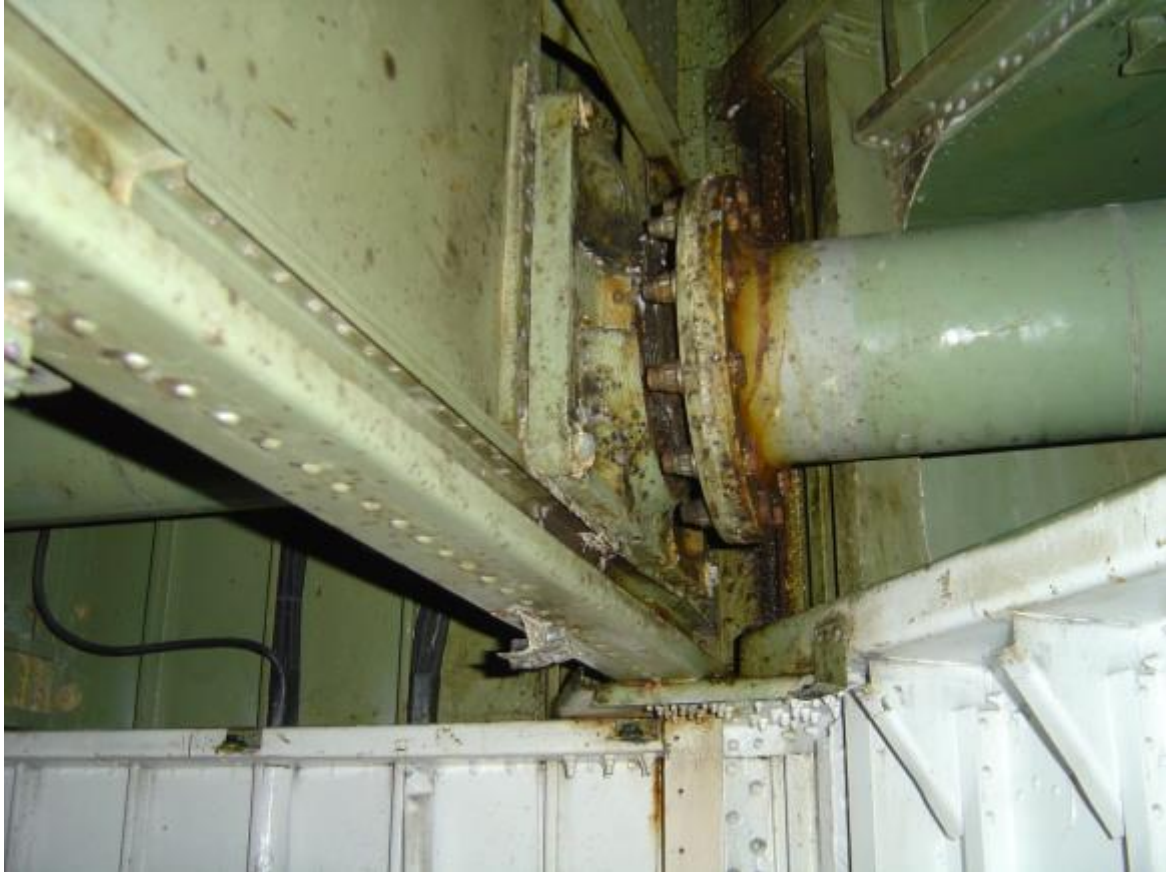
- 4.10 The covers of the drive shaft case were opened to port exposing the drive shaft running to the port forward pylon and one bearing. There will be numerous bearings supporting the shaft along its length, see photograph 15. This also gives access to the window washer tanks which are partially filled, see photograph 16.

Photograph 14 – Drive shaft

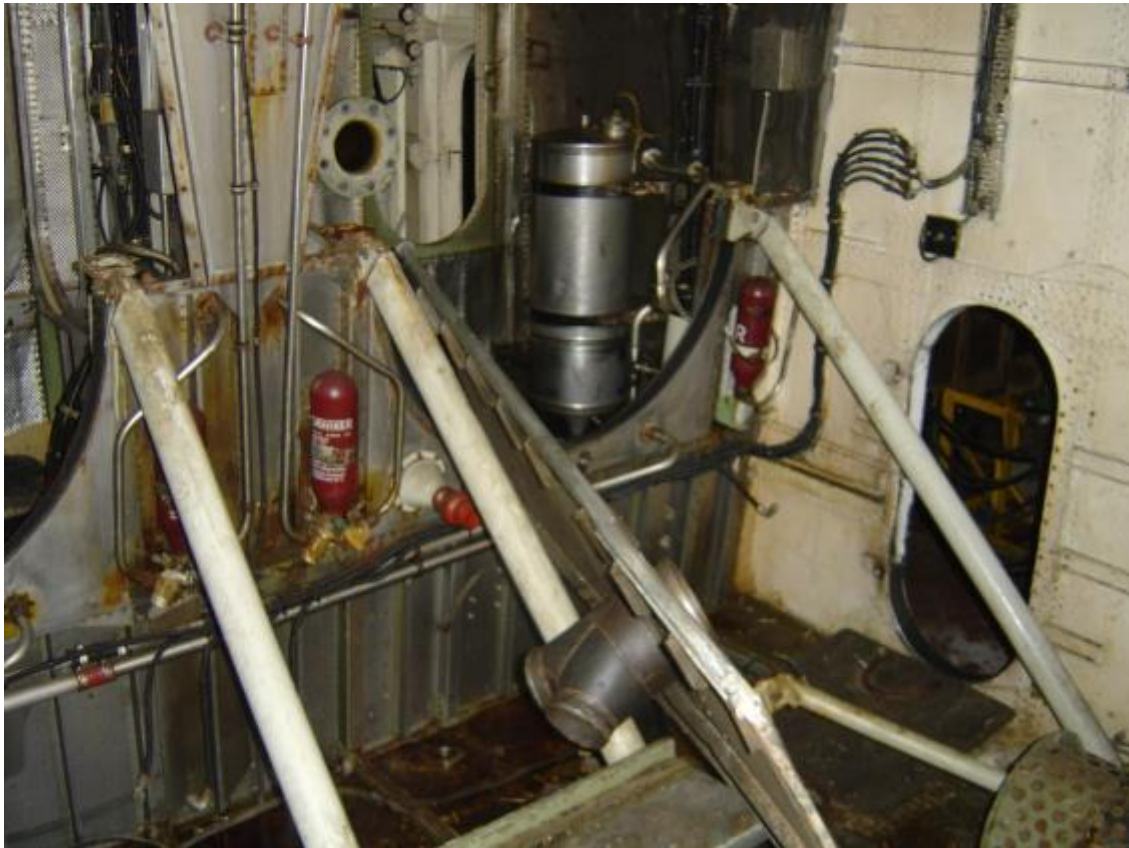
Photograph 18 - Empty machinery compartment – with BCF (Bromochlorodifluoromethane) bottles

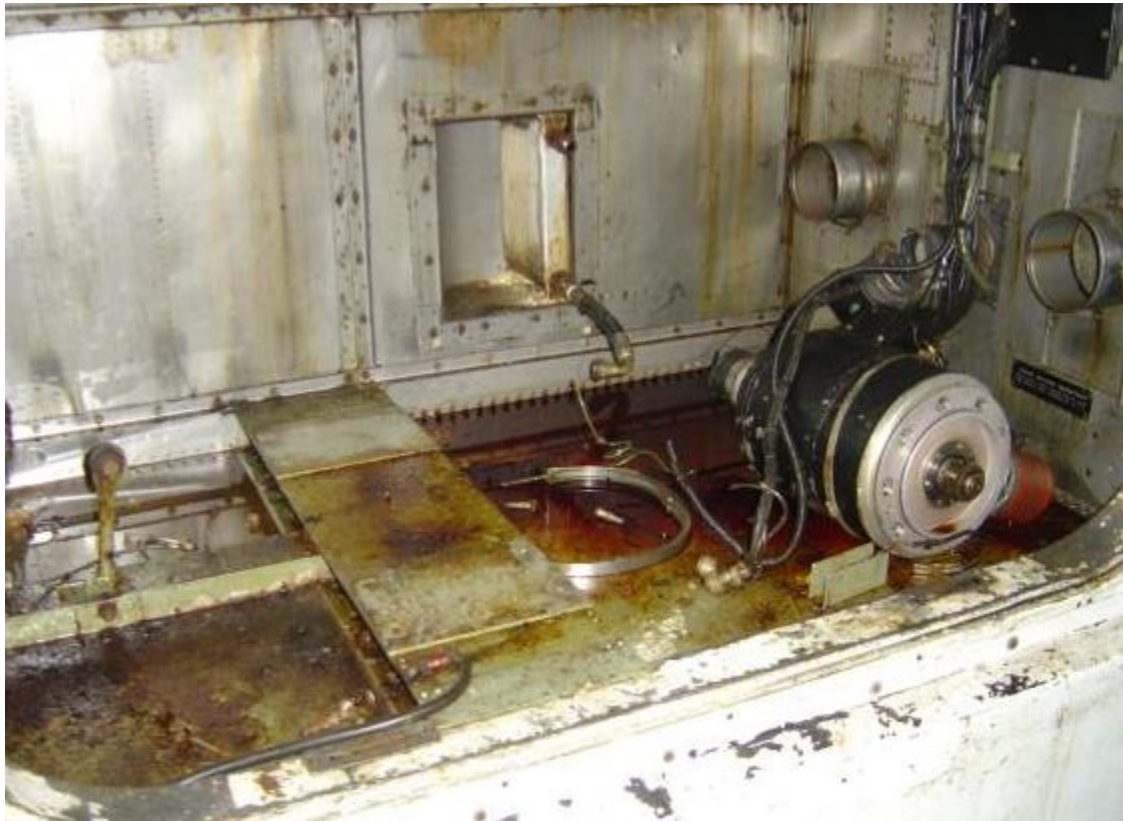
Photograph 20 – APU (Auxiliary Power Unit) bay
